Title of Thesis: Performance of EPB-TBM in Mixed Face Conditions:
City of Edmonton South LRT Extension – University Station
to Health Sciences Station

Performance of EPB-TBM in Mixed Face Conditions:

City of Edmonton South LRT Extension – University Station to Health Sciences Station

Geotechnical Engineering

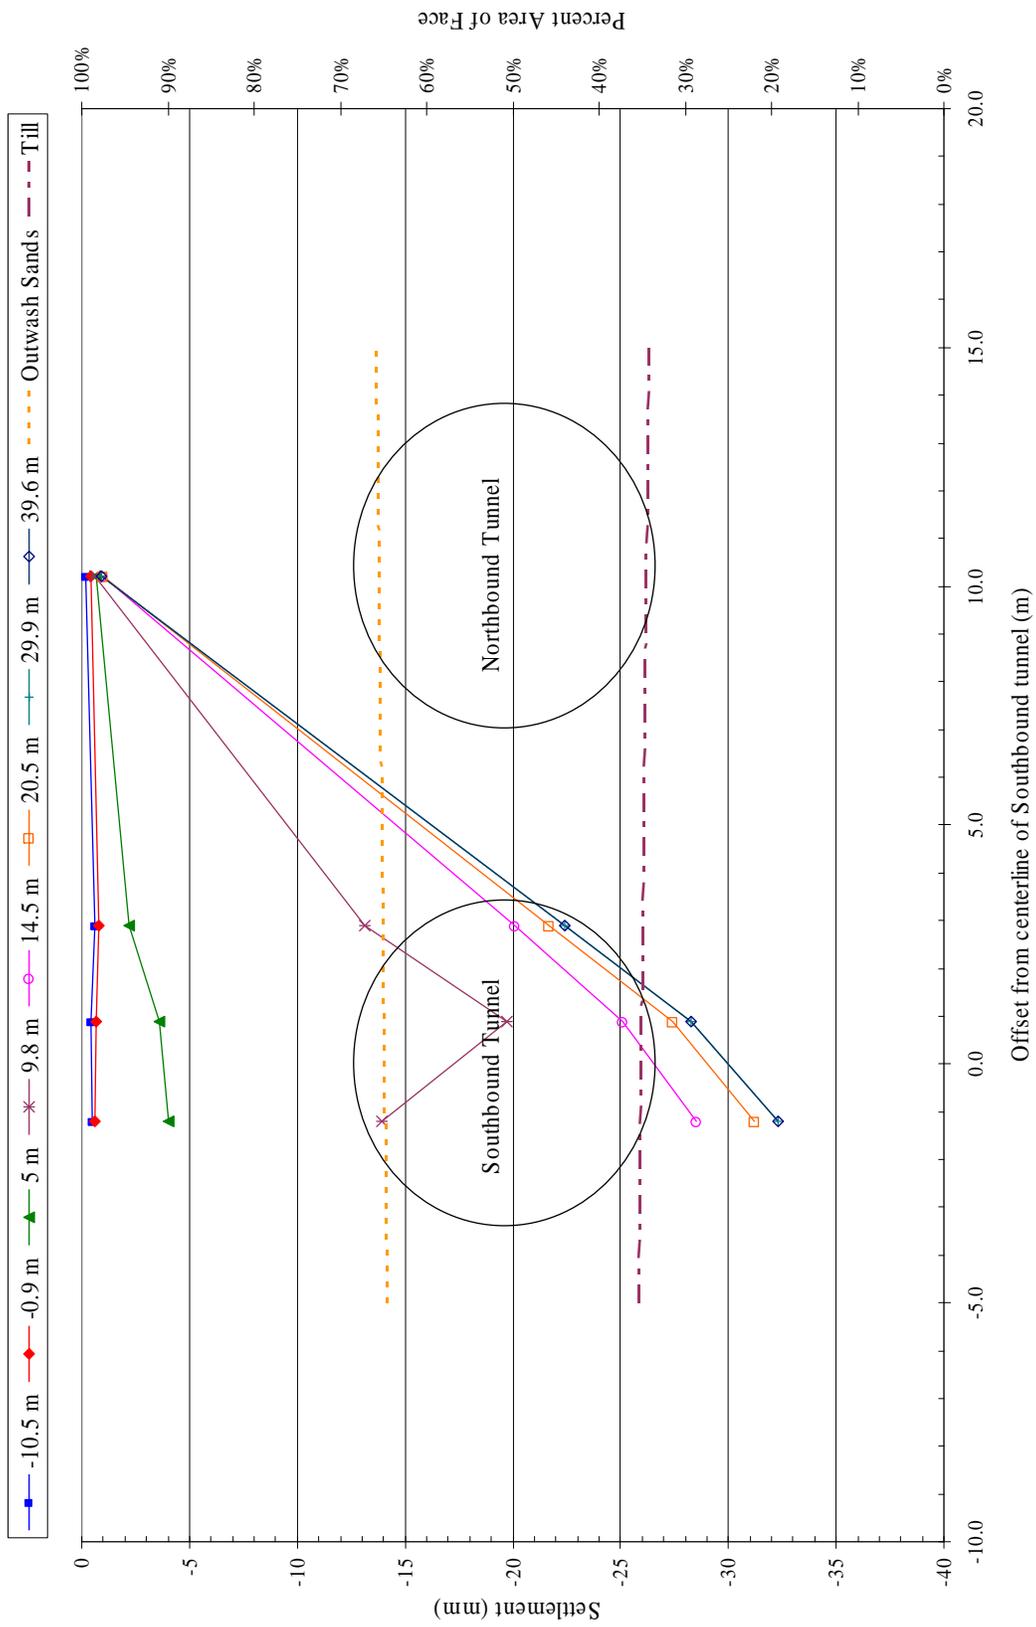
Figure H-1 Observed deep settlement at Array D during construction of Southbound Tunnel.

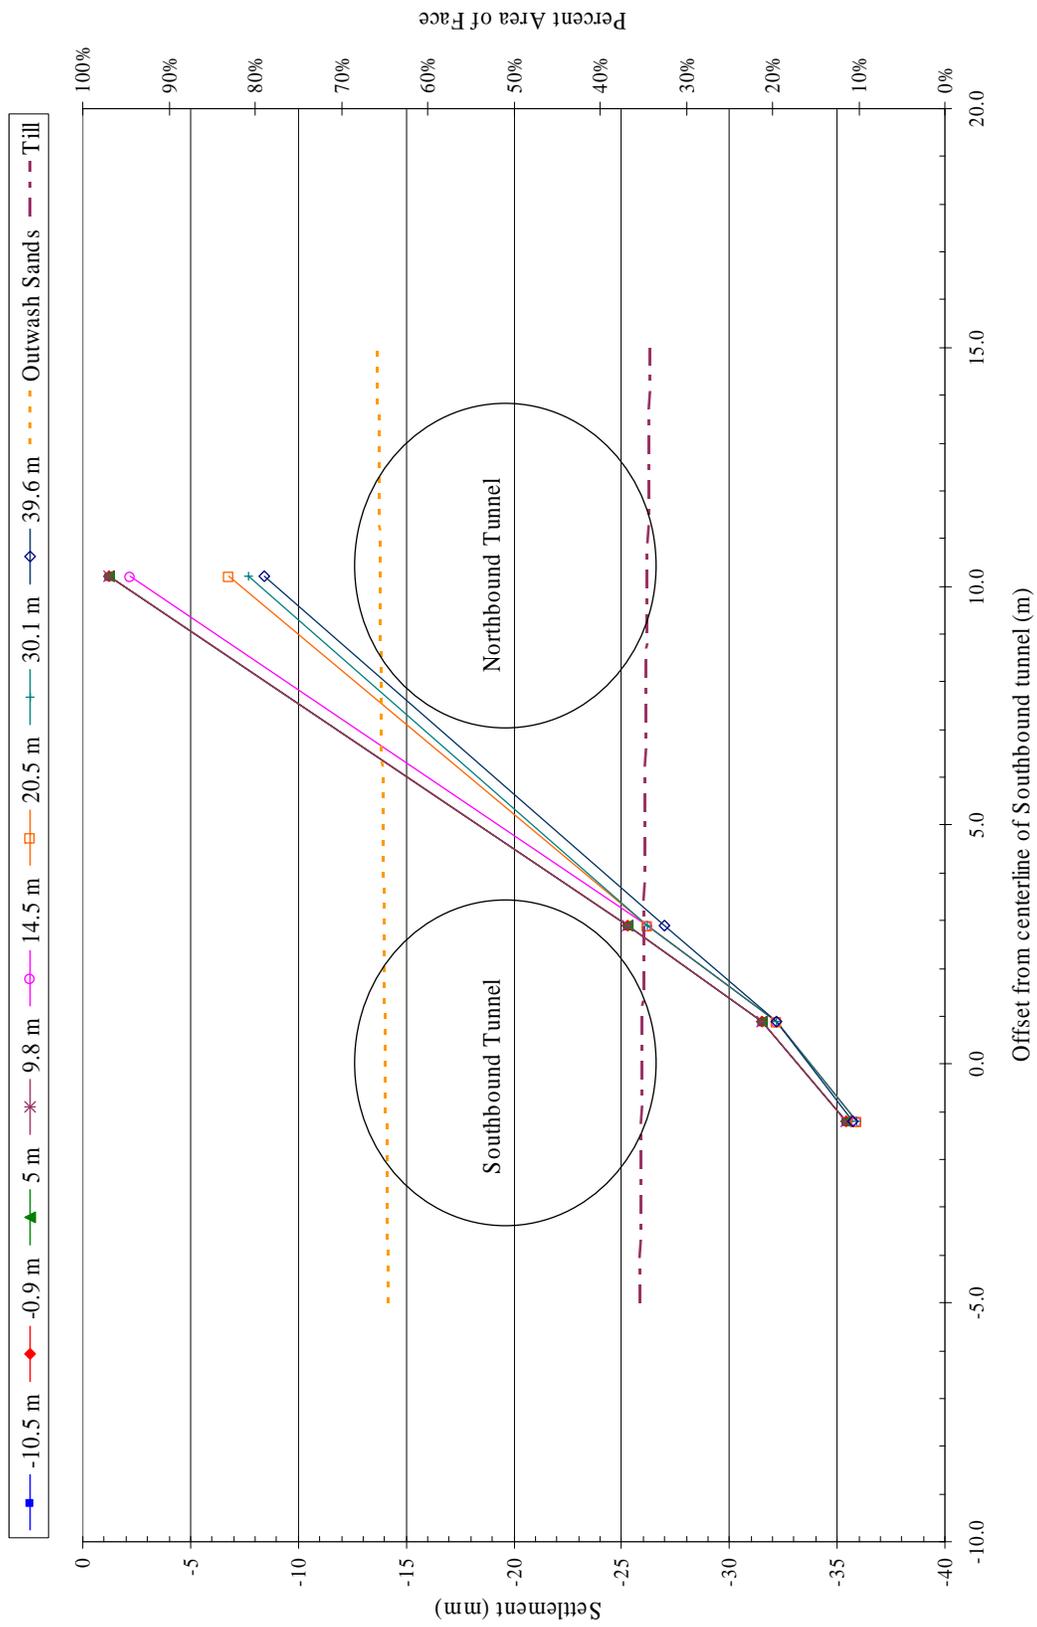
Figure H-2 Observed deep settlement at Array D during construction of Northbound Tunnel.

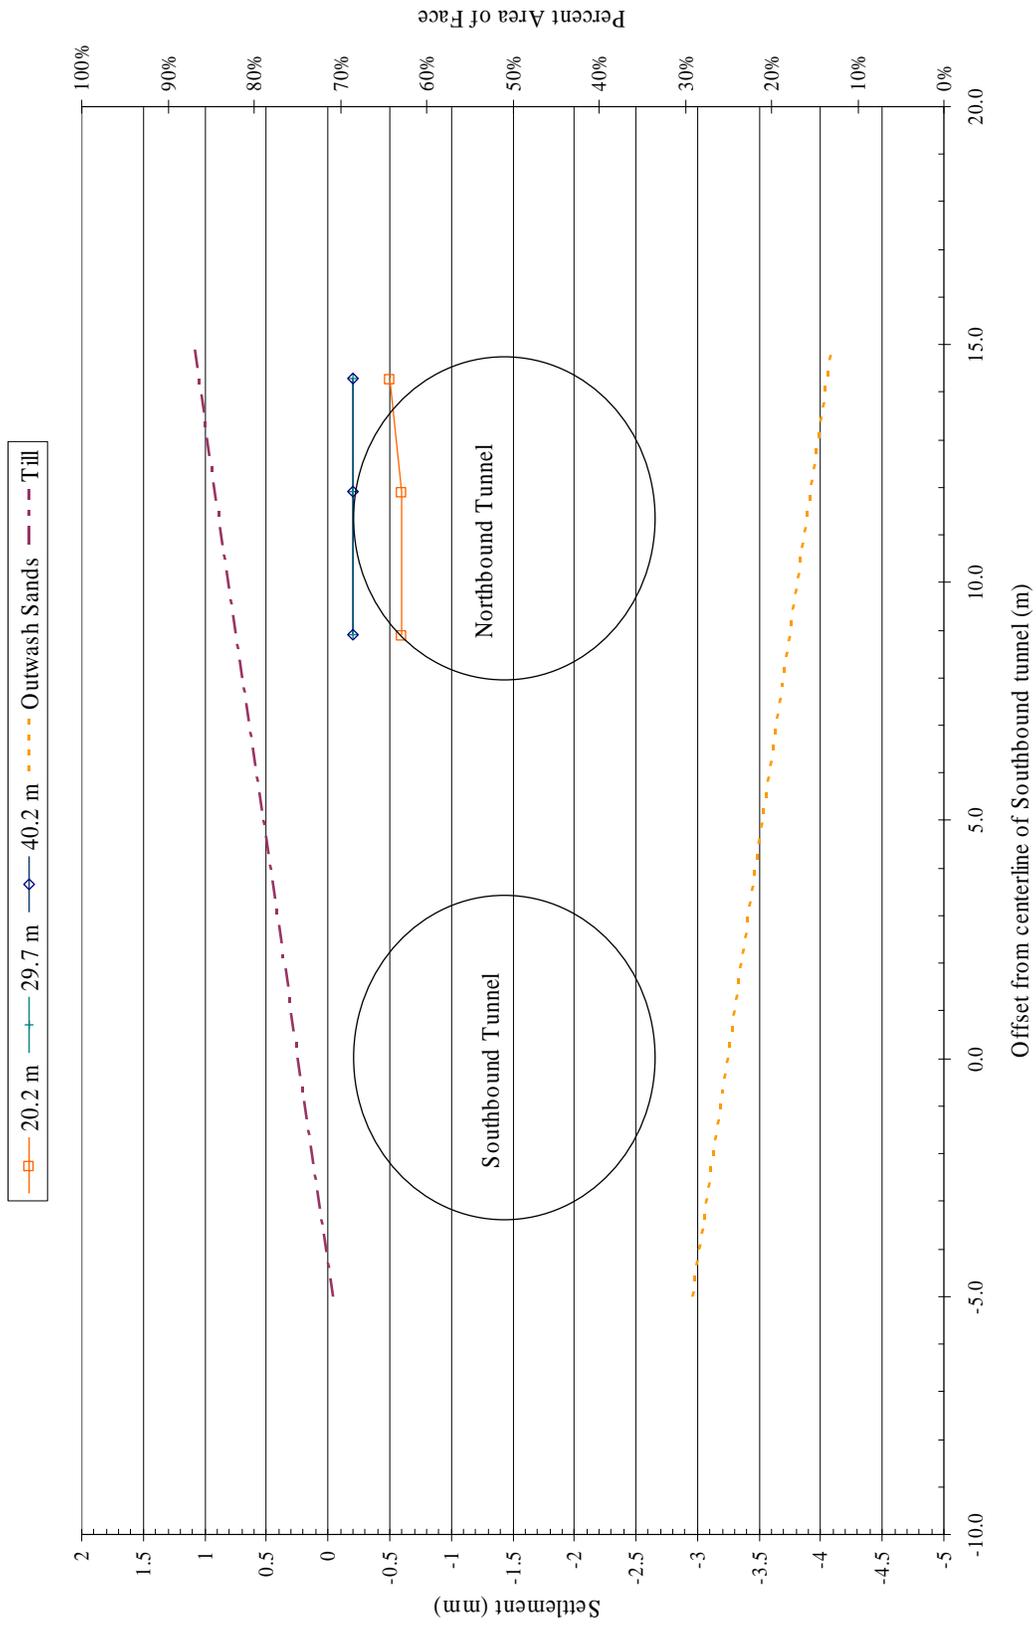
Figure H-3 Observed deep settlement at Array C during construction of Southbound Tunnel.

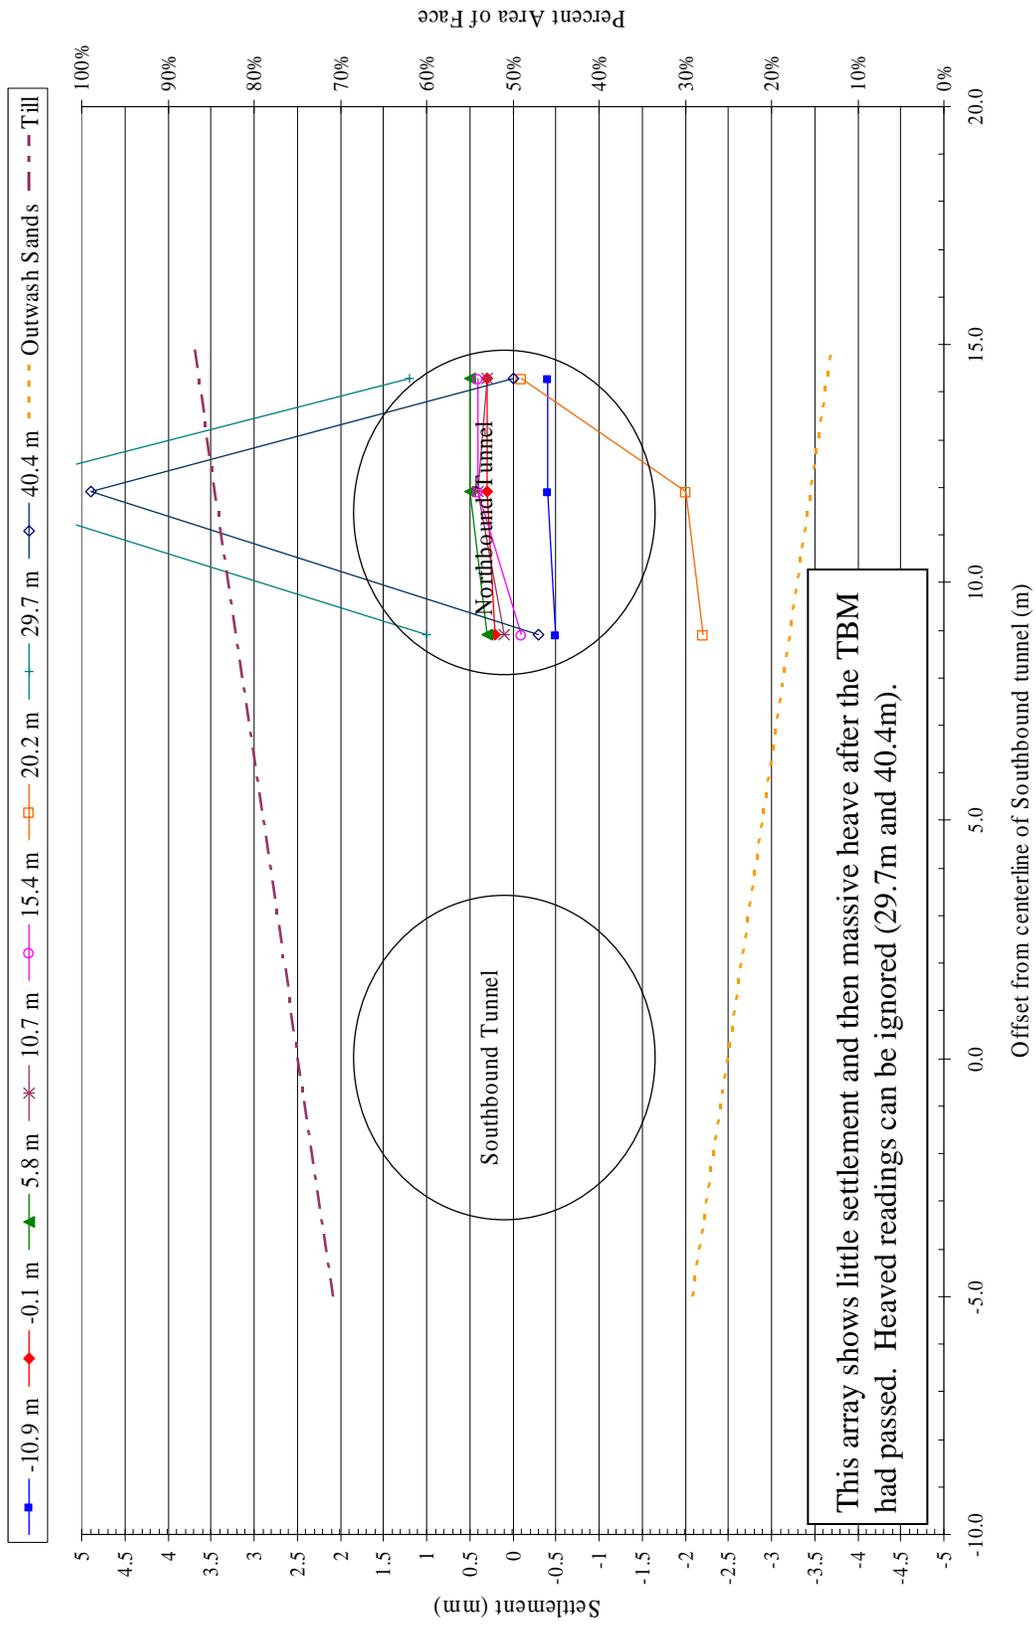
Figure H-4 Observed deep settlement at Array C during construction of Northbound Tunnel.

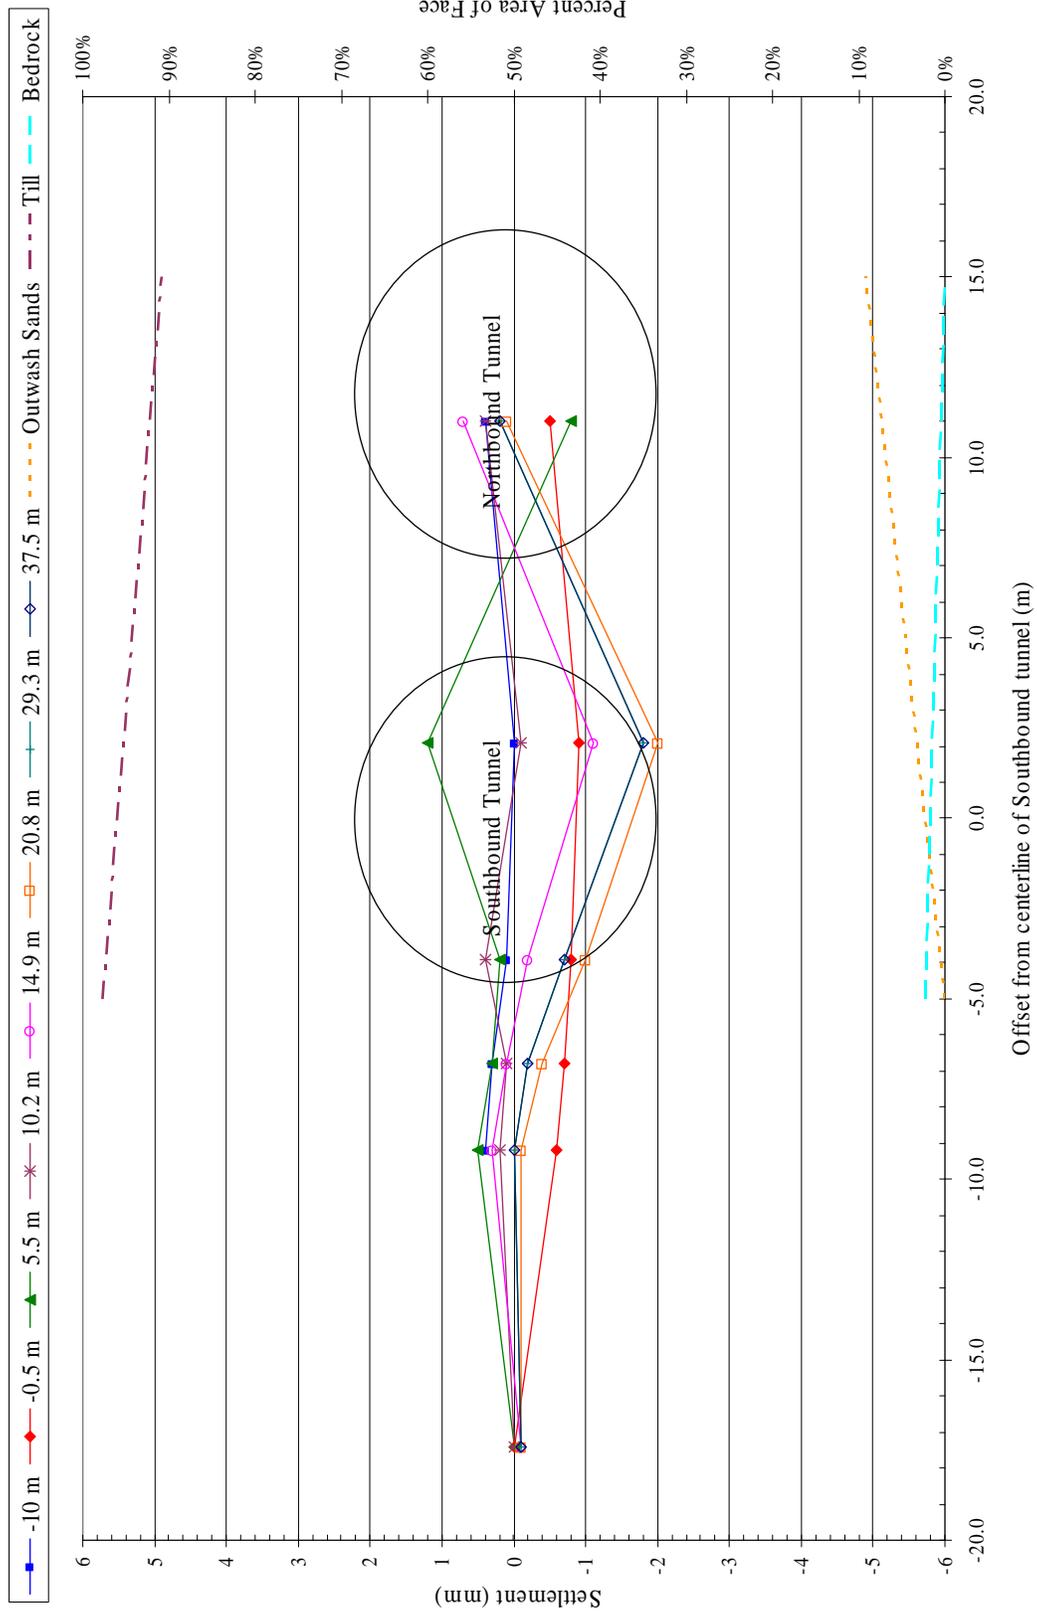
Figure H-5 Observed deep settlement at Array B during construction of Southbound Tunnel.

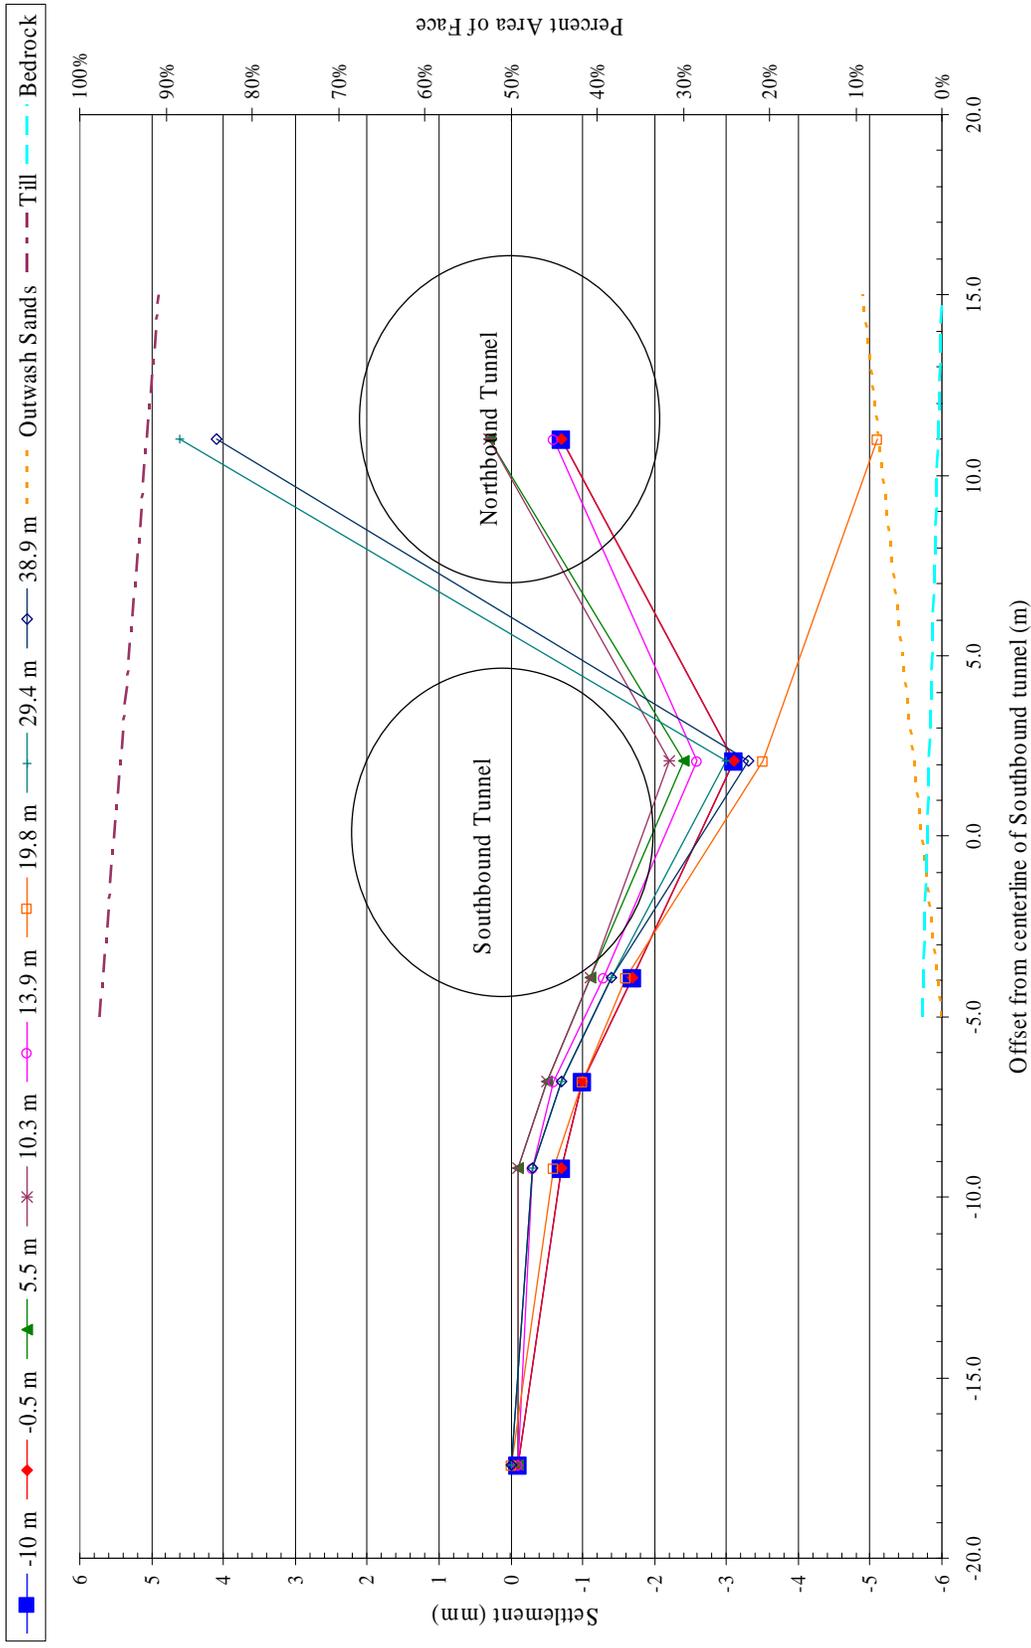
Figure H-6 Observed deep settlement at Array B during construction of Northbound Tunnel.

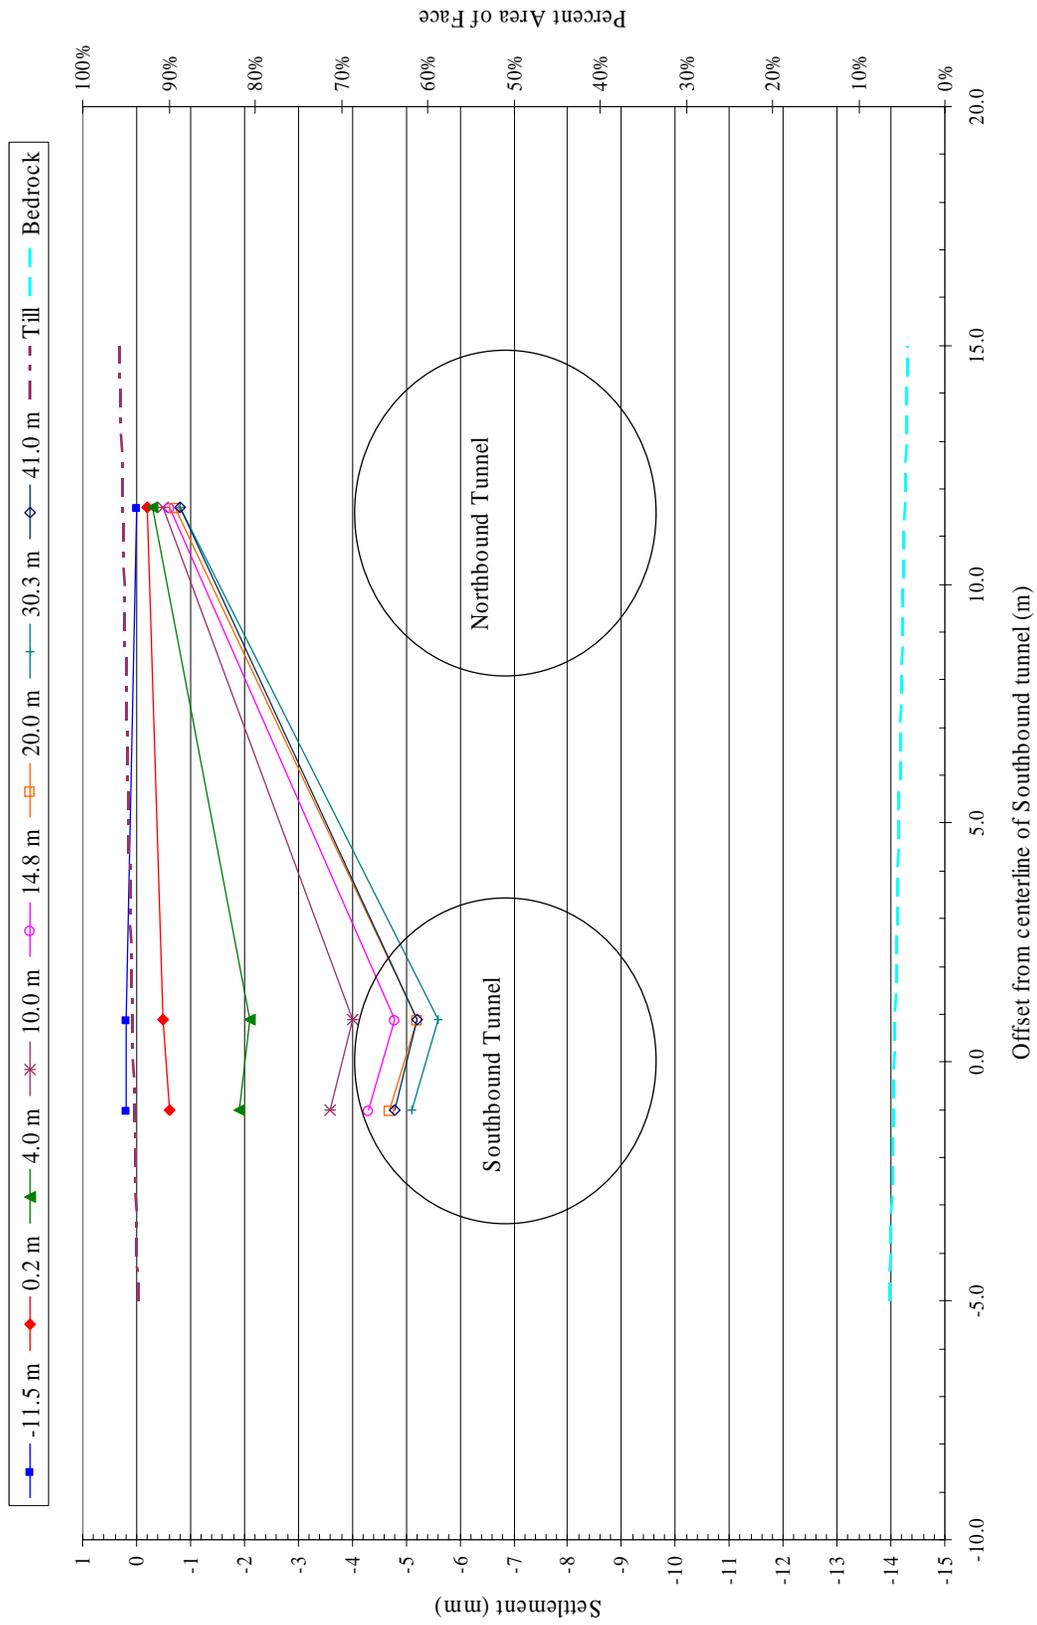
Figure H-7 Observed deep settlement at Array A during construction of Southbound Tunnel.

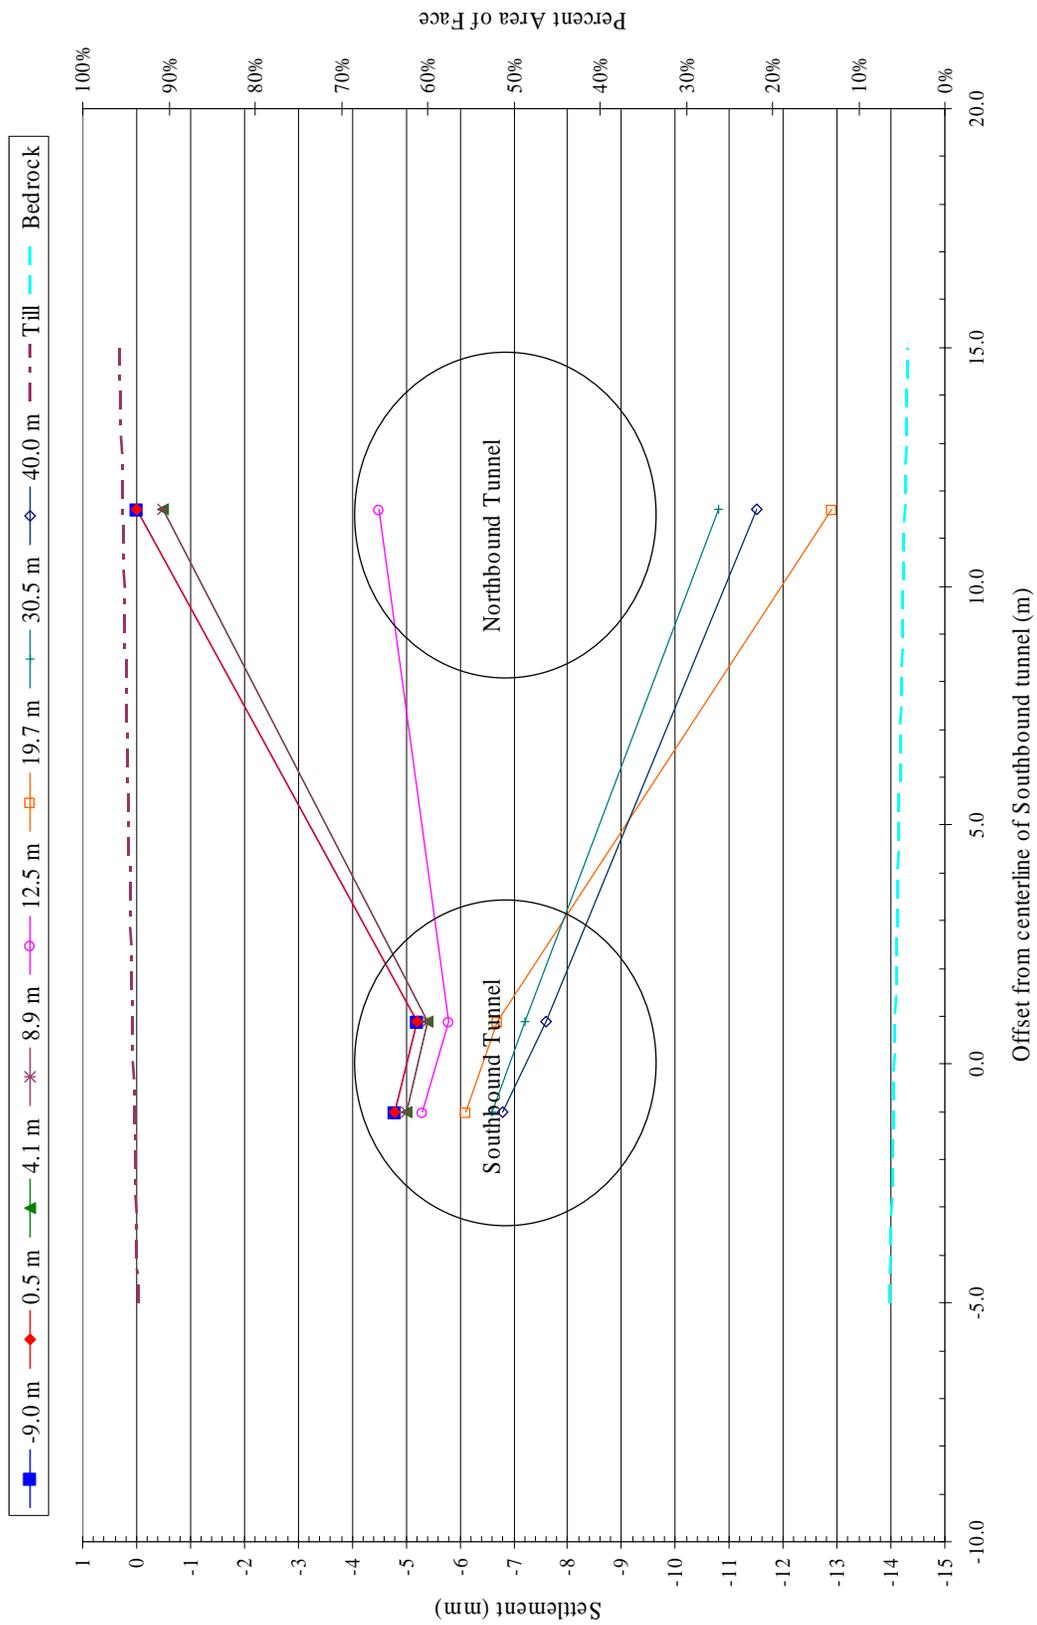
Figure H-8 Observed deep settlement at Array A during construction of Northbound Tunnel.

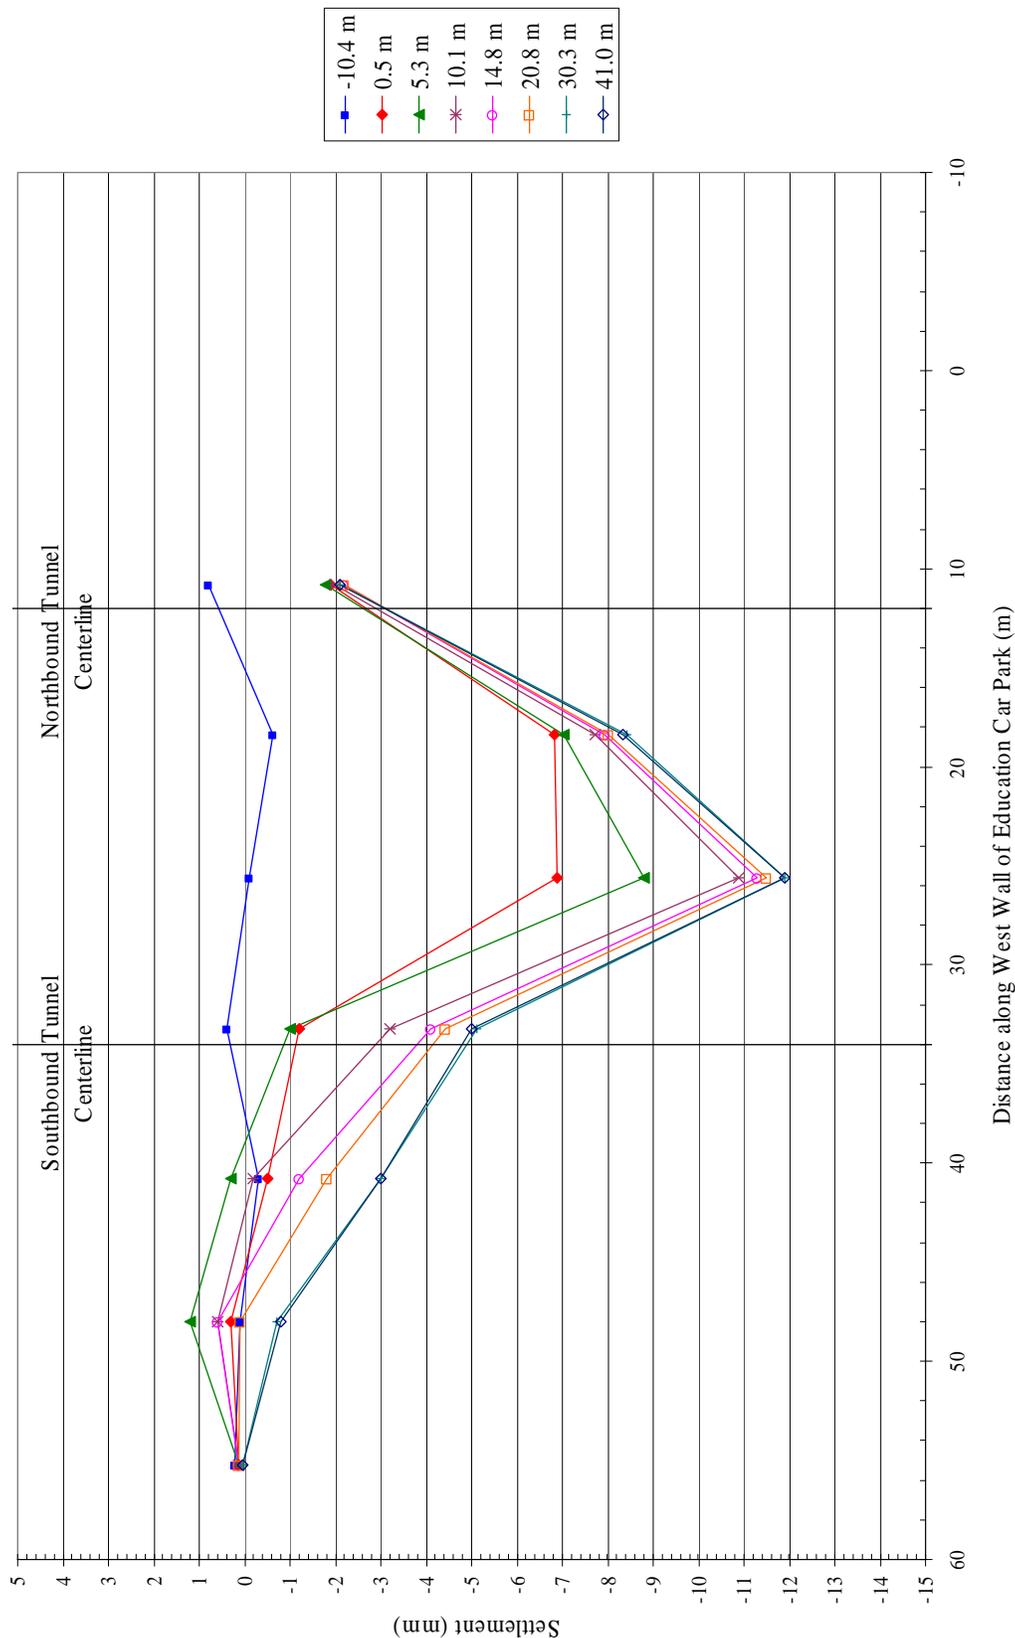
Figure I-1 Observed settlements along West Wall of Education Car Park during construction of Southbound Tunnel.

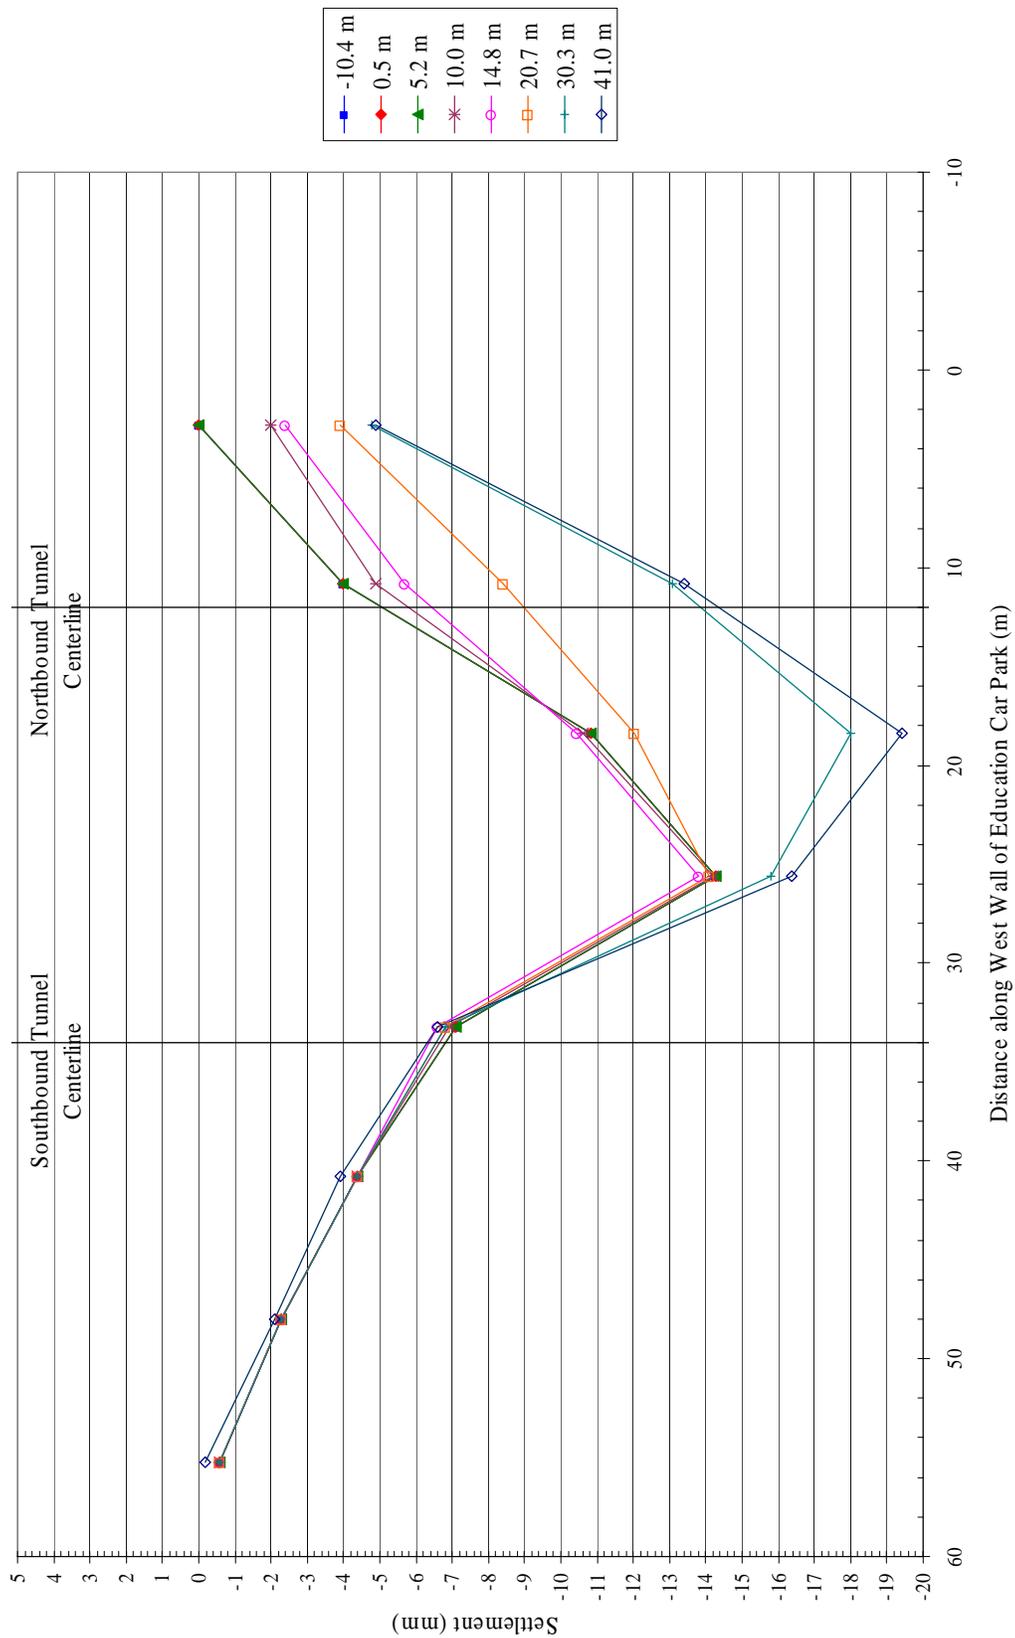
Figure I-2 Observed settlements along West Wall of Education Car Park during construction of Northbound Tunnel.

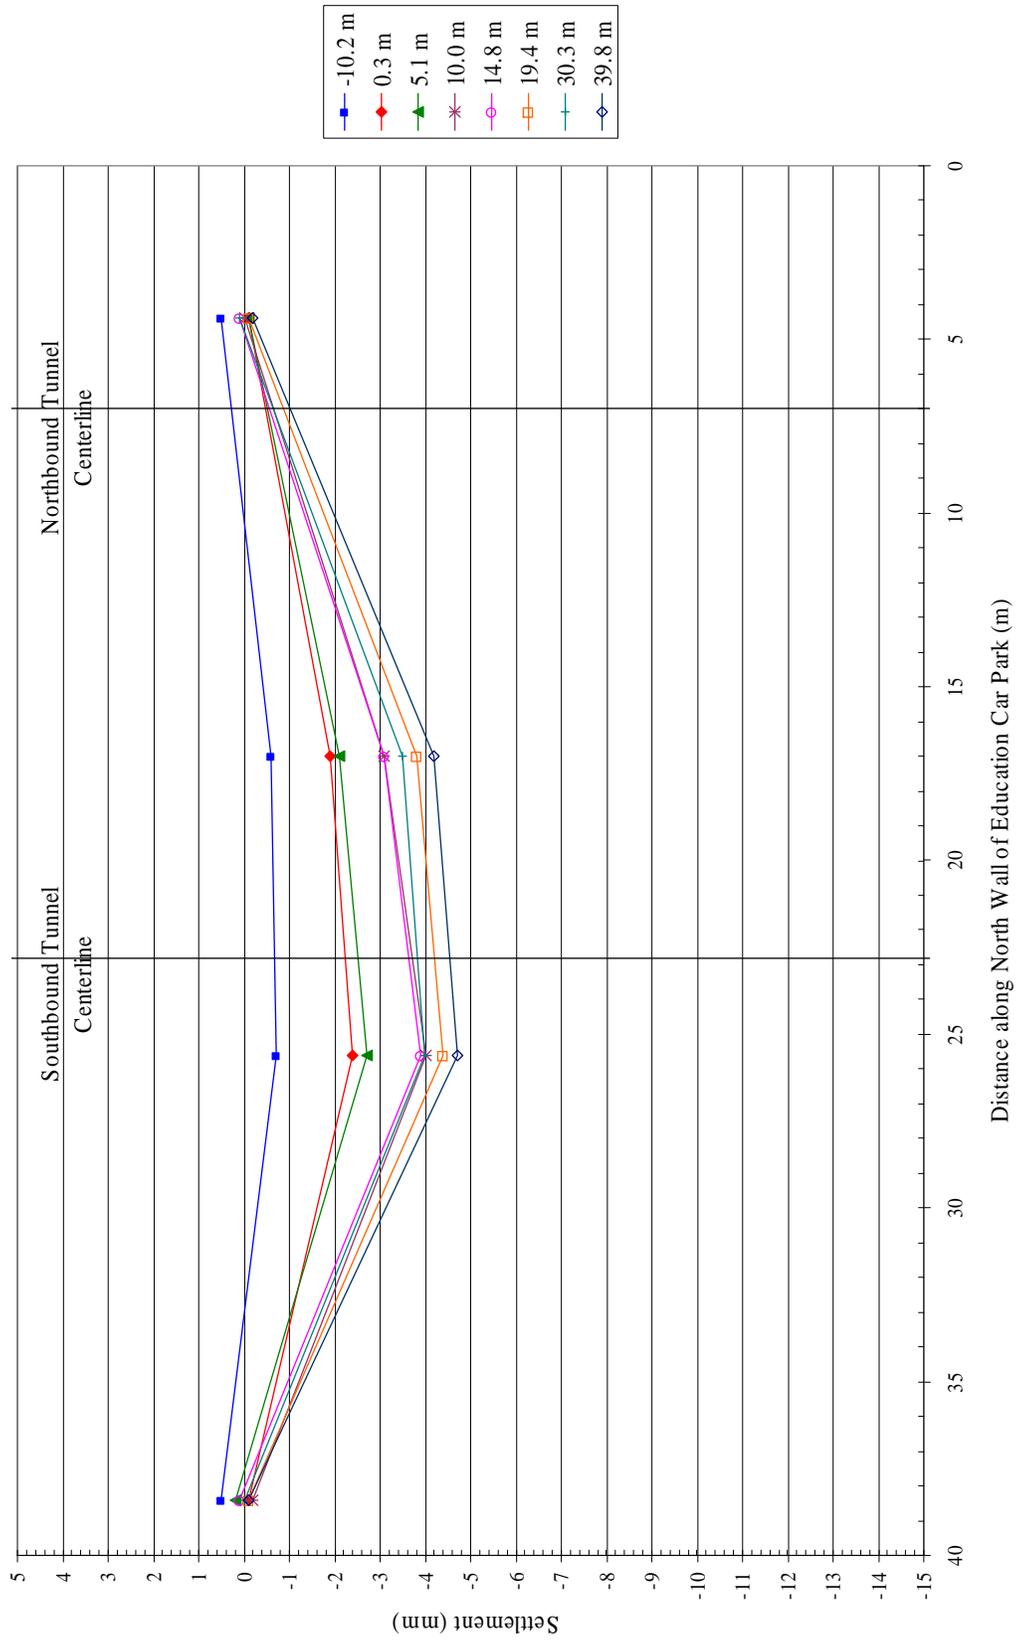
Figure I-3 Observed settlements along North Wall of Education Car Park during construction of Southbound Tunnel.

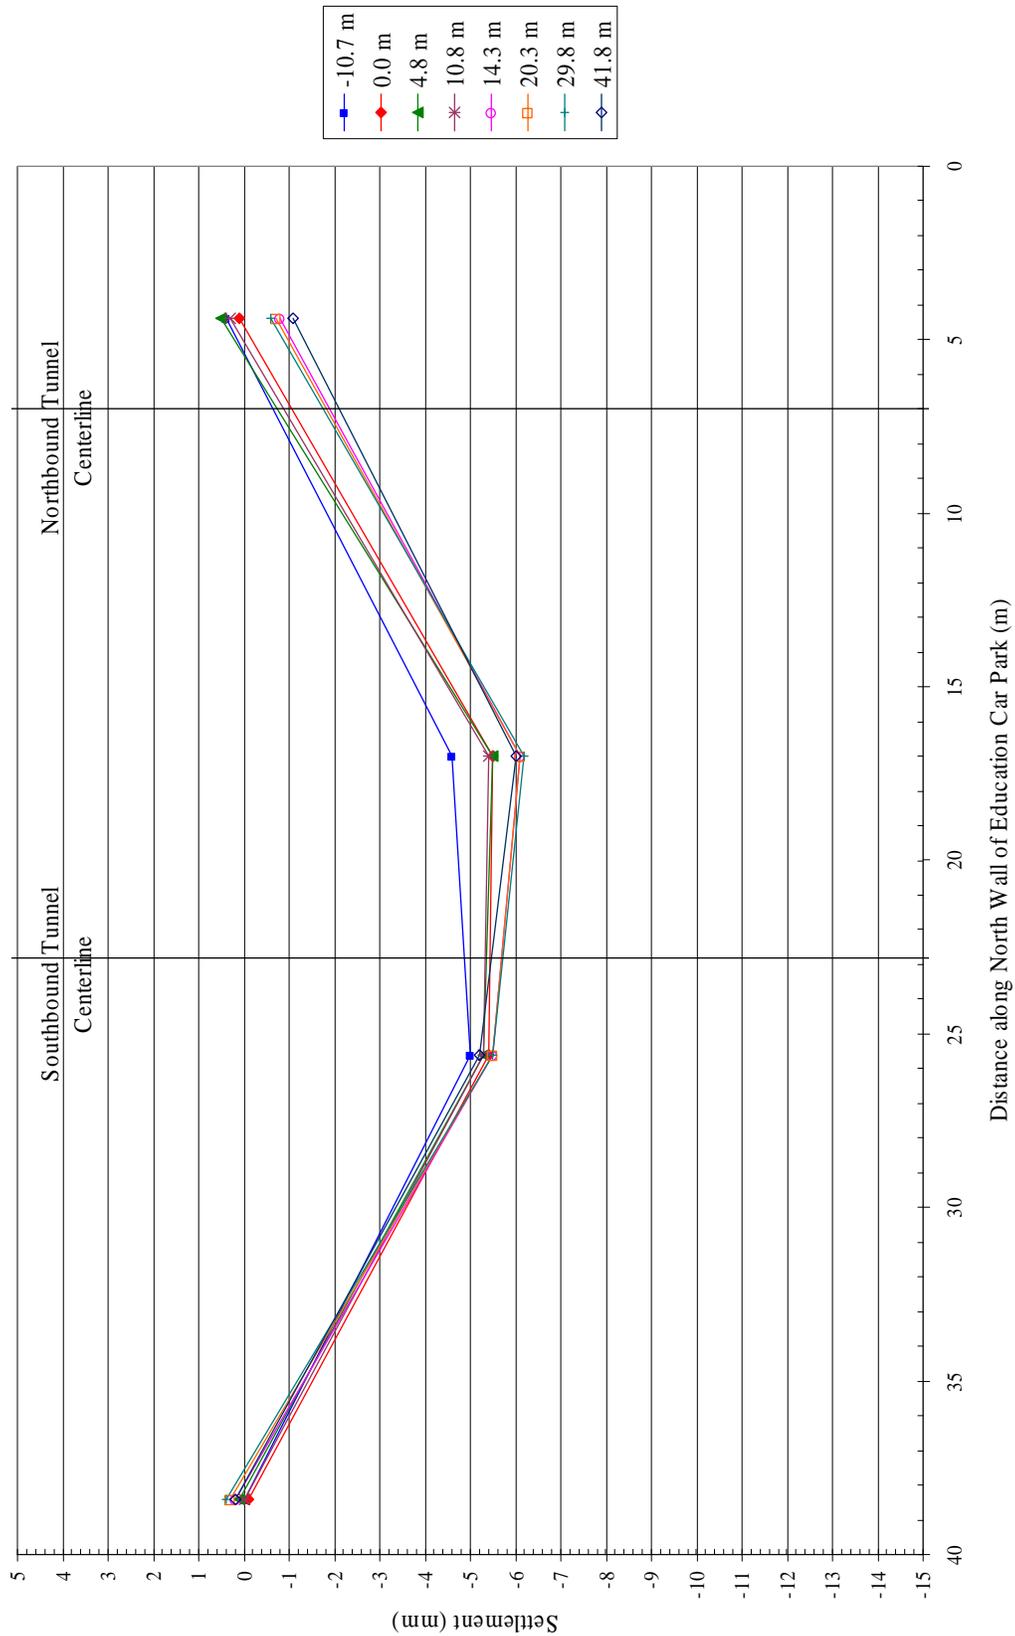
Figure I-4 Observed settlements along North Wall of Education Car Park during construction of Northbound Tunnel.

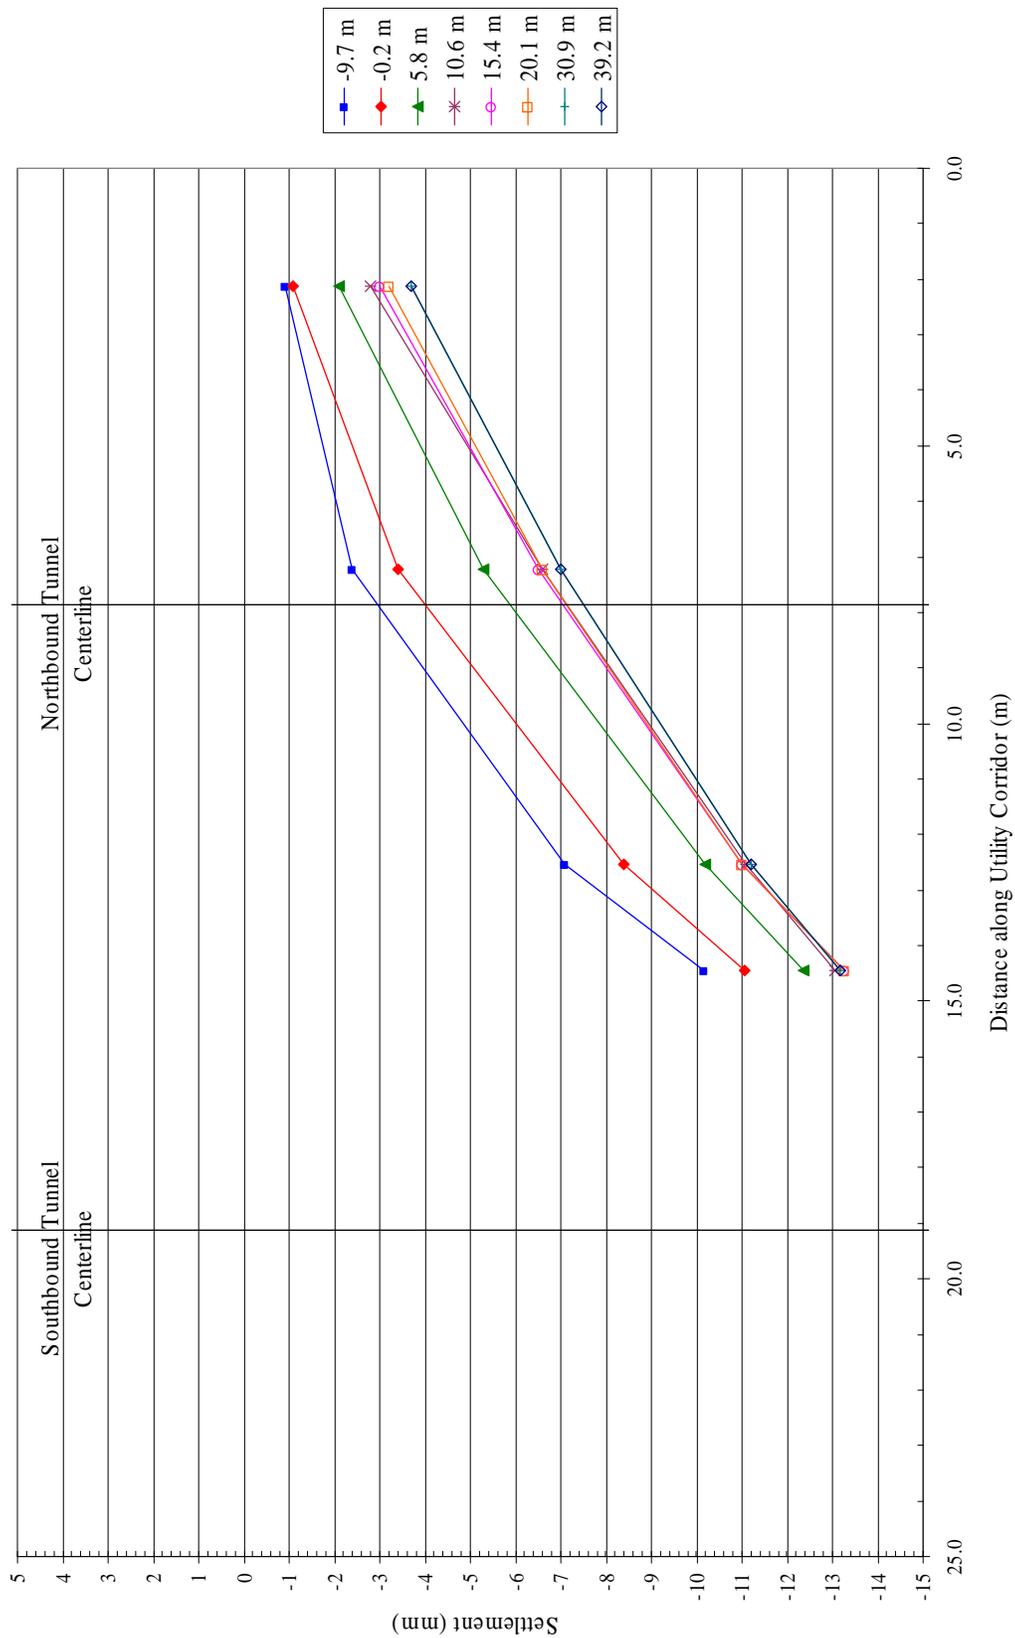
Figure I-5 Observed settlements along Utility Corridor on the approaches to Education Car Park during construction of Northbound Tunnel.
