THE UNIVERSITY OF ALBERTA

GEOTECHNICAL CHARACTERISTICS OF GENESEE CLAY

SUBMITTED TO THE FACULTY OF GRADUATE STUDIES AND RESEARCH  
IN PARTIAL FULFILMENT OF THE REQUIREMENTS FOR THE DEGREE  
OF DOCTOR OF PHILOSOPHY

DEPARTMENT OF CIVIL ENGINEERING

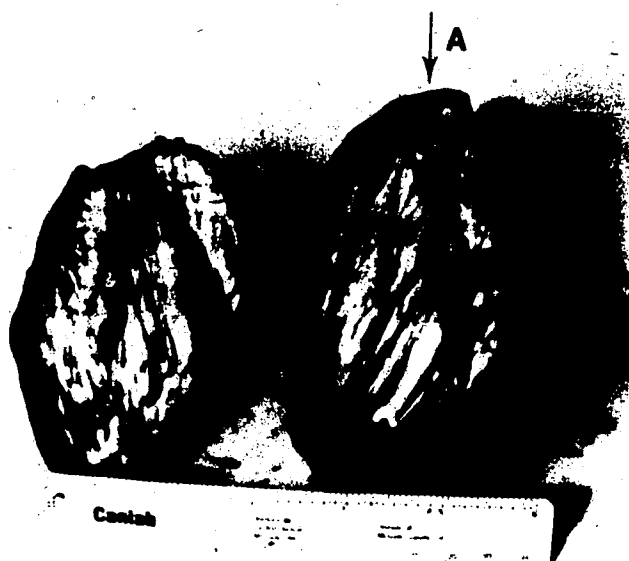
Plate 3.13 Highly striated high angle slickenside (sample 1-6).
