WEAR OF COUPLINGS WITH OILFIELD TUBING

A Thesis submitted to the Faculty of Graduate Studies and Research
in partial fulfillment of the requirements for the degree of Master of
Science.

Department of Mechanical Engineering

Spring 1993

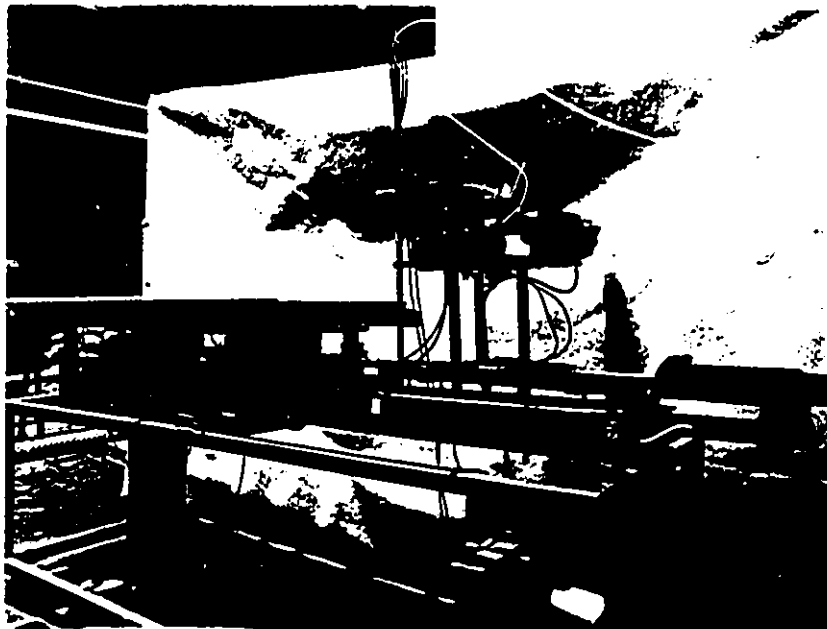
The test apparatus was activated by a hydraulic piston that drove four specimen carriages, each holding one coupling specimen back and forth along four stationary tubing test sections. Each test section was sloped to allow fluid to flow down all tubings (Figure 4.1 - 4.2). The wear of actual downhole components is accelerated by corrosion, therefore, the test apparatus was designed to incorporate fluid flow to wet the contact surfaces continuously. Water was used to represent the above environment, rather than salty water or other fluid combinations because each well contains water with different salinity. The water flow rate was set at 0.5 l/m using fresh non-recirculated tap water at 18°C, pH 7.8-7.9.

Figure 4.1. Side View of Wear Testing Apparatus

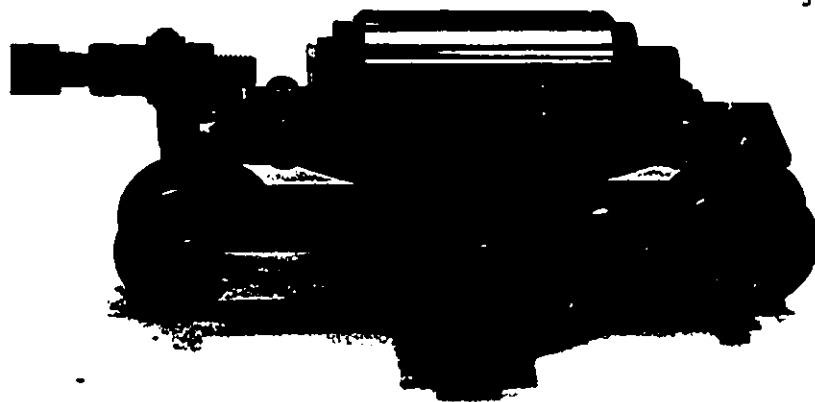
Figure 4.5. Coupling Carriage

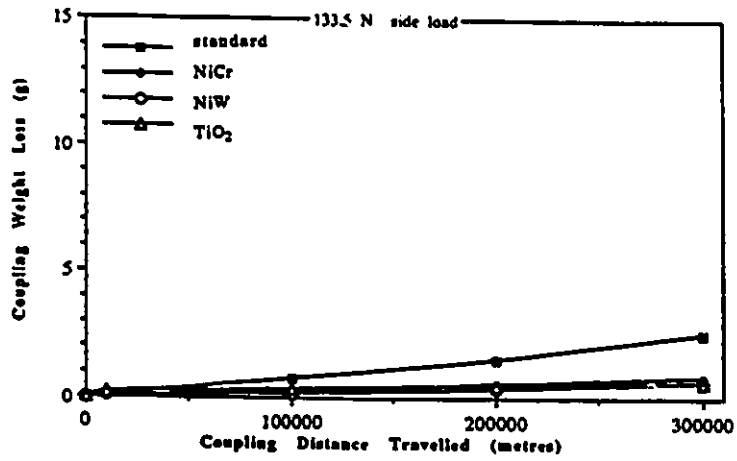
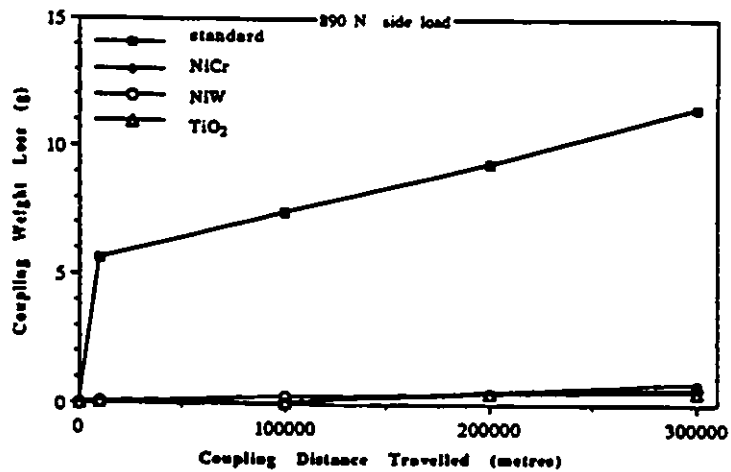
As expected, coupling weight loss increased as the applied side load increased. The results shown in Figures 5.1 - 5.3 demonstrate an increase in the coupling weight loss trend while distance

Figure 5.1. Coupling Weight Loss at 133.5 N -Water Environment

Figure 5.2. Coupling Weight Loss at 445 N - Water Environment

Figure 5.3. Coupling Weight Loss at 890 N -Water Environment

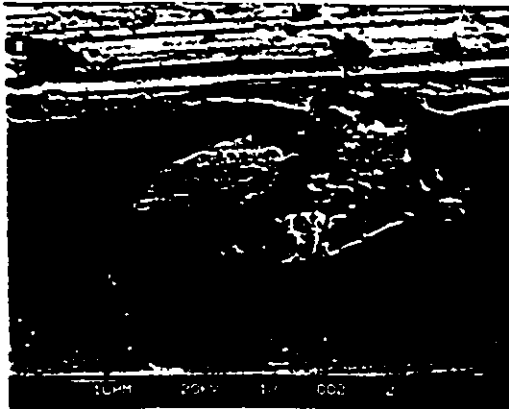
Fig. 3. TUBING vs. NiCr COUPLING
890 N , x 700
water only

Adhesion is characterized by the transfer of material from one surface to another. Plate 1 (Figures 1-8) shows the adhesive wear observed for different tubings using different couplings and side loads. Figure 1-3 shows smeared Nickel (bright areas) from the NiCr coated couplings under different side loads. In Figures 4-5, ceramic particles were released from the TiO₂ coated coupling as loose wear debris and they became embedded in the surface of the tubing. This explains one of the ways in which the third body abrasion caused wear in the coupling. Figure 6 shows a sand particle embedded in the tubing using a standard coupling. The sand source was from the sand-water environment. Figure 7 shows Co and W particles from the NiW coated coupling under a 445 N side load. In Figure 8, adhesion of nickel from the NiW coated coupling was found along with the abraded surface. This is an example of two mechanisms controlling the wear of the tubing under an 890 N side load.

of tubing in a water-sand environment using a standard coupling. Figure 10 shows abrasive wear in the tubing using a NiCr coated coupling at a 890 N side load. In this test, adhesive wear was also observed as transfer of Nickel from the NiCr coated coupling (see Figure 3). Figure 11 shows partial abrasion of the contact surface along with the wear debris being removed. The back scattered image of the abraded wear surface shown in Figure 12 reveals that the gouges occurred parallel to the sliding motion due to the surface contact of the tubing with a harder asperity of the NiW coated coupling. The abrasive wear track was also found in the tubing using the TiO₂ coated coupling (Figure 13) and in the water-sand environment. This mainly was caused by the third body abrasive sand particles. Figure 14 shows a rough surface due to ploughing by a NiCr counterface in a water-sand environment. Figure 15 shows the abrasive wear of the tubing using the NiW coated coupling in the

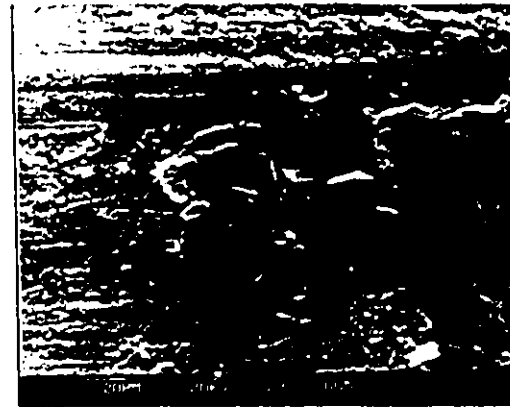
delamination

Fig. 22. TUBING vs. TiO2 COUPLING
445 N , x 1000
water & sand
