UNIVERSITY OF ALBERTA

CYCLIC BEHAVIOR OF STEEL GUSSET PLATE CONNECTIONS

A thesis submitted to the Faculty of Graduate Studies and Research in partial fulfillment of the requirements for the degree of Master of Science.

DEPARTMENT OF CIVIL ENGINEERING

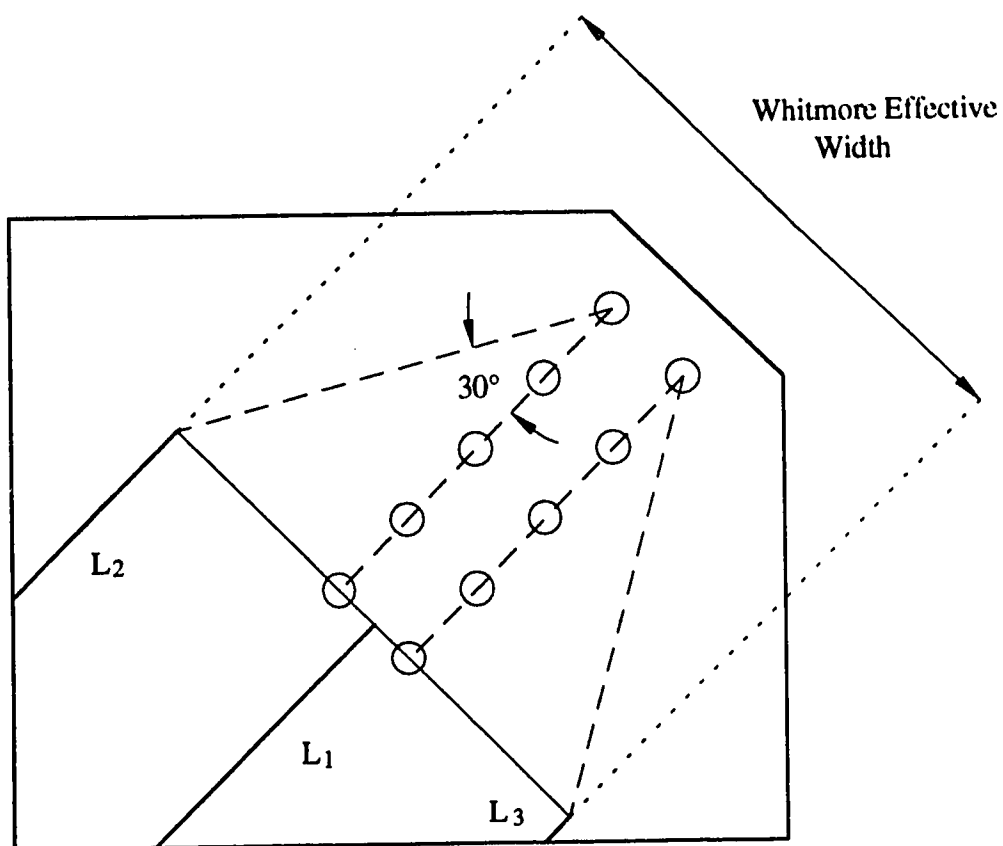
Imaginary Fixed-Fixed Column Strip: $k = 0.65$

$$\text{Equivalent slenderness} = \frac{kL}{r}$$

Figure 2.3. Thornton Equivalent Column Method

Thornton (1984) presented an approach to the design of vertical bracing connections based on satisfying the dual requirement of equilibrium and yield, with sufficient attention given to stiffness to preclude buckling and failure. Thornton considered all components of a typical bracing connection. To determine the gusset plate ultimate strength under tension, he considered the tear-out of the gusset plate. The capacity is related to the block shear requirements of the 1978 AISC Specification. The tear-out capacity is based on the net section with hole size taken as bolt diameter plus 1/16 inch. In compression, Thornton considered gusset plate buckling by establishing the capacity of an equivalent column section. This method considers an imaginary fixed-fixed column strip (effective length coefficient, $k=0.65$) of unit width below the Whitmore section. The length of the column strip may be taken as the largest of L_1 , L_2 , and L_3 as defined in Figure 2.3. This strip is used to determine an equivalent slenderness ratio. Alternately, Thornton suggests that a shorter length, such as the average of L_1 , L_2 , and L_3 , may give a more reasonable approximation of the buckling strength. Thornton originally presented his approach as an allowable stress method. From an ultimate strength perspective, the compressive buckling resistance of the gusset plate can be evaluated according to the column curves in the CAN/CSA-S16.1-M89 standard (CSA, 1989) using the Whitmore effective width (Whitmore, 1952) as the column area and the equivalent slenderness from the fixed-fixed column strip. Thornton states that this approach is conservative because it ignores plate action and the post-buckling strength of plates.

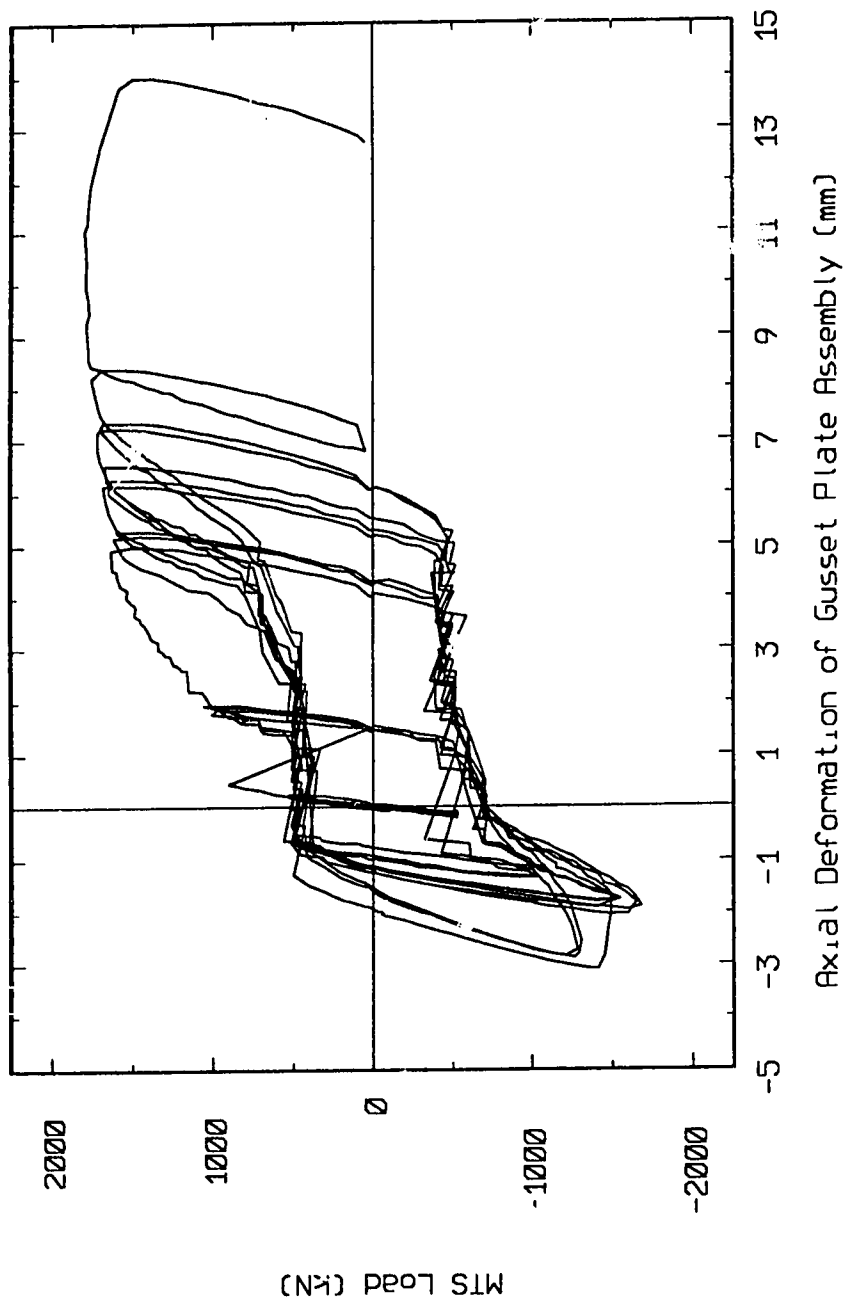
Figure 4.2. Load vs. Axial Displacement Response of the Gusset Plate Assembly - Specimen 1

By examining the tension portion of the loading in Figure 4.2, it is observed that the specimen response under tension is relatively stable; as the axial deformation level is increased the load carrying capacity of the specimen is maintained. Conversely, in compression, the overall plate buckling of the specimen is accompanied by a sudden increase in axial deformation and a significant drop in load carrying capacity. Although, the cyclic specimen loading was not continued very far into the post-buckling range, it can still be observed that there is a deterioration of the compressive load carrying capacity as the cyclic axial deformation level and the specimen's out-of-plane deformations increase. A photograph of the failed specimen and the final yield line pattern is shown in Figure 4.3.
