**CFRP SHEETS APPLICATION TO MASONRY SHEAR WALLS  
WITH OPENINGS**

A thesis submitted to the Faculty of Graduate Studies and Research in partial fulfillment  
of the  
requirements for the degree of MASTER OF SCIENCE

Structural Engineering

This thesis described an experimental program that investigated strengthening of masonry shear walls with openings using externally bonded Carbon Fiber Reinforced Polymer (CFRP) Sheets carried out at University of Alberta. Four wall specimens were designed and tested under combined uniformly distributed constant vertical load and monotonic in-plane lateral load. The variables in this test included the amount and layout of CFRP Sheets. This thesis analyzed the general shear wall behavior based on lateral load-top displacement curves, cracking patterns and the action of the CFRP Sheets to walls. The test results showed that the lateral load capacity and displacement ability of strengthened walls with CFRP Sheets were increased remarkably. Moreover, CFRP Sheets were effective in enhancing the stiffness of walls in the later loading stage. Finally, several mechanical models were presented to estimate the shear contribution of CFRP Sheets to the pe

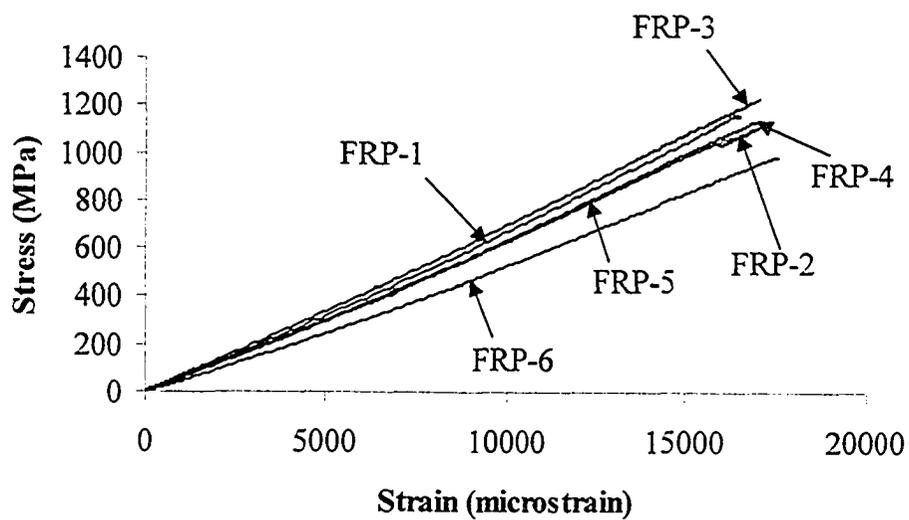
**Figure 3-1 CFRP Coupon Tension Test Behavior**

The stress-strain behaviour of the carbon sheet coupons in tension shown in Figure 3-1 is characteristically linear and elastic in a wide range of stress level. The failure modes of all the coupons belong to explosive gage middle failure. Table 3-6 reports the major material properties obtained from tests and the theoretical modulus of elasticity, which is obtained using Equation 3.1 provided by Hollaway (1993). That theoretical modulus of elasticity ( $E_c$ ) is only approximate 3% higher than the experimental modulus of elasticity ( $E_t$ ) shows that the strain in the matrix equals the strain in the fibre and the bond between the two components is perfect since the theoretical equation of  $E_c$  is based on the assumption that strain in the matrix equals the strain in the fibre and the bond between the two components is perfect.

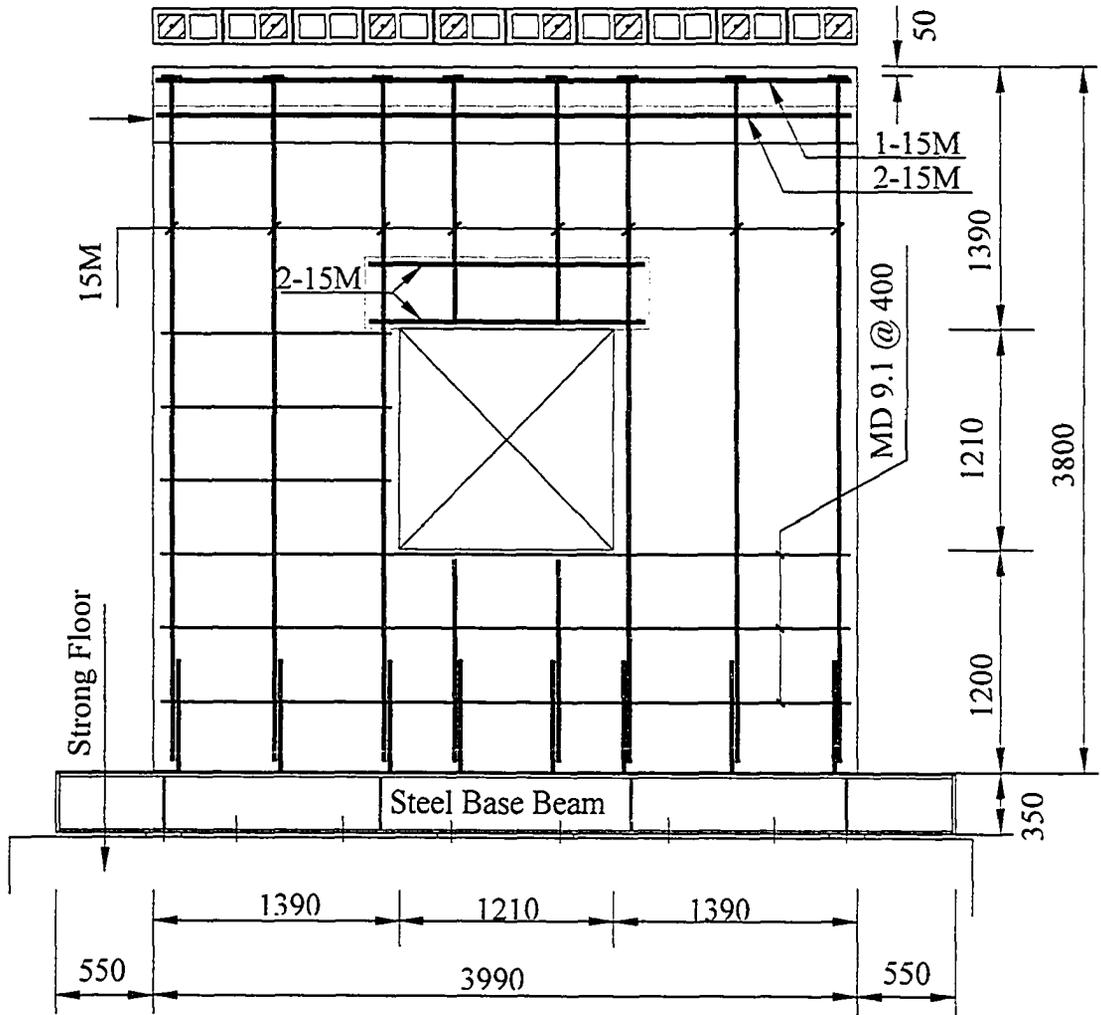
**Figure 3-2 Steel Reinforcement Arrangement**

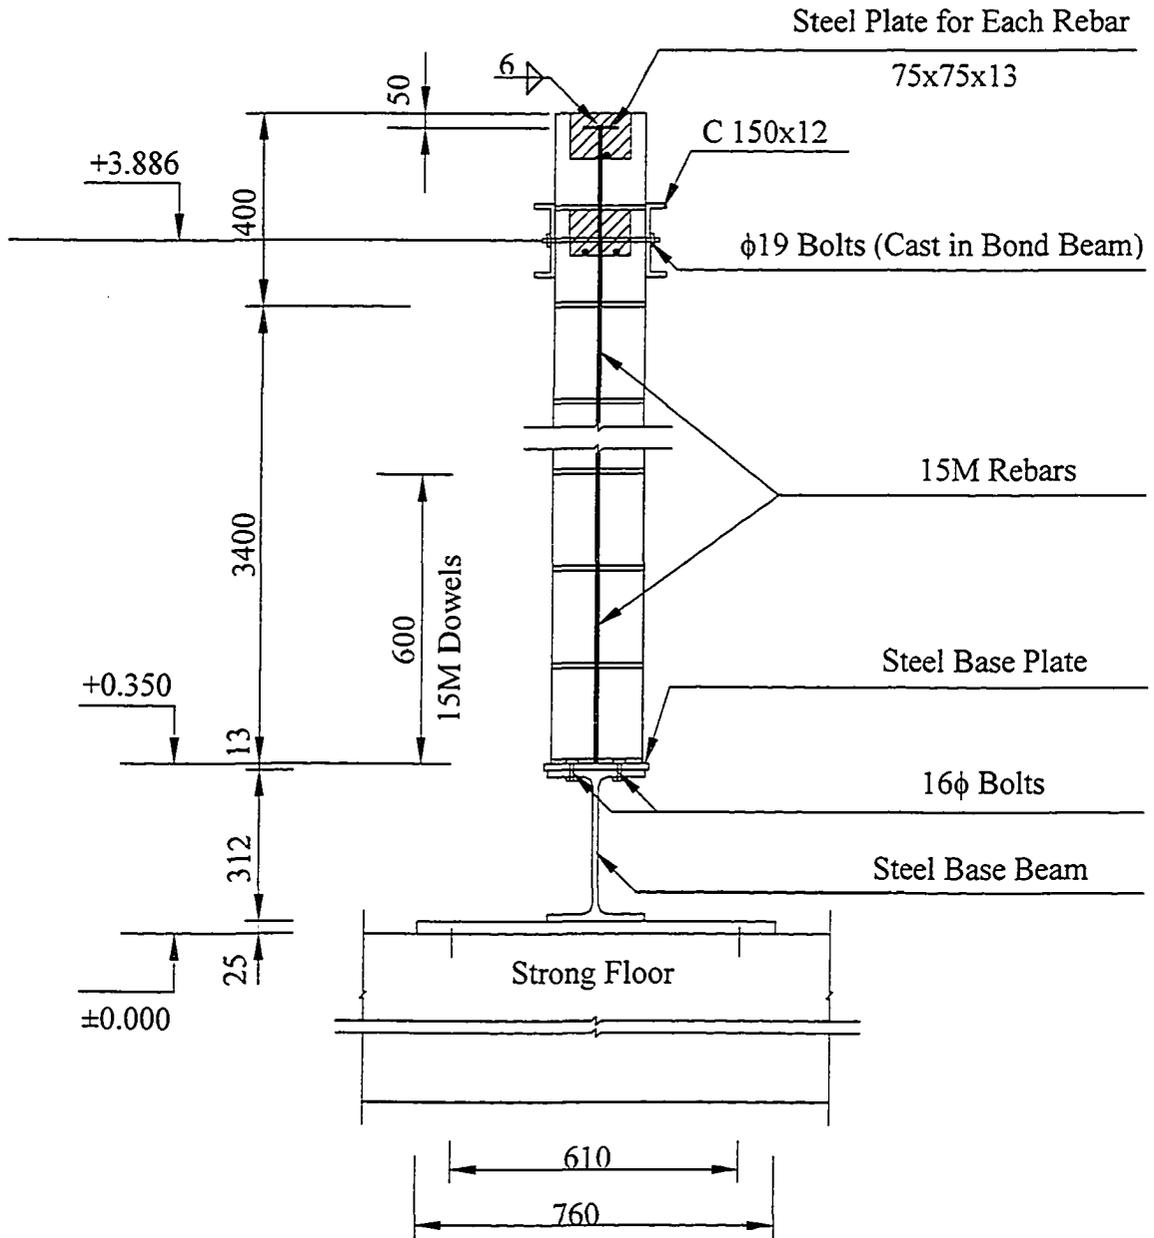
**Figure 3-3 Specimen Cross-Section**

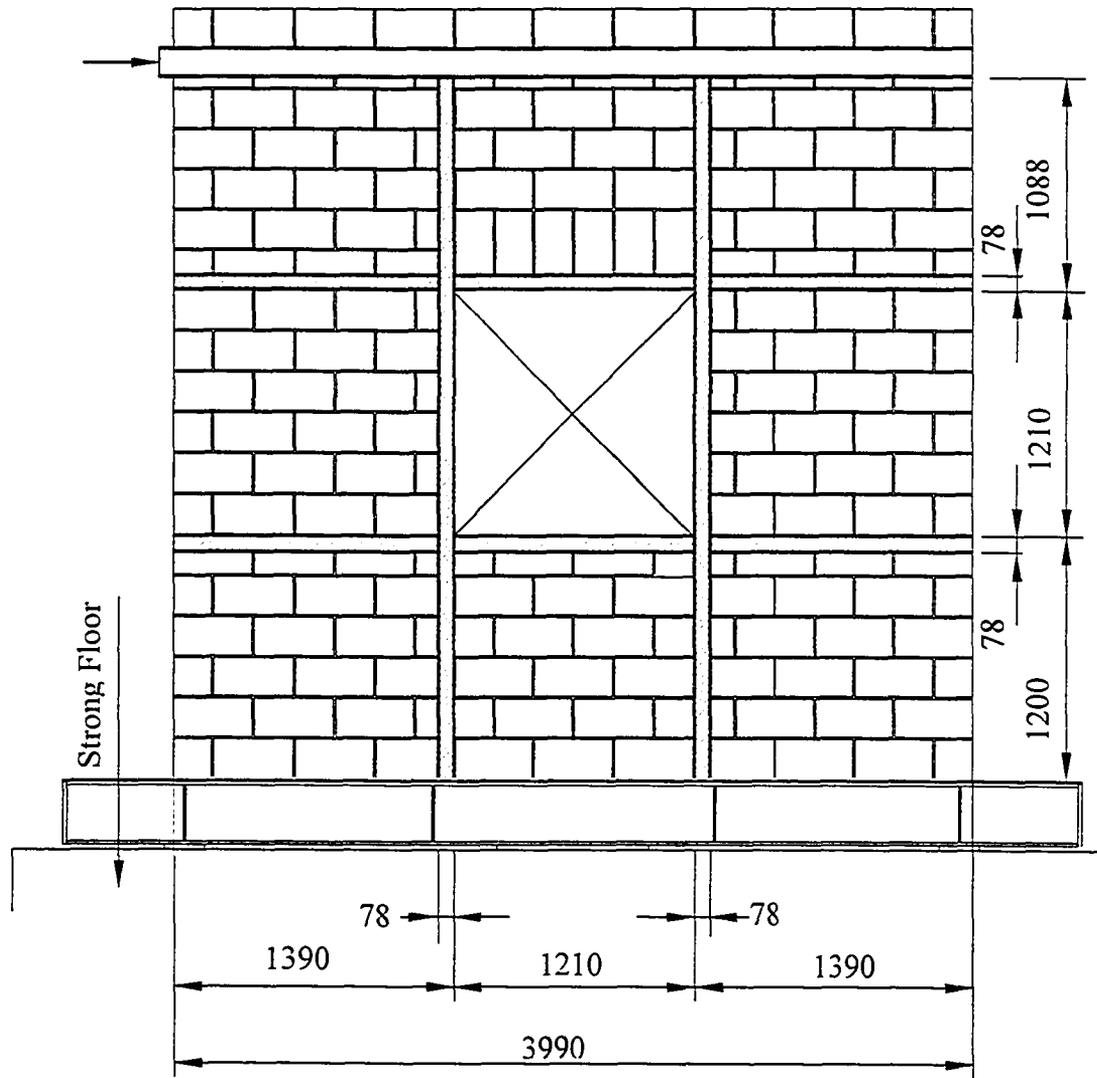
**Figure 3-5 CFRP Layout for Wall 3**

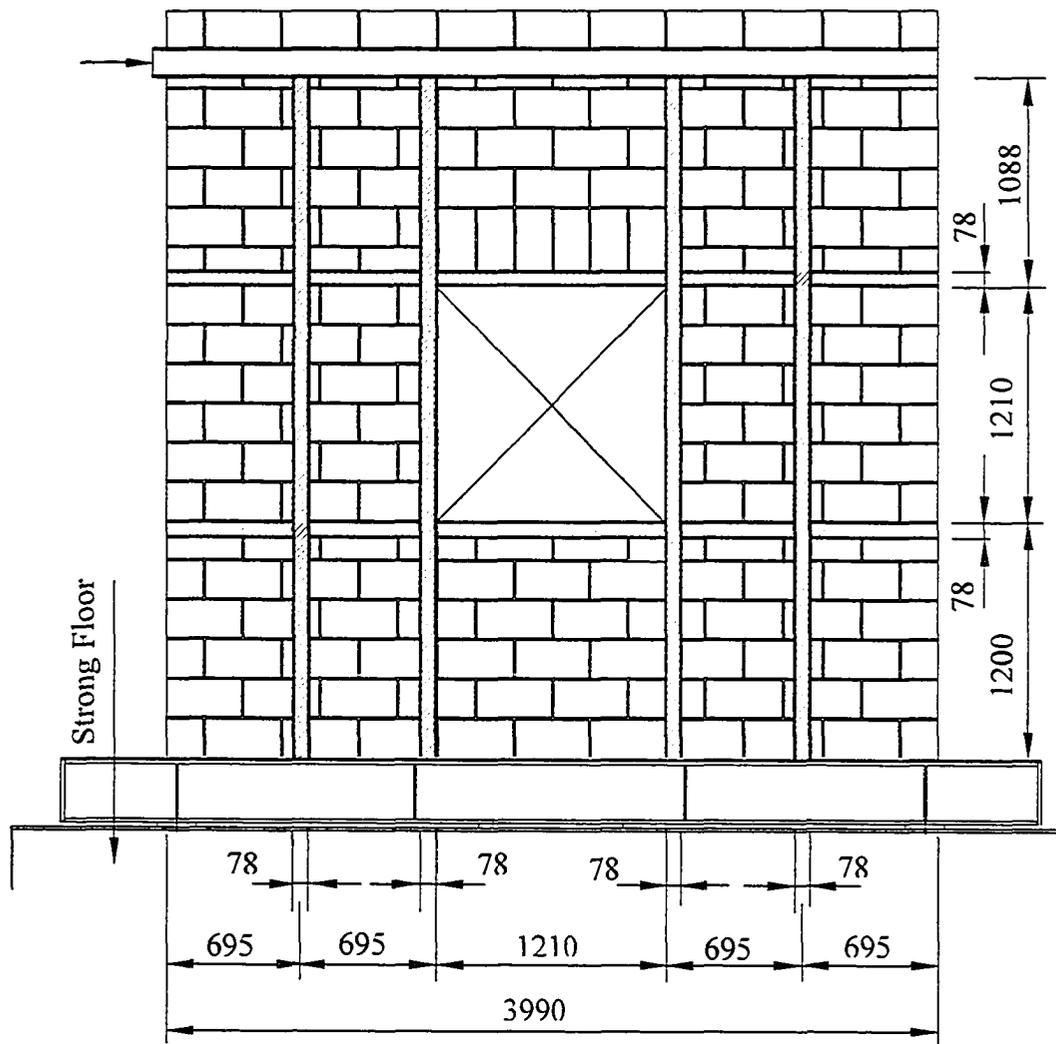
**Figure 3-6 CFRP Layout for Wall 4**

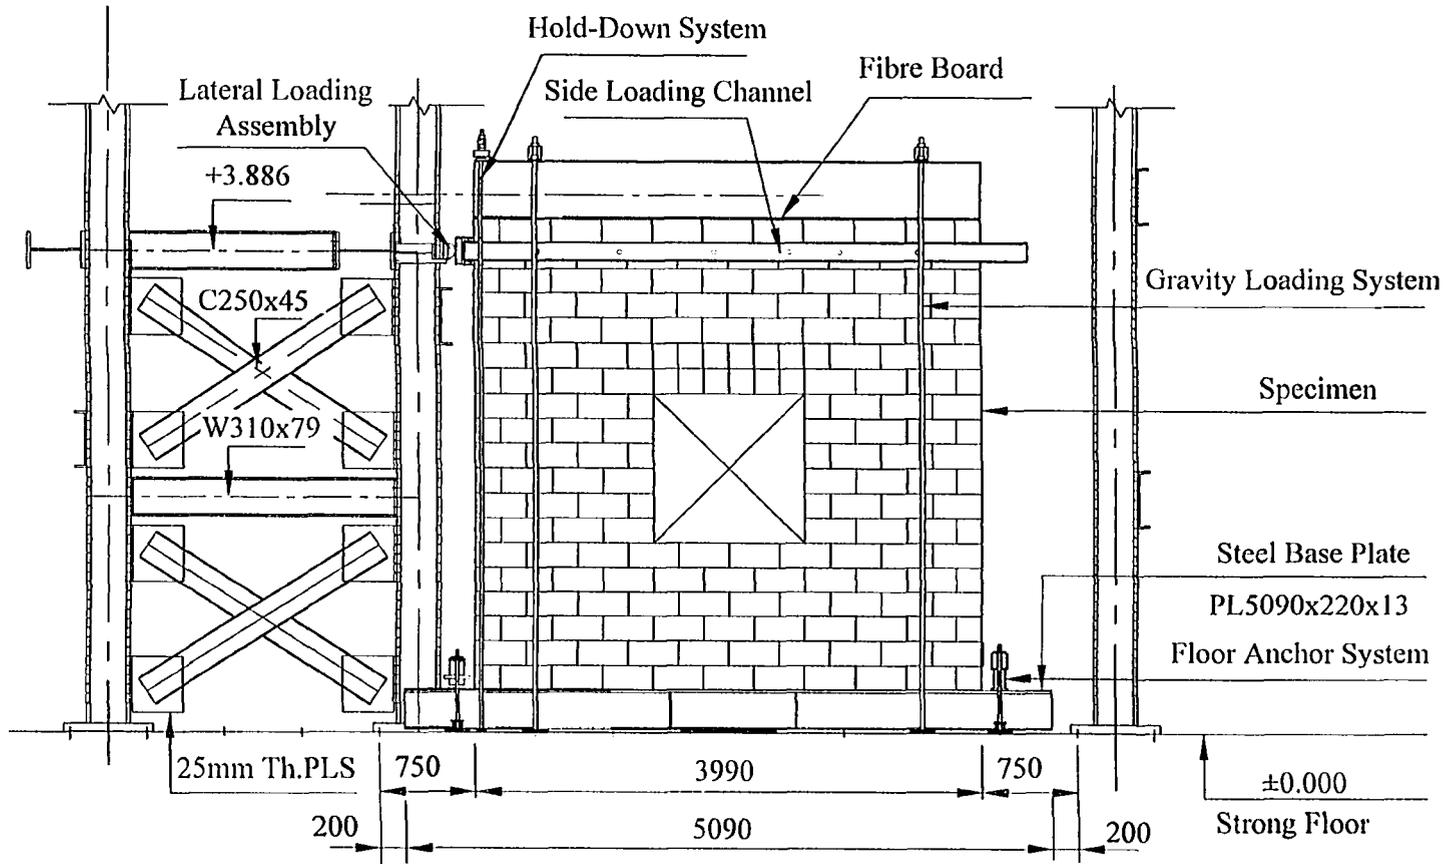
Figure 3-7 Test Set-up

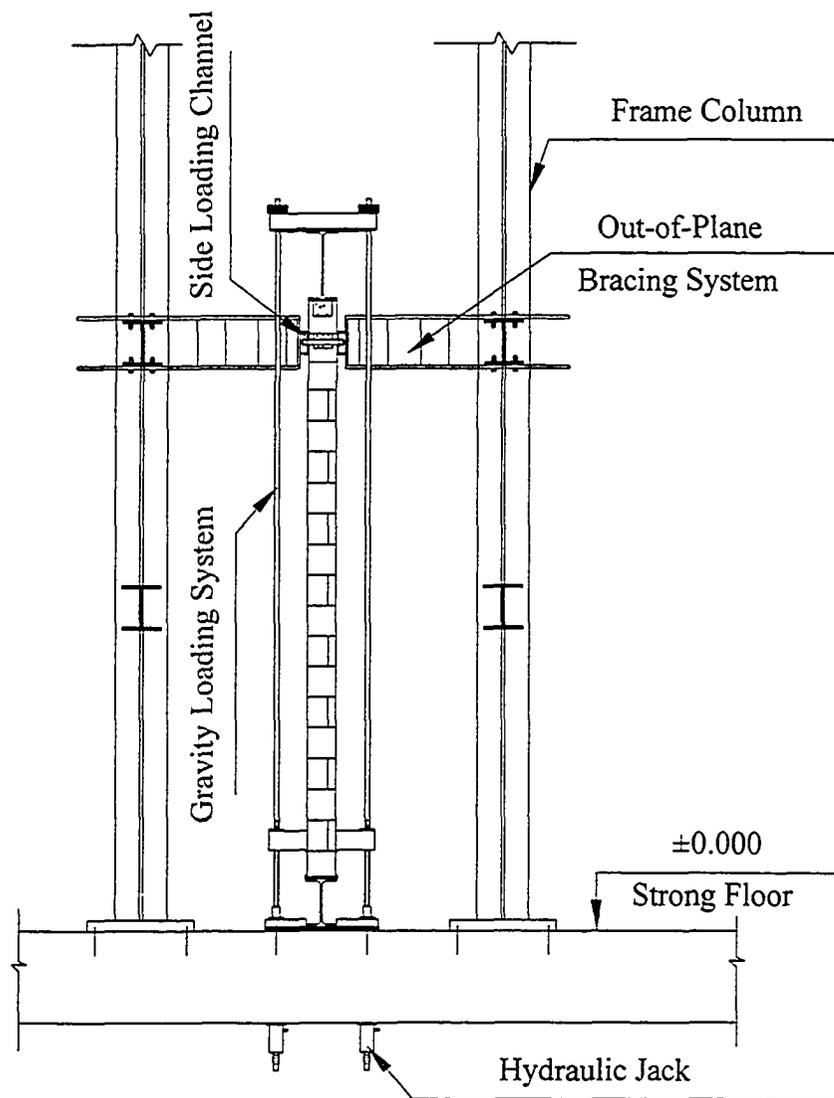
**Figure 3-8 Set-up Cross-Section**

To avoid out-of-plane movement of the wall caused by an accidental eccentricity of the lateral load, an out-of-plane bracing system was introduced at the level of the lateral load. It consisted of two large steel plates (1500mmx400mmx21mm) and a steel cylinder 50mm Ø, 300mm long that formed a rectangular steel frame. Two small steel plates (350mmx190mmx6mm) were welded to the rectangular steel frame between two large steel plates to enhance the stiffness. Four out-of- plane braces were used, two of which provided on each end of the wall. Each brace was attached to the lateral load reaction frame beams at one end through eight bolts, while the steel cylinder roller at the other end of the brace bore on the side loading channels bolted to the wall. Figure 3-8 and Photo 3-11 show the details of this out-of-plane bracing system.

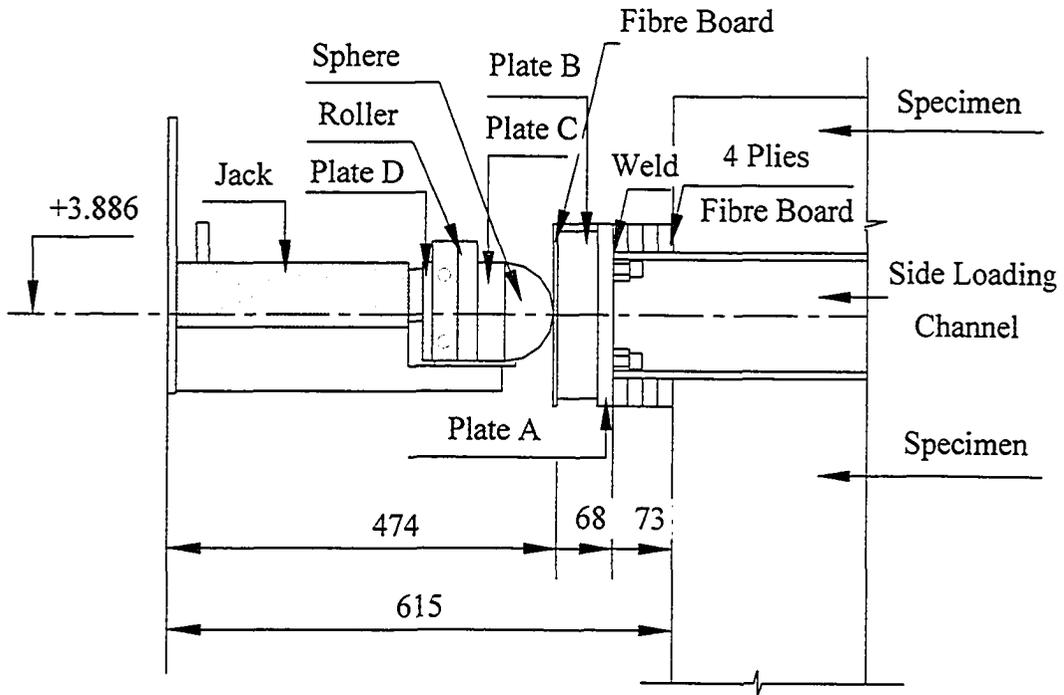
**Figure 3-9 Lateral Loading Assembly**

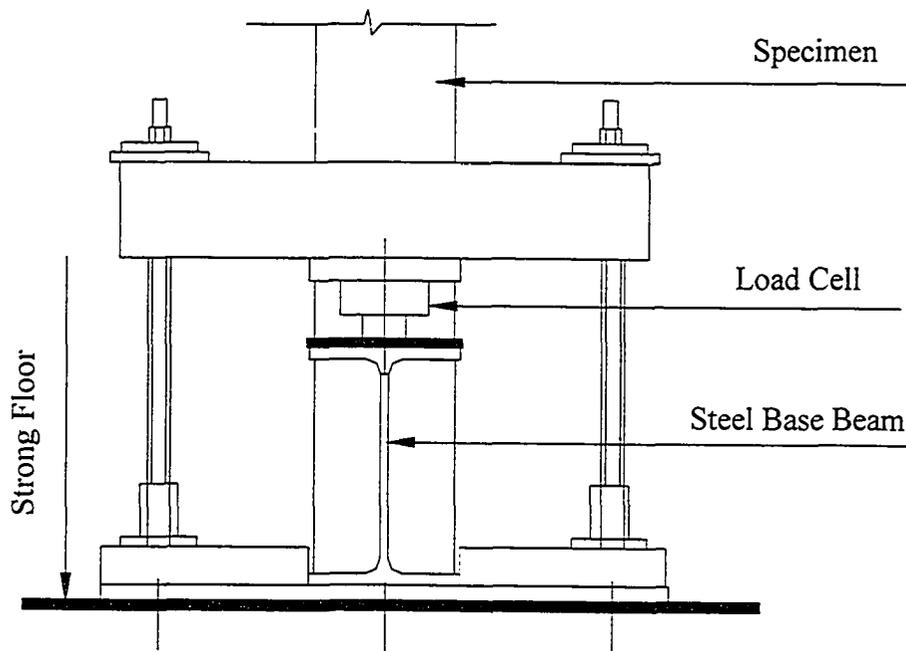
**Figure 3-10 Floor Anchor Systems**

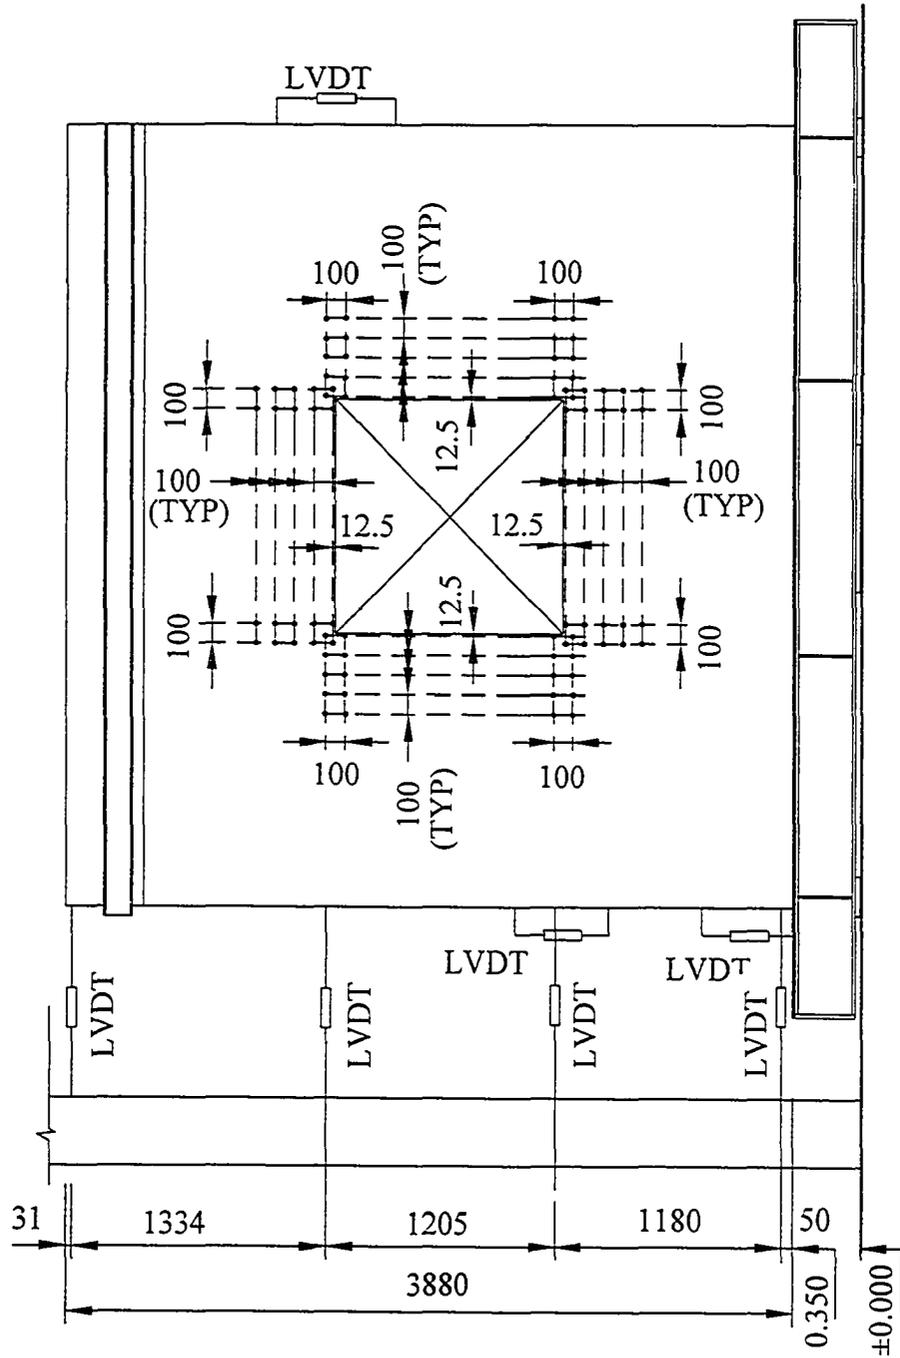
**Figure 3-11 Instrumentation Layout for Wall 1**

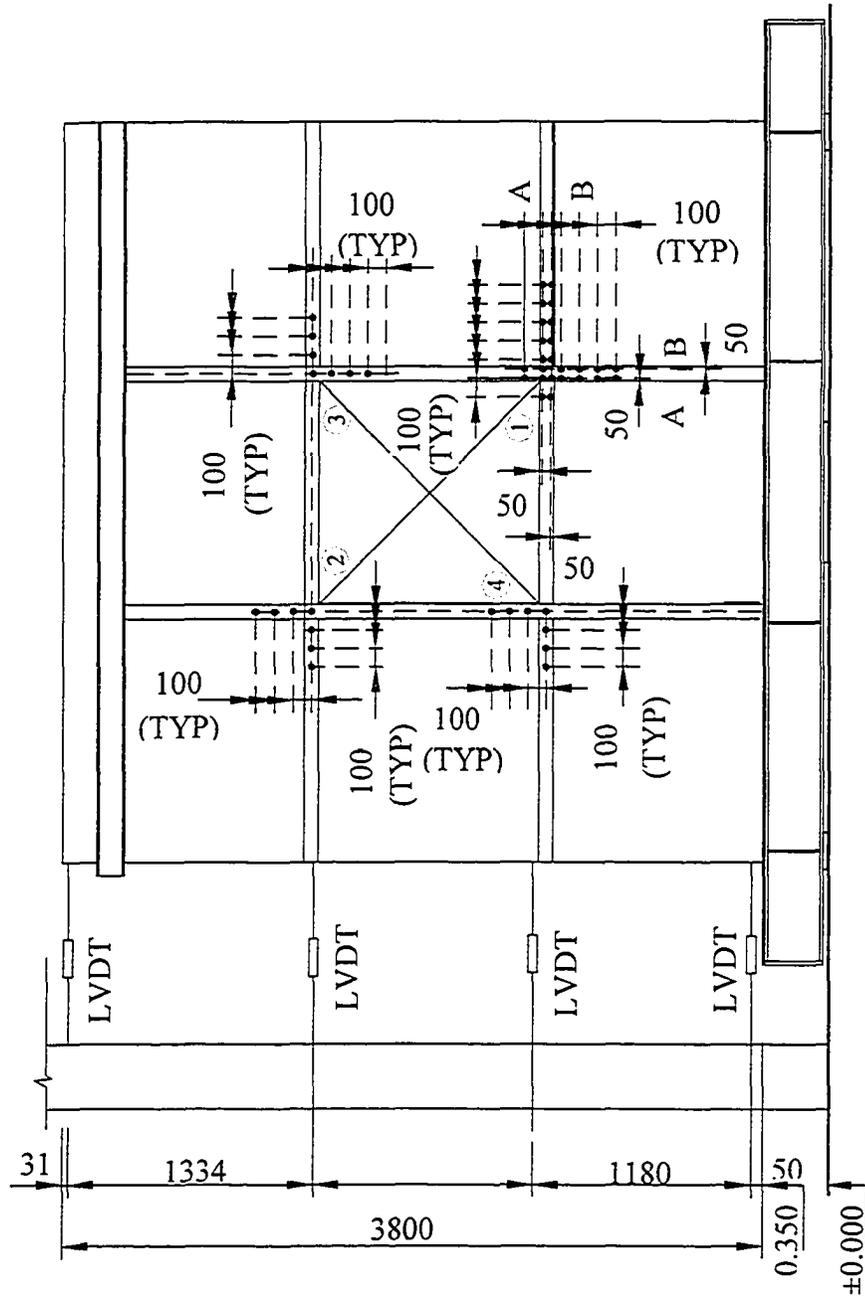
**Figure 3-13 Instrumentation Layout for Wall 3**

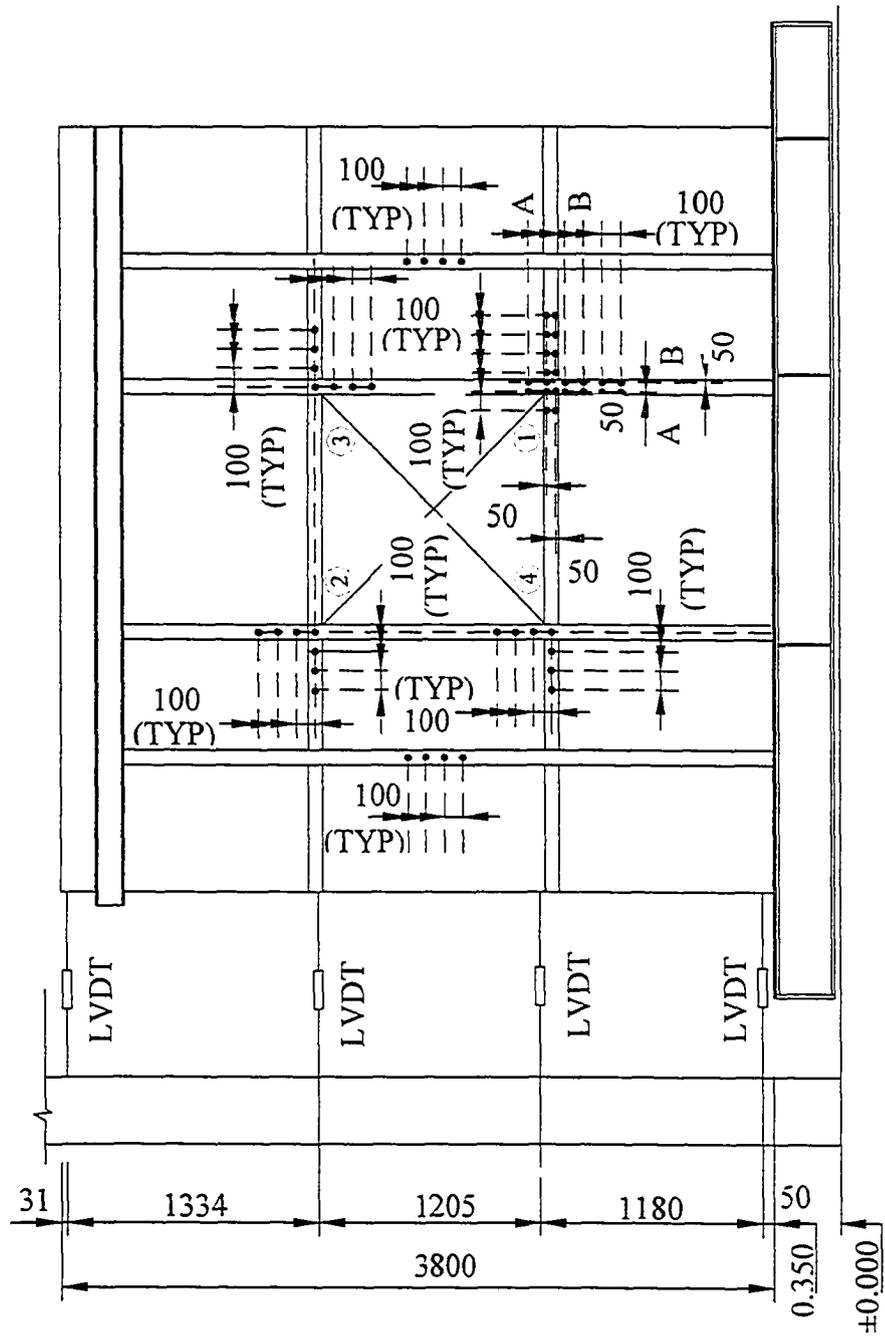
Figure 3-14 Instrumentation Layout for Wall 4

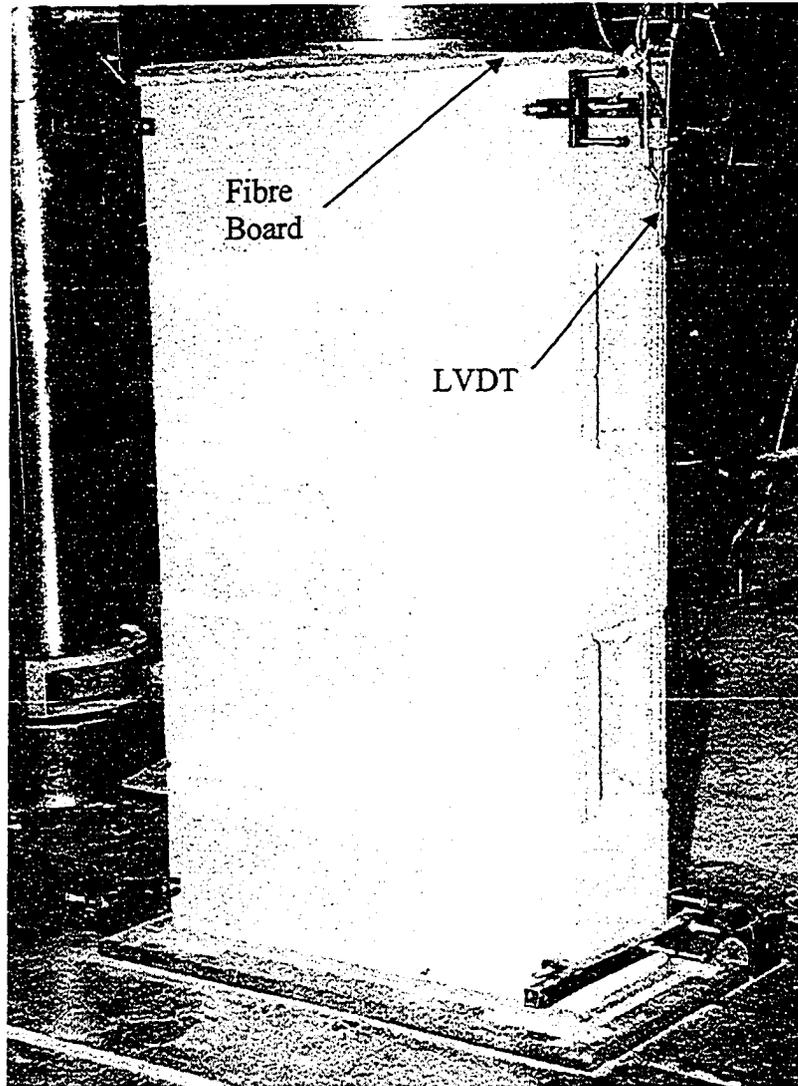
**Photo 3-3 Typical Prism Specimen and Instrumentations**

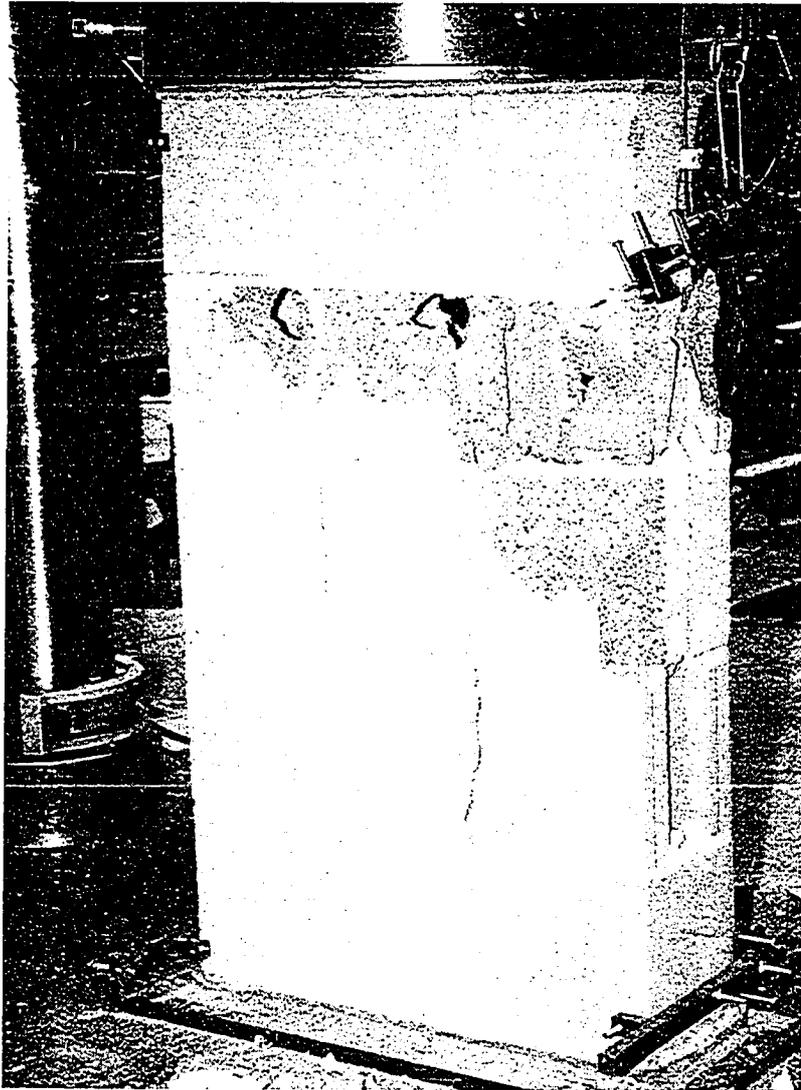
**Photo 3-4 Typical Failure Modes for UngROUTed Prisms**

The failure mode observed was as expected based on the basic concept summarized by Hendry (1991). The ungrouted prisms failed by vertical splitting in their own plane. The final failure also involves some crushing of mortar as the two halves of masonry buckle out. For grouted prisms under compressive loading, the face-shells of the masonry typically split always from the grout cores. This failure mechanism is caused by a

wedging action of the grout, the wedge shape developing because of the taper of cores of the hollow units. Photos 3-4 and Photo 3-5 show the typical failure modes for fully grouted and ungrouted prisms.

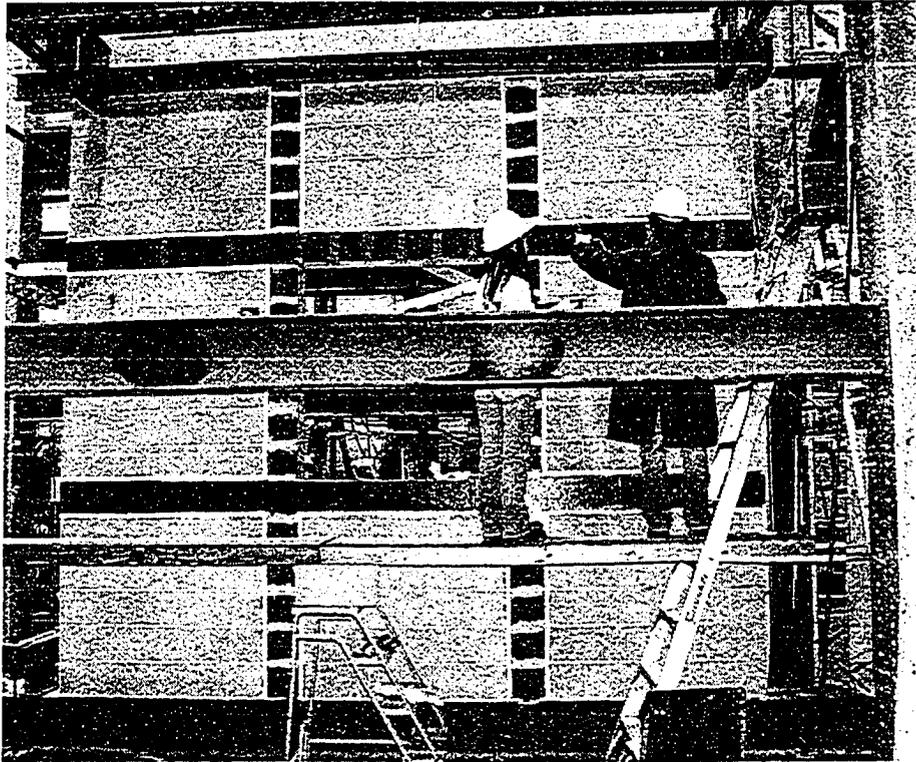
**Photo 3-8 Application of CFRP Strips**

The process of application of CFRP Sheets involved the following steps. First a primer coat was applied on the surface of masonry to provide a high bond base coat for this composite strengthening system and a roller was used as application equipment for primer. After twenty four hours to cure primer the putty which functions as the second component of the epoxy system was applied to the primed substrate using a spring steel trowel to level small surface defects and fill the joints, and to provide a smooth surface. Another Twenty four hours later, the base coat of saturant was applied using a roller to begin saturation of the fibre reinforcement sheets. Then the strips of fibre were laid out on the first layer of wet saturant and pressed into place by hand. Next the second coat of saturant was applied to the top of the fibre strips using a roller to ensure full penetration of the saturant throughout the fibre strips. Last a steel roller was used to press and smooth the surface of the composite strengthening system to remove any air bubbles. All components of the epoxy system have the same Part A to Part B mix ratio of 3:1 by volume. The fibre reinforcement was allowed to cure for at least one week before instrumentations were applied. Photo 3-8 shows the application of CFRP Sheets.

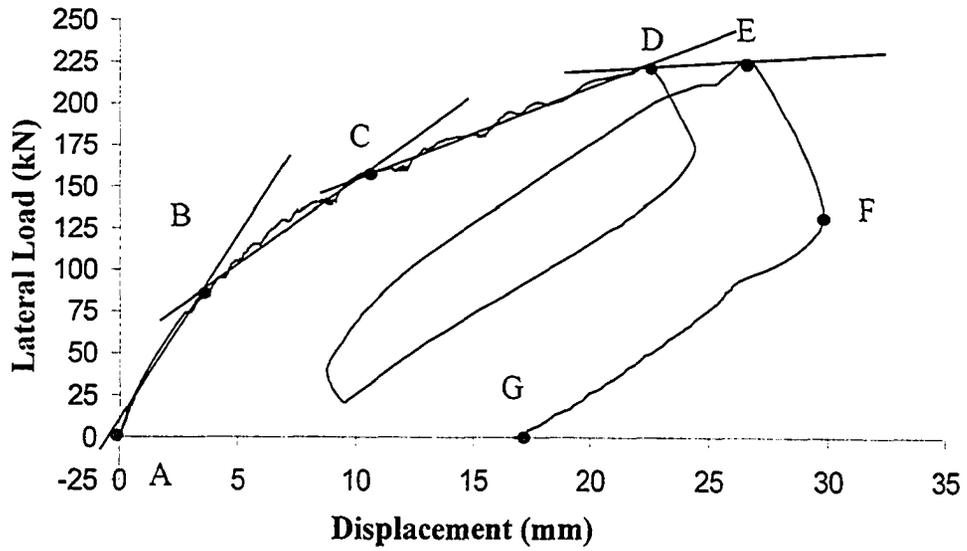
**Figure 4-1 Lateral Load Vs. Top Displacement of Wall 1**

The Load versus Displacement curve in Figure 4-1 shows six regions. The first stage of loading ended at point B in Figure 4-1 with a lateral load of 75kN and 3.0mm top displacement. The control wall was in the elastic stage before this point. At this point, first cracks were observed and these cracks caused a slight degradation in stiffness

resulting in slight change in slope of the response curve. From point B to C the effective stiffness was almost constant and only some small cracks appeared at the bottom corner of the opening during this period. At point C, the second degradation in stiffness occurred because a large number of cracks appeared in the two piers beside the opening at this time. This stiffness was kept constant from point C to D. The loop between point D and E was due to an unloading process started at the point D. As the increase of lateral load, tensile stress developed at the heel of the wall due to up-lifting. When the lateral load level reached 220kN, corresponding to point D in Figure 4-1, a wide tension crack appeared in the heel of the wall and wall failed in flexure. To continue the test and obtain a shear failure mode, an external hold-down system was introduced at the heel of the wall. During the application of this hold-down system, the wall was unloaded for safety purpose and then the wall specimen was loaded to shear failure at Point E. It's evident that another degradation in stiffness occurred at point D as a result of the tension failure at the heel of the wall. Point E defines the lateral load capacity of 226kN with 26.8 mm top displacement. The load decreased dramatically after point E, and the top displacement continued to increase to 29.7 mm at the point F with the lateral load of 132kN. The test was then terminated. All loads corresponding to major cracking occurrences will be shown in Sec 4.4. The roughness of the curve was due to small creep during the halt of loading to take Demec reading or mark cracks during test.

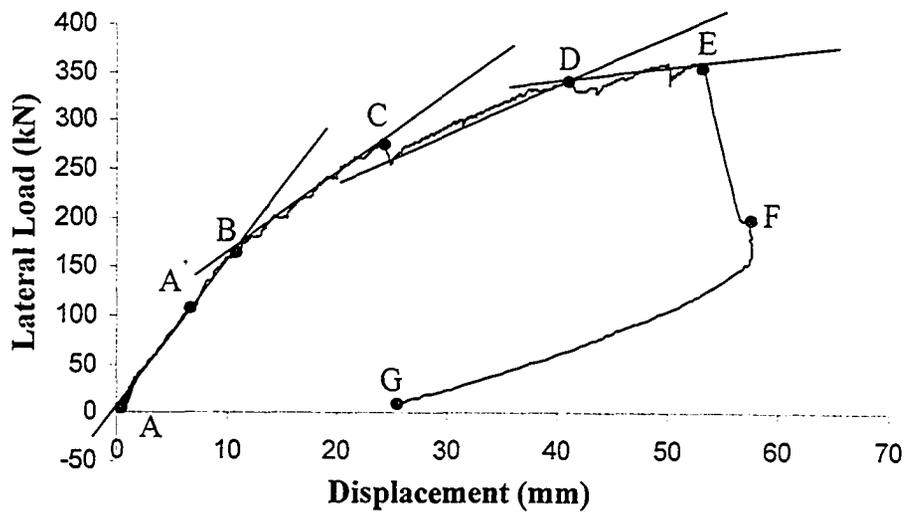
**Figure 4-2 Lateral Load Vs. Top Displacement of Wall 2**

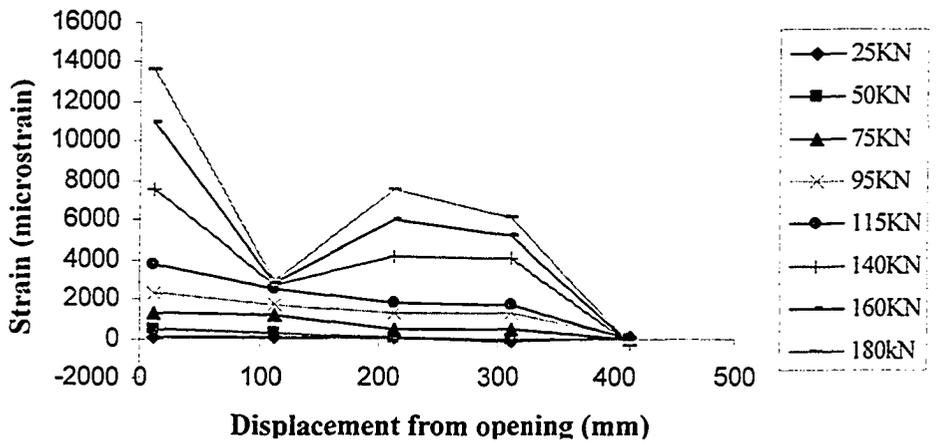
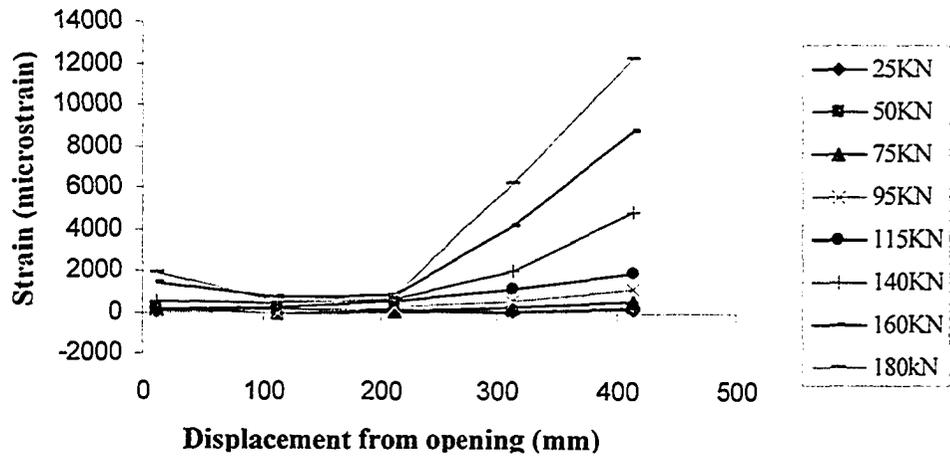
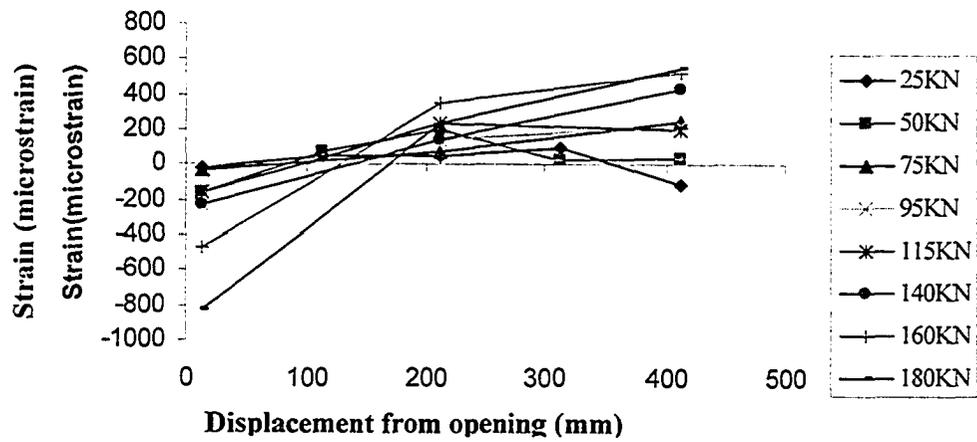
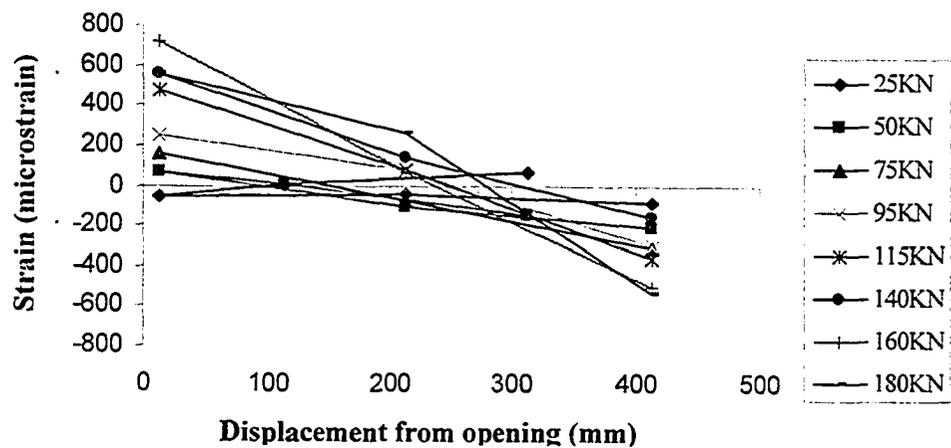
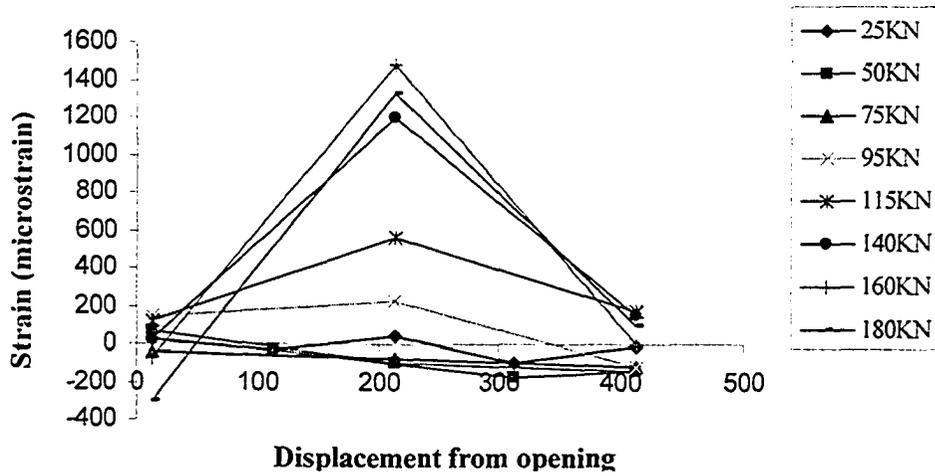
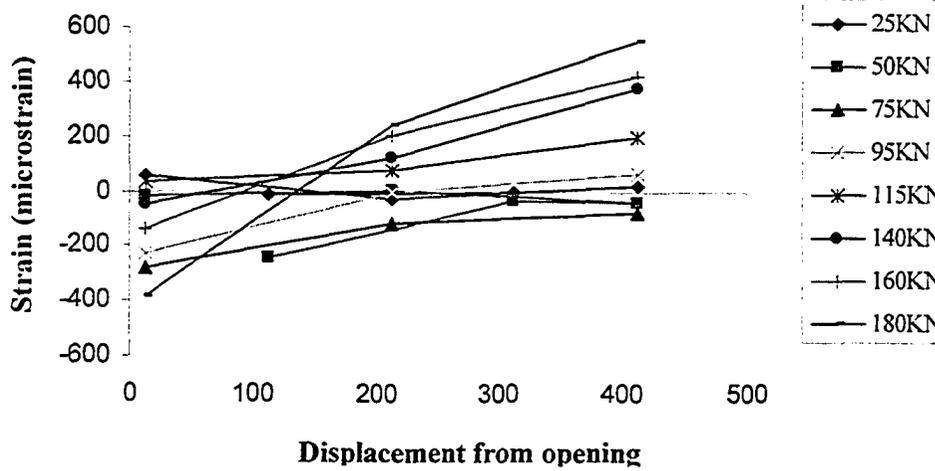
**Figure 4-5 Strain Behaviors of Wall 1**

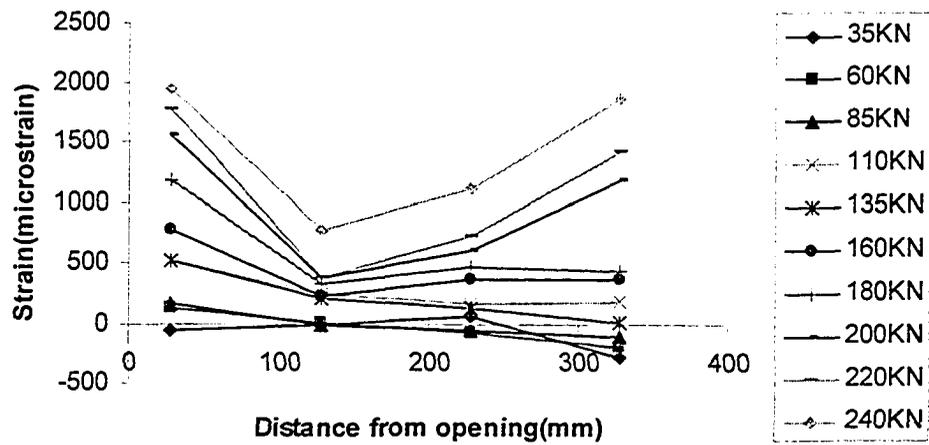
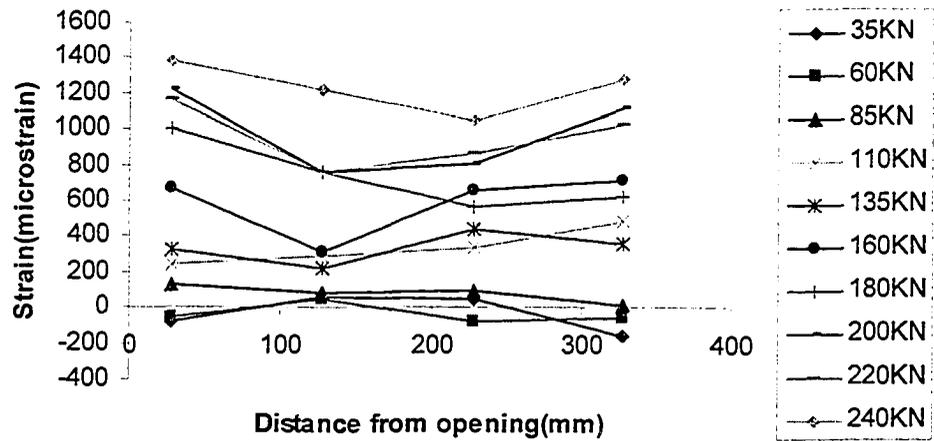
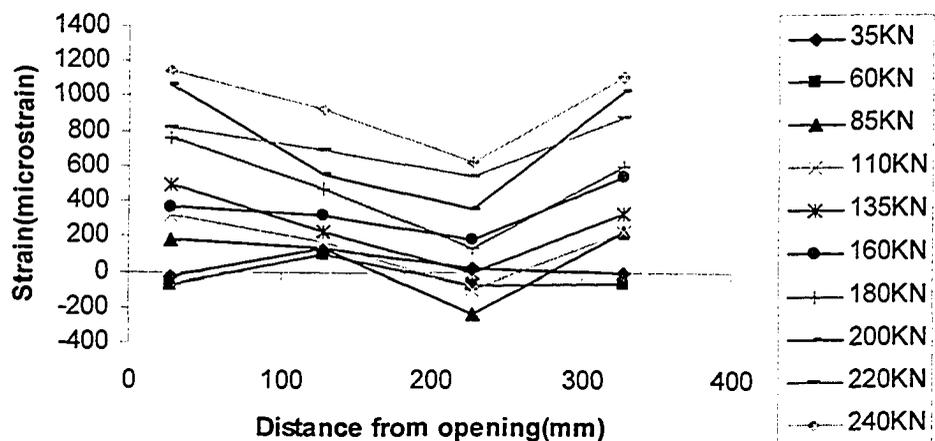
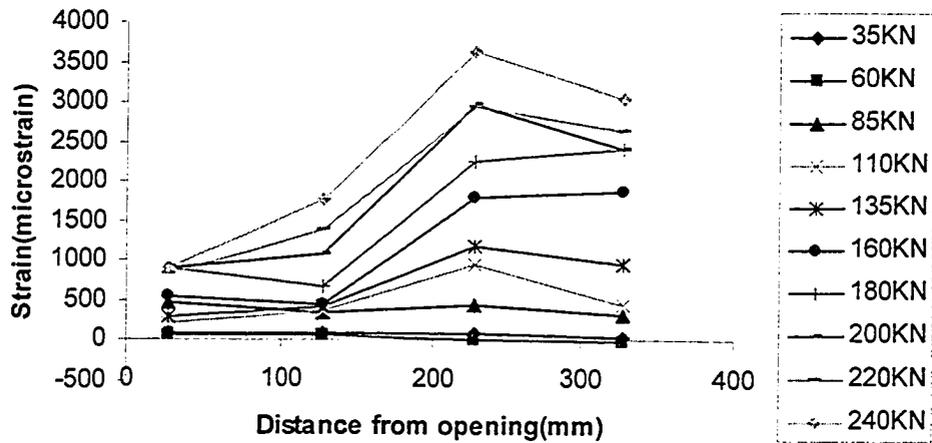
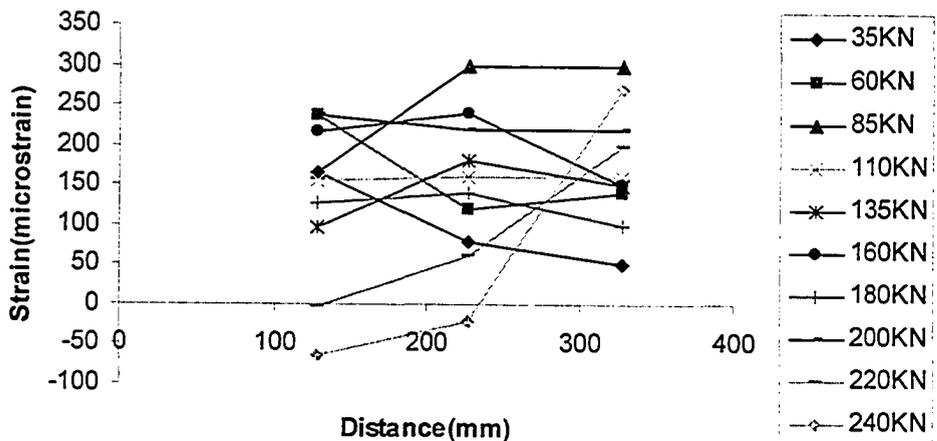
Figure 4-6 Strain Behaviors of Wall 2
