**CFRP SHEETS APPLICATION TO MASONRY SHEAR WALLS  
WITH OPENINGS**

A thesis submitted to the Faculty of Graduate Studies and Research in partial fulfillment  
of the  
requirements for the degree of MASTER OF SCIENCE

Structural Engineering

This thesis described an experimental program that investigated strengthening of masonry shear walls with openings using externally bonded Carbon Fiber Reinforced Polymer (CFRP) Sheets carried out at University of Alberta. Four wall specimens were designed and tested under combined uniformly distributed constant vertical load and monotonic in-plane lateral load. The variables in this test included the amount and layout of CFRP Sheets. This thesis analyzed the general shear wall behavior based on lateral load-top displacement curves, cracking patterns and the action of the CFRP Sheets to walls. The test results showed that the lateral load capacity and displacement ability of strengthened walls with CFRP Sheets were increased remarkably. Moreover, CFRP Sheets were effective in enhancing the stiffness of walls in the later loading stage. Finally, several mechanical models were presented to estimate the shear contribution of CFRP Sheets to the pe

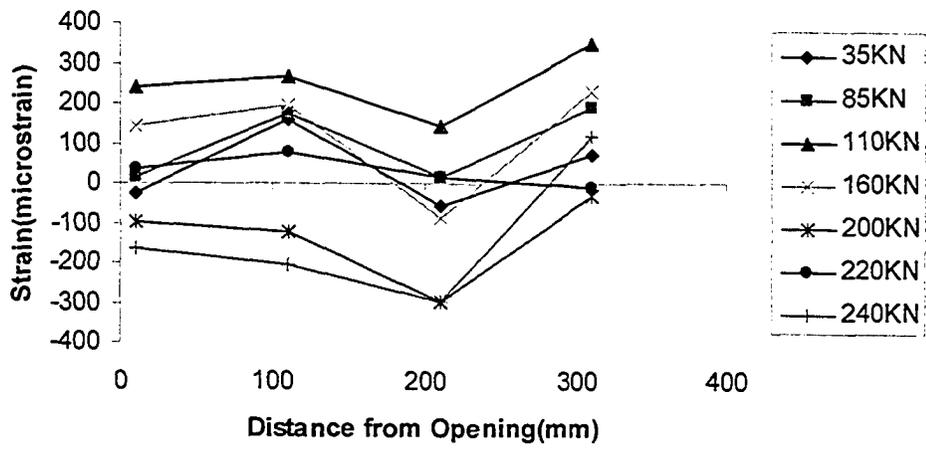
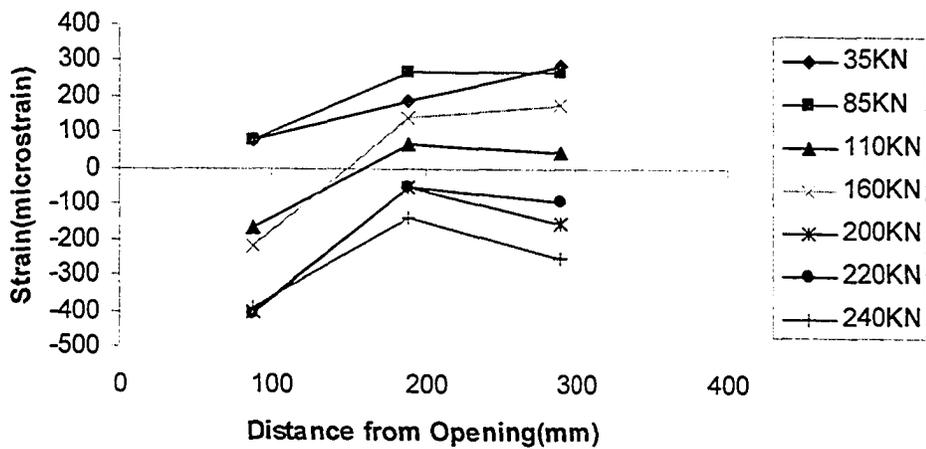
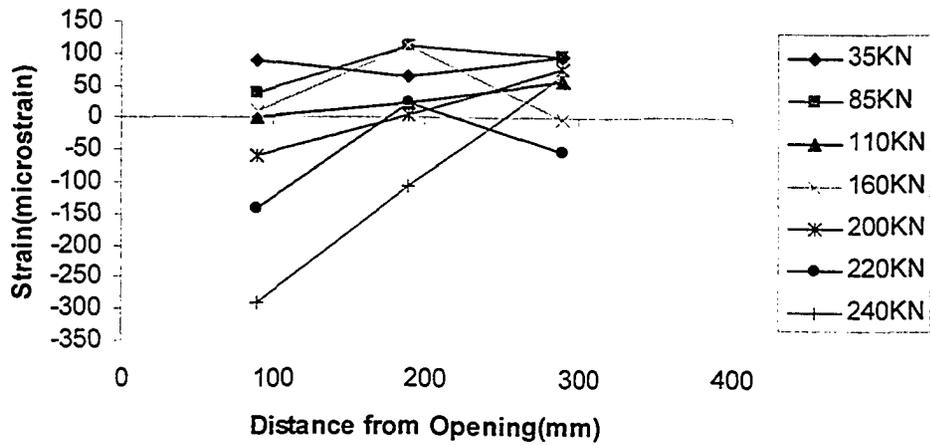
**Figure 4-7 Strain Behaviors of Wall 3**

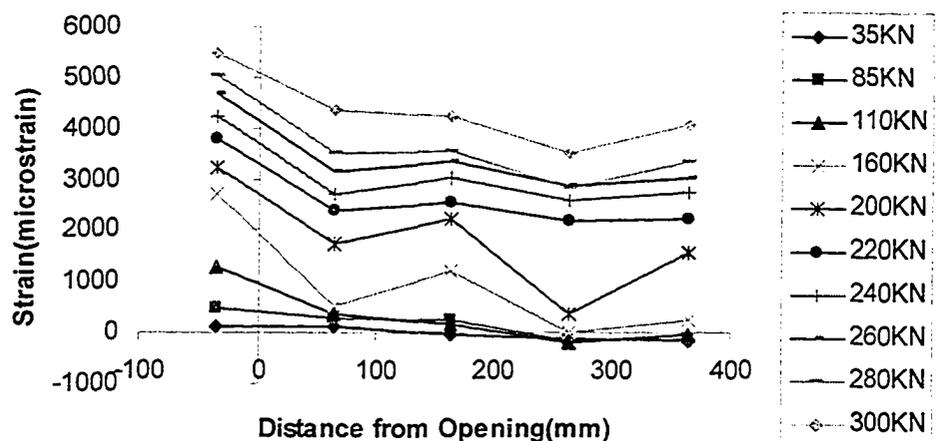
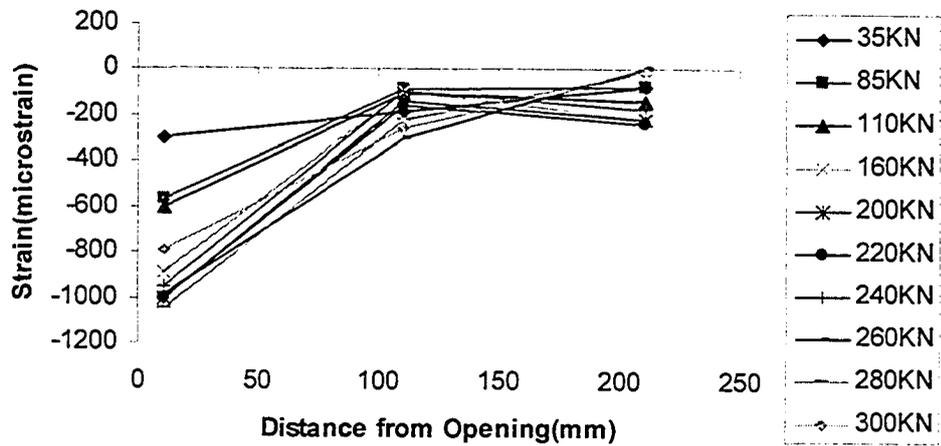
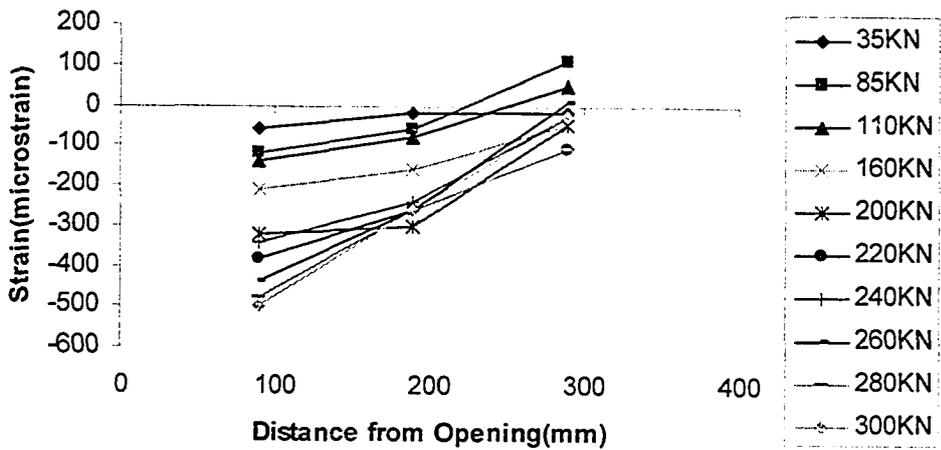
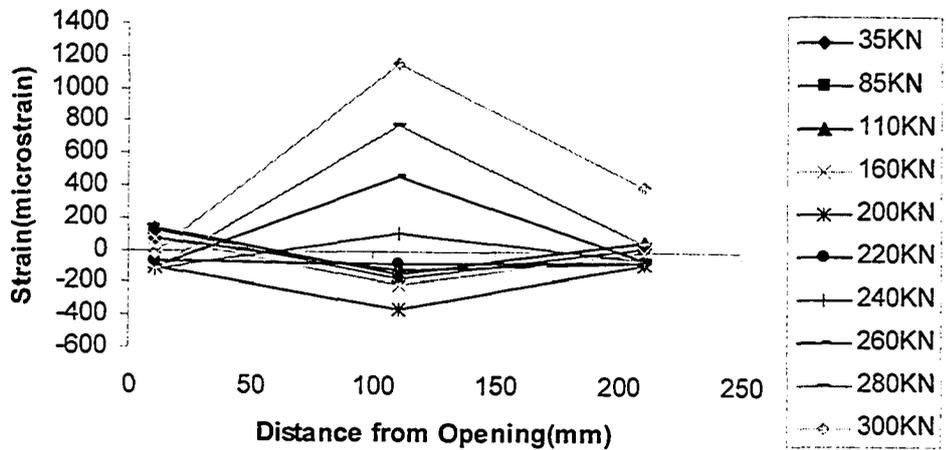
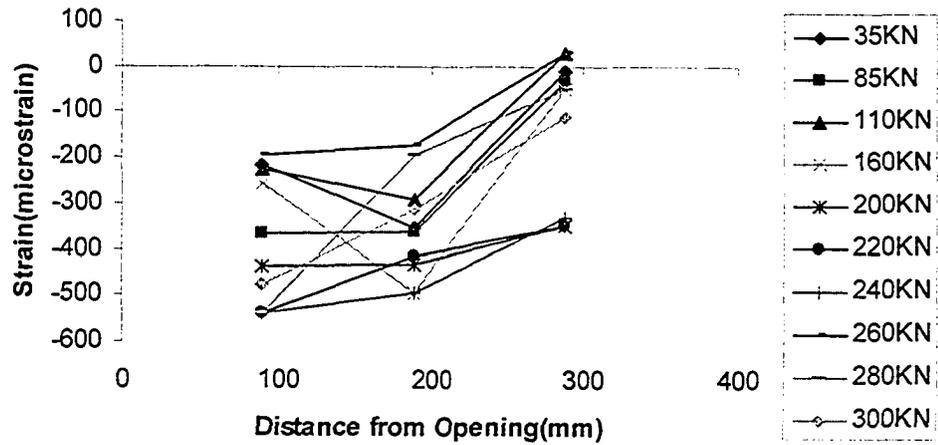
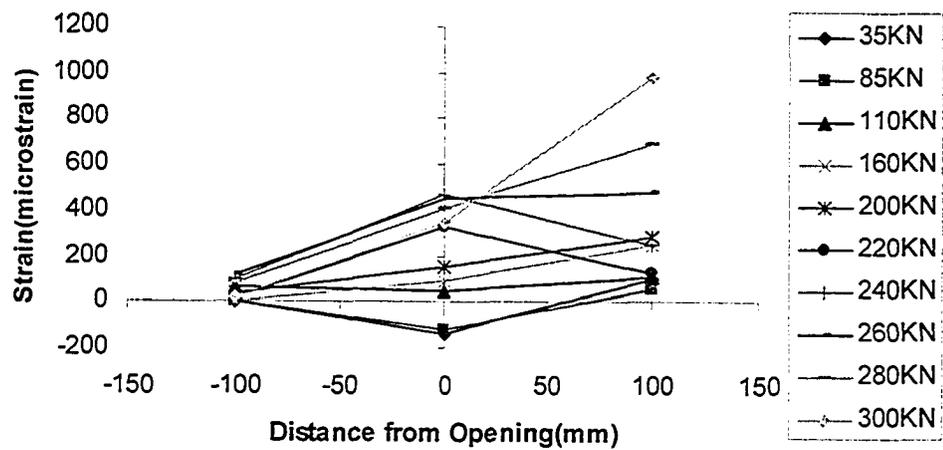
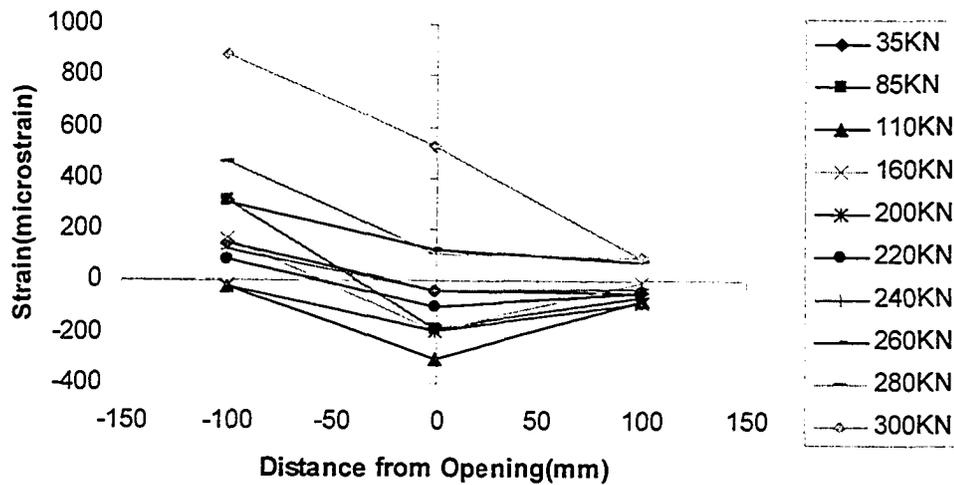
**Figure 4-8 Strain Behaviors of Wall 4**

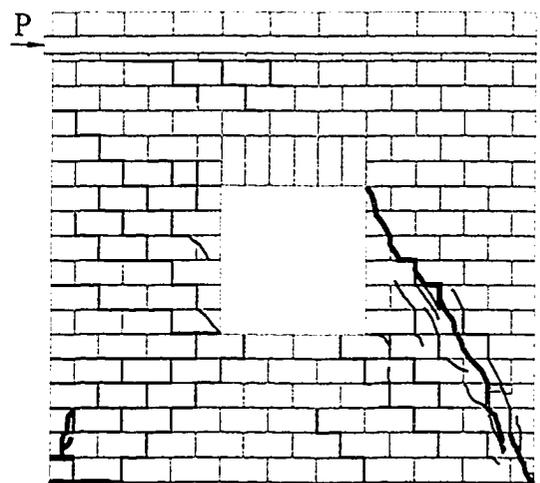
**P = 220kN (failure load) (Wall 1)**

**Figure 4-9 Crack Patterns of Wall 1**

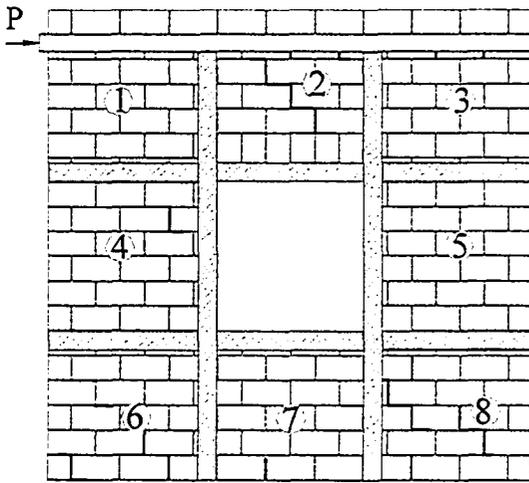
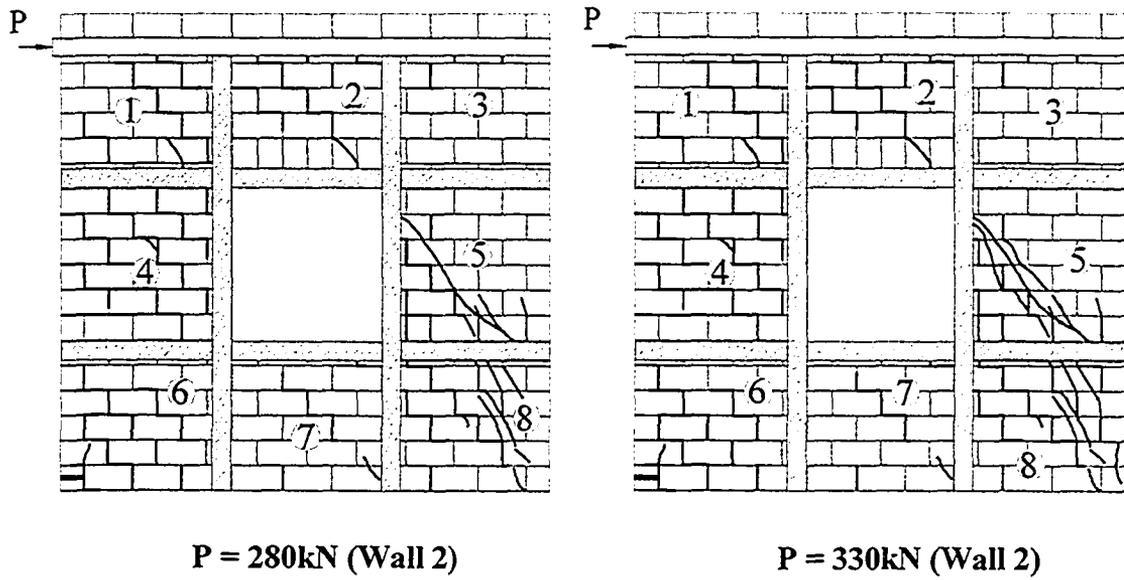
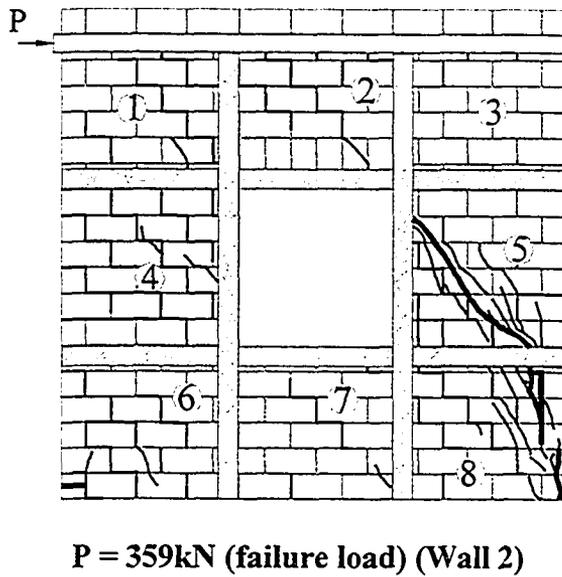
**Figure 4-10 Crack Patterns of Wall 2**

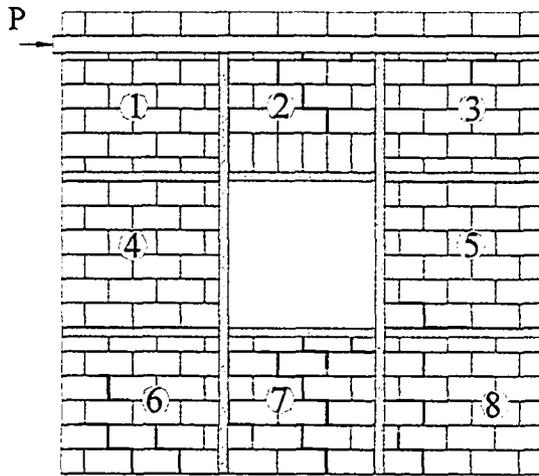
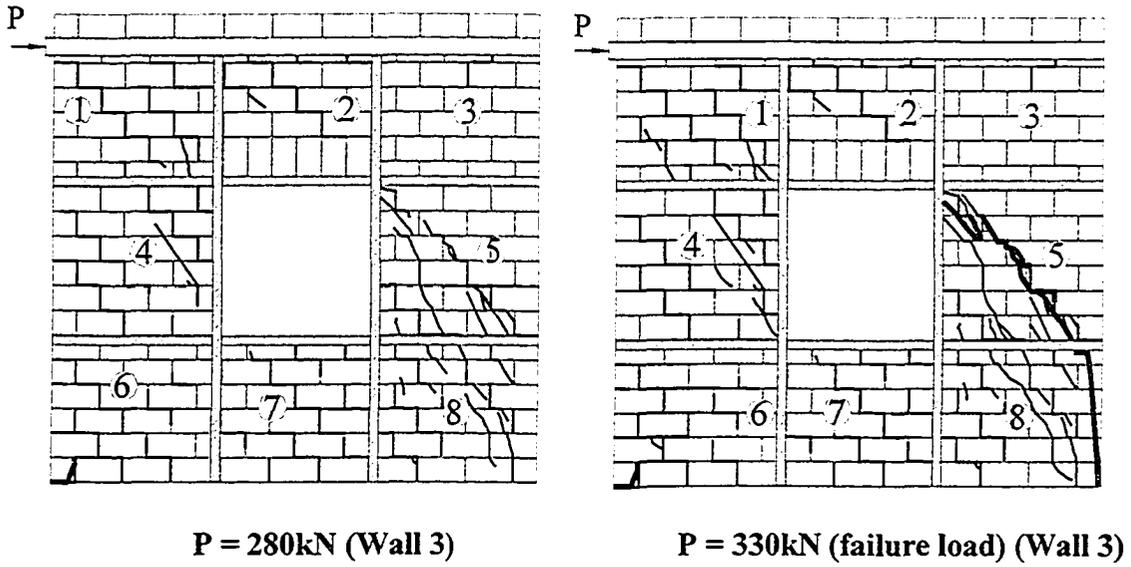
**Figure 4-11 Crack Patterns of Wall 3**

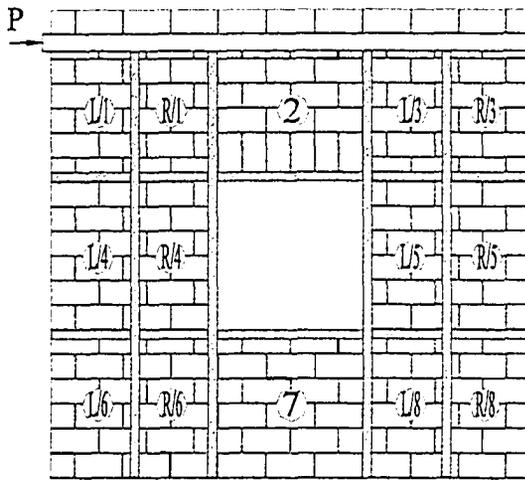
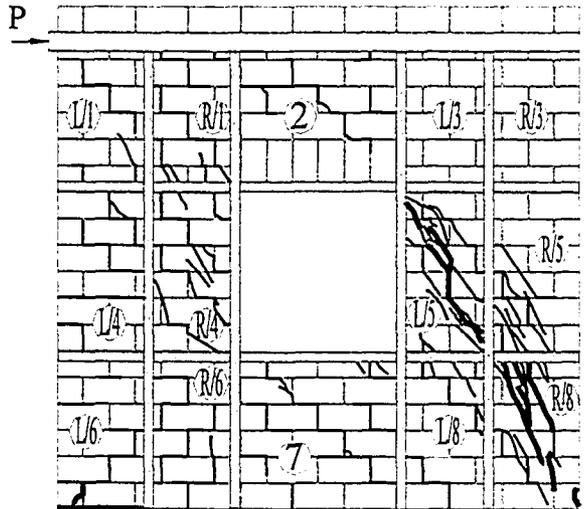
**P = 351kN (failure load) (Wall 4)**

**Figure 4-12 Crack Patterns of Wall 4**

It's important to mention that there was not an abrupt drop in maximum lateral load at failure in Wall 4. The maximum lateral load decreased slowly to 93% of this load capacity and then there was a sudden loss of load carrying capacity of about 33%. During this period the wall gave an enough damage warning. Apparently Wall 4 demonstrated more ductile than other three walls.

After testing the failed wall investigation was carried out and it showed that all the vertical reinforcement rebars in the middle of right pier bent where the major diagonal tension shear cracks crossed and this behaviour illustrated the effective dowel action of vertical reinforcement under In-Plane lateral load.

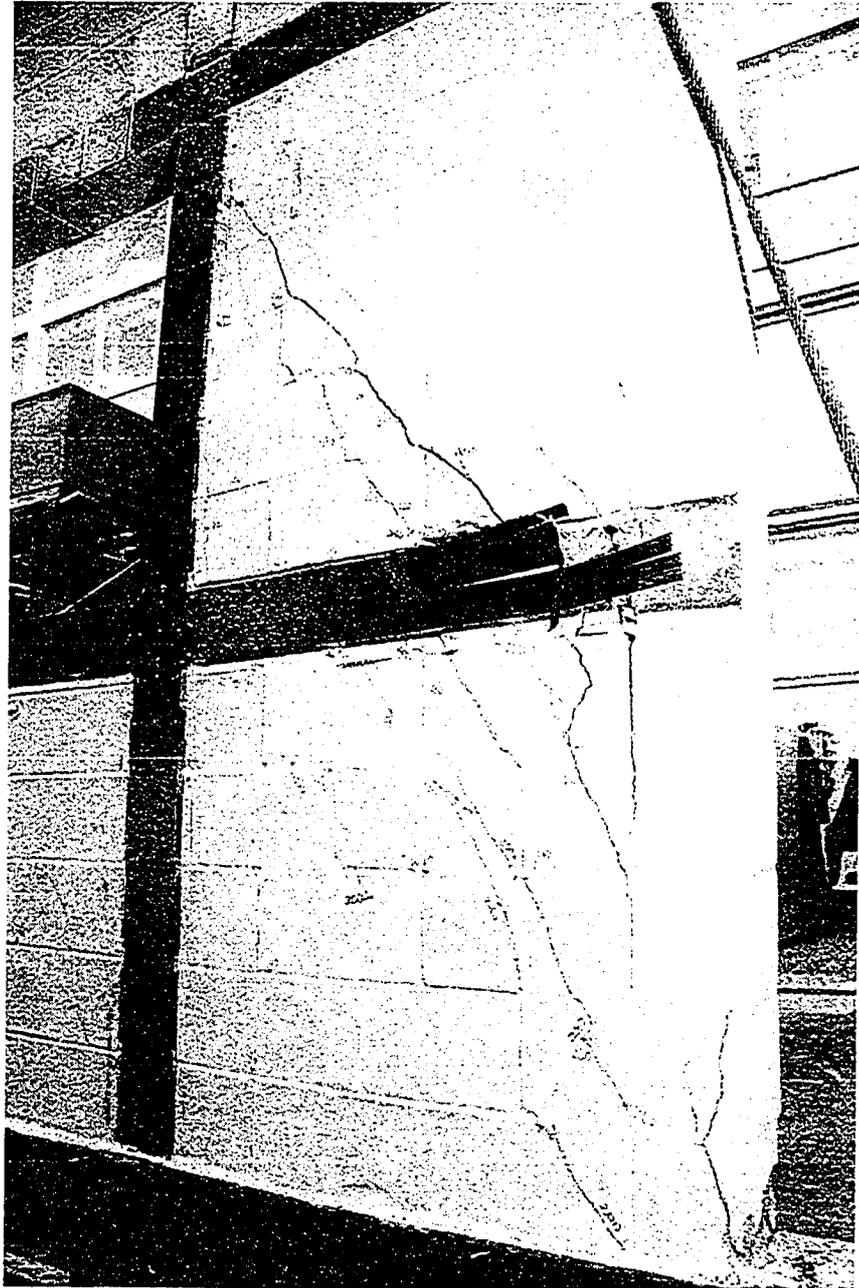
**Photo 4-2 Crack Patterns for Wall 2**

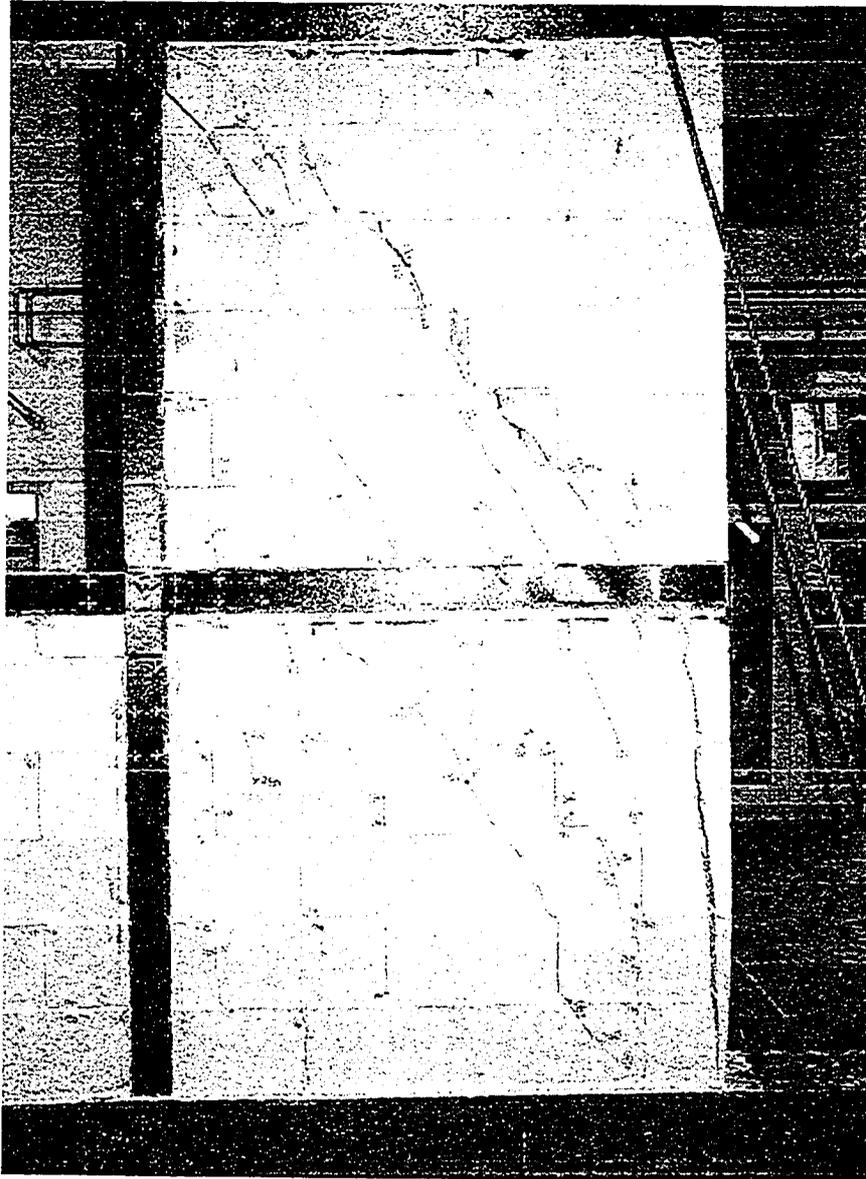
**Photo 4-3 Crack Patterns for Wall 3**

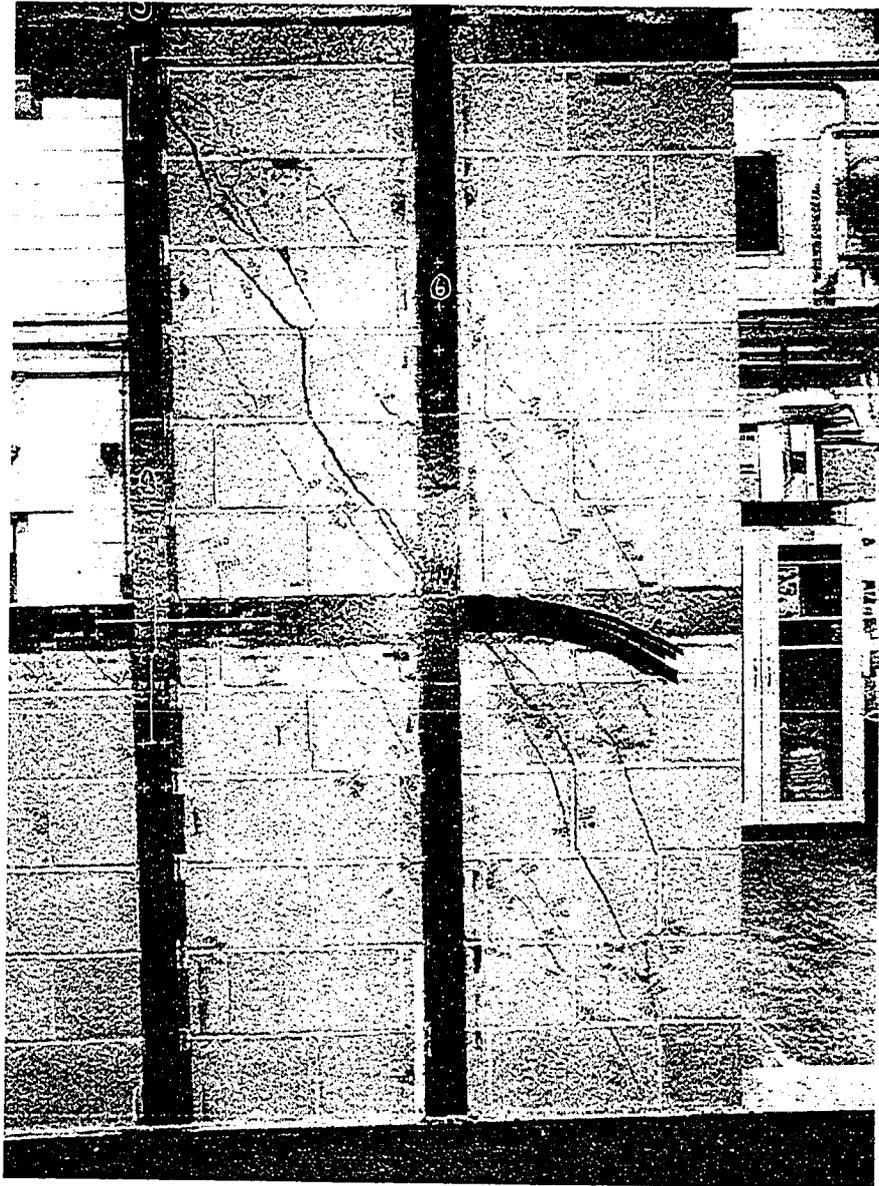
**Photo 4-4 Crack Patterns for Wall 4**

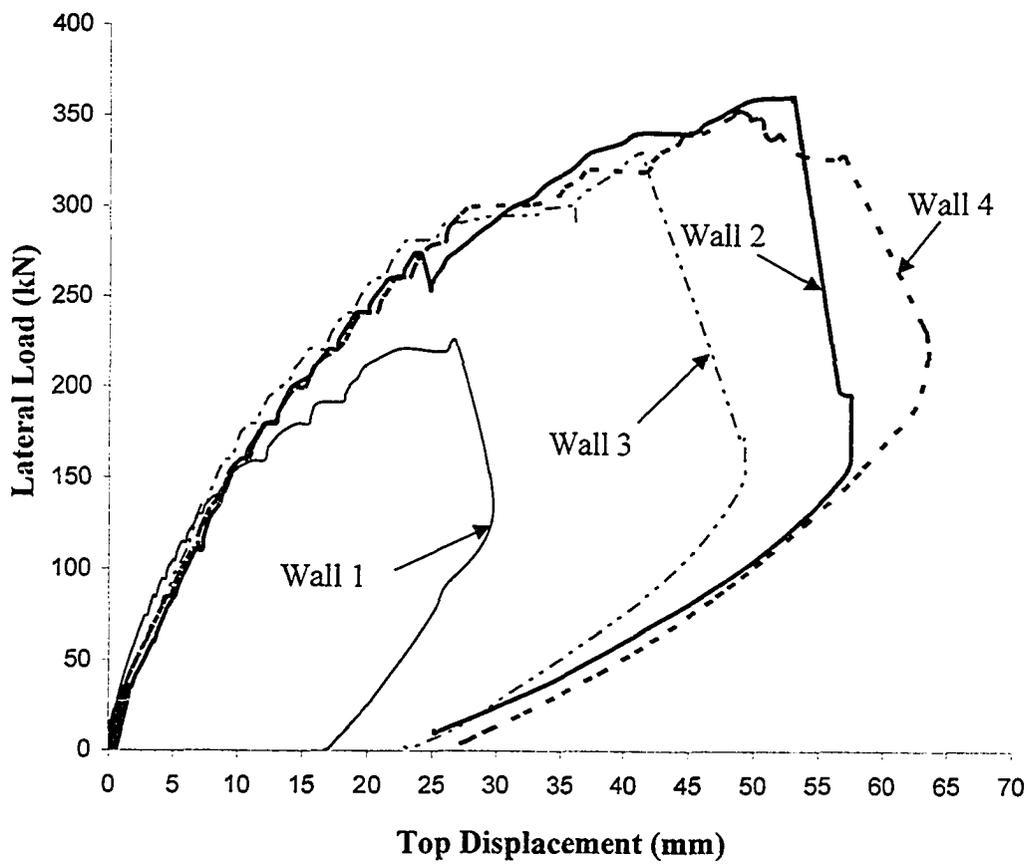
**Figure 5-1 Lateral Load Vs. Top Displacement**

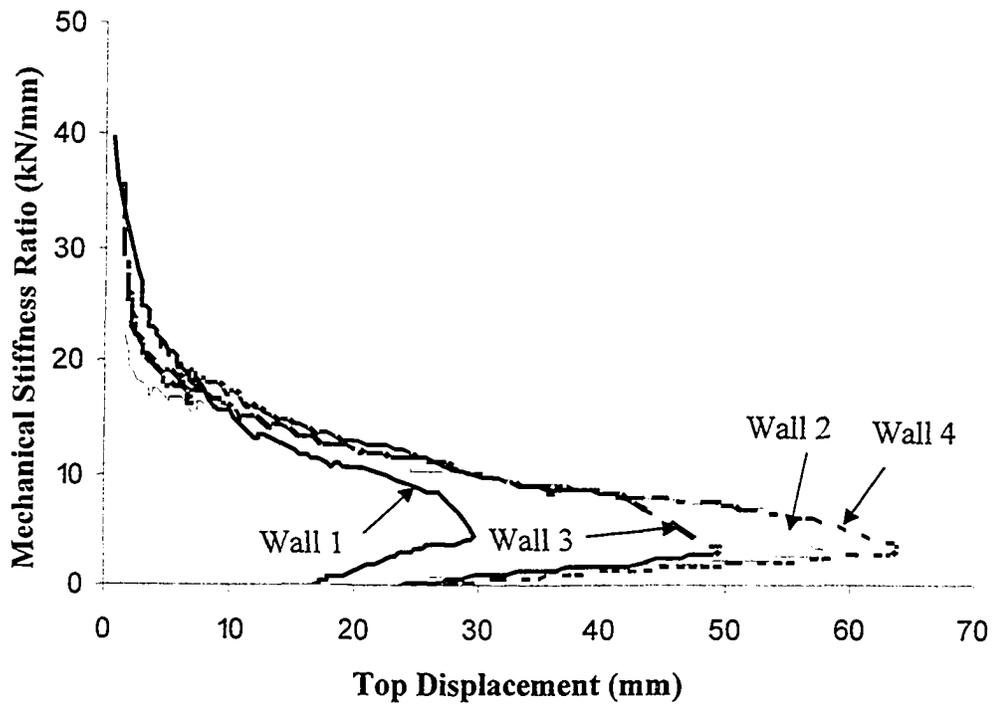
**Figure 5-2 Mechanical Stiffness Ratio Vs. Top Displacement**

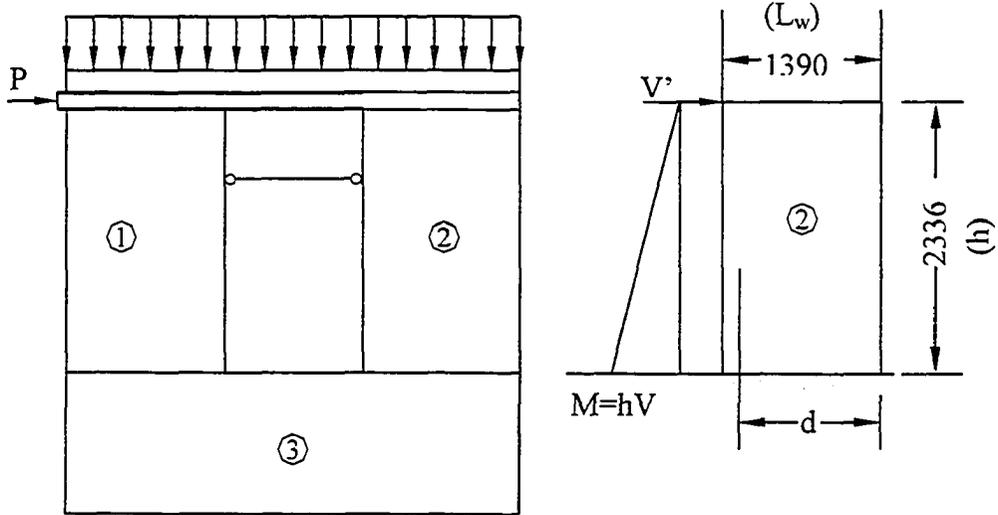
$$M/(Vd) = (hV)/(Vd) = h/(0.8L_w) = 2.10$$

**Pier Model (a)**

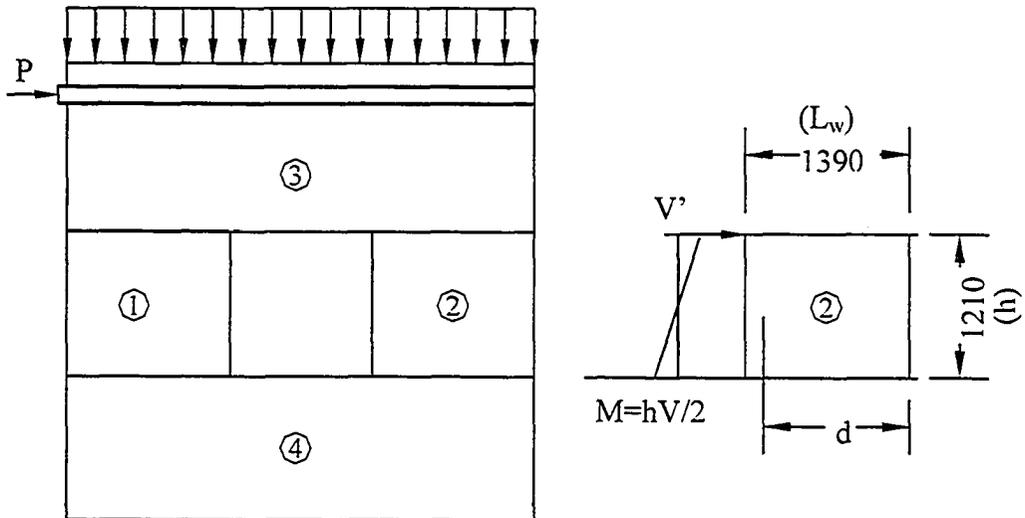
$$M/(Vd) = (hV)/[2(Vd)] = h/[2(0.8L_w)] = 0.54$$

**Pier Model (b)**

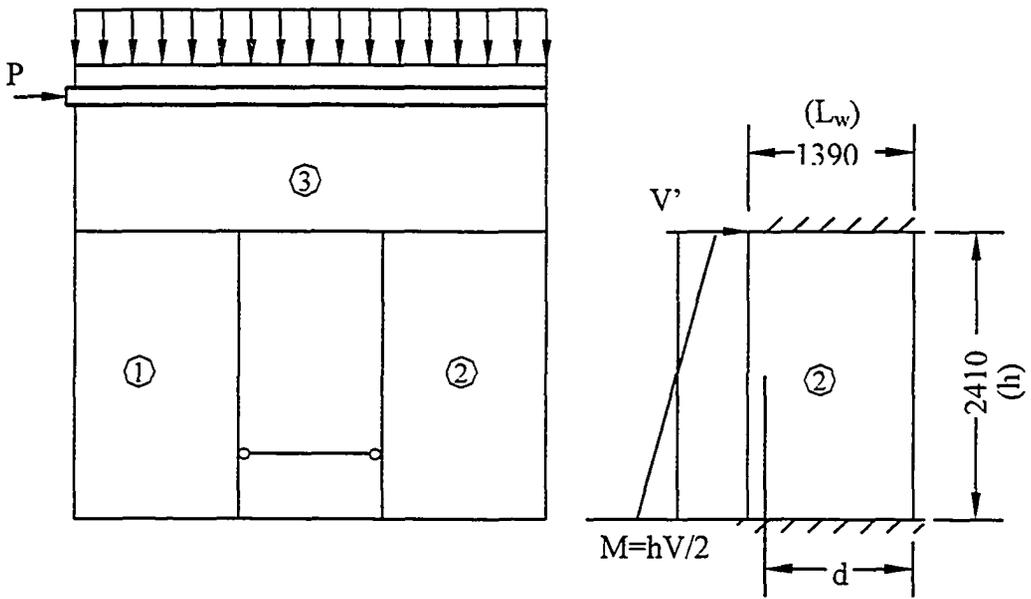
$$M/(Vd) = (hV) / [2(Vd)] = h / [2(0.8L_w)] = 1.08$$

**Pier Model (c)**

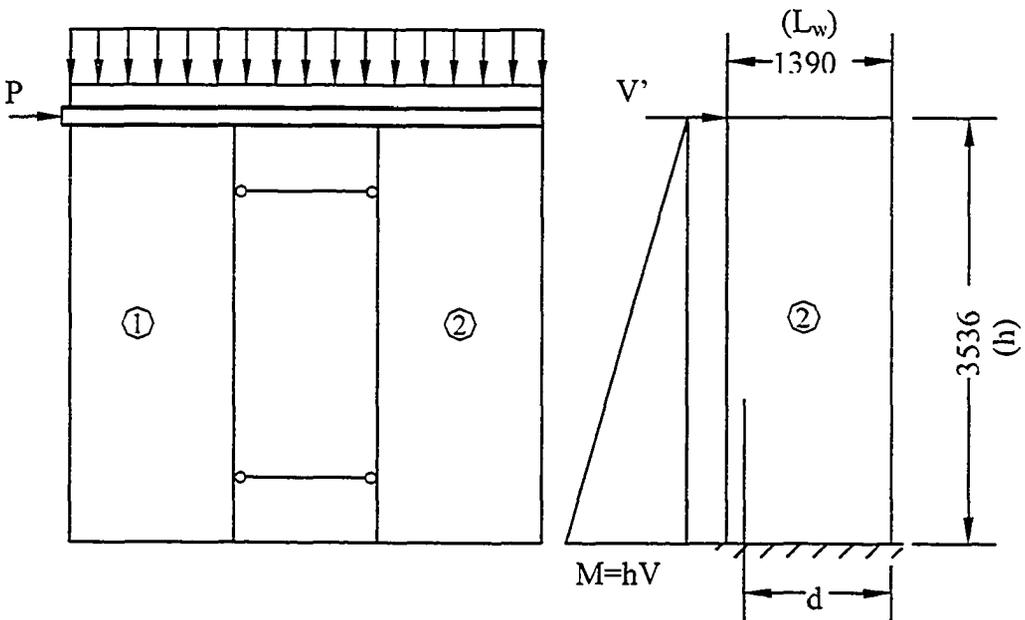
$$M/(Vd) = (hV) / (Vd) = h / (0.8L_w) = 3.18$$

**Pier Model (d)**

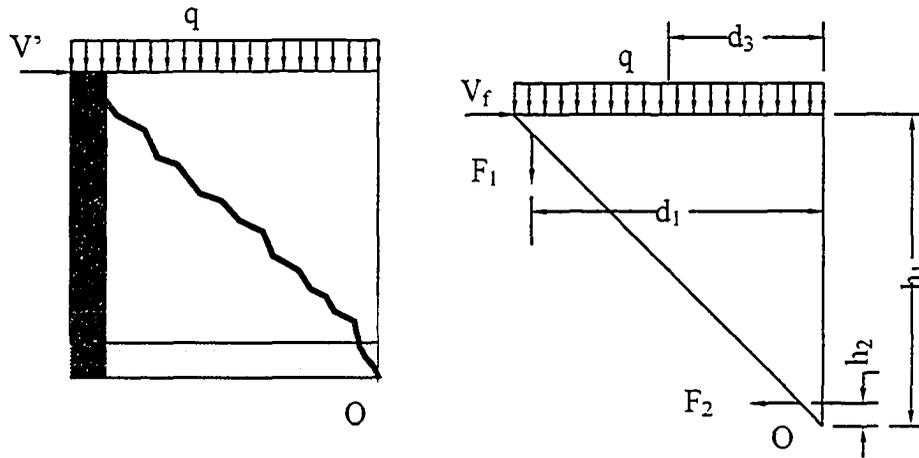
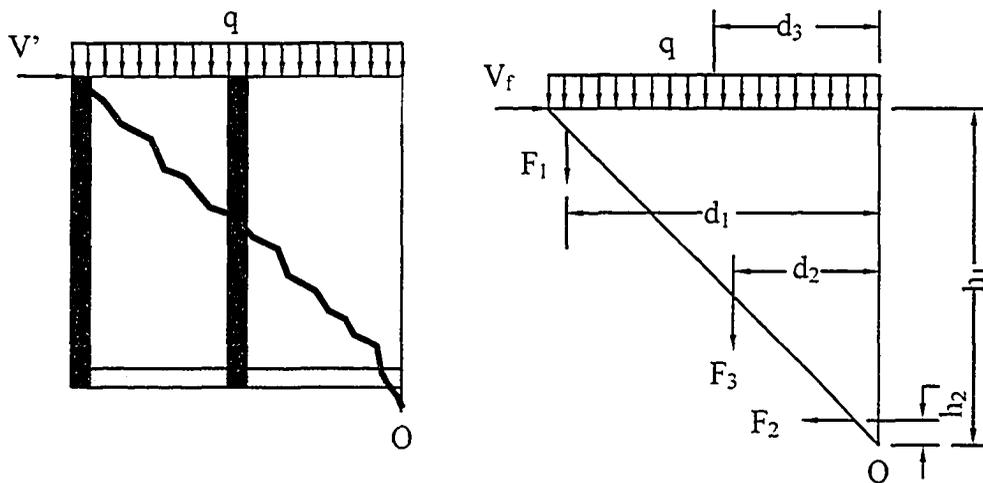
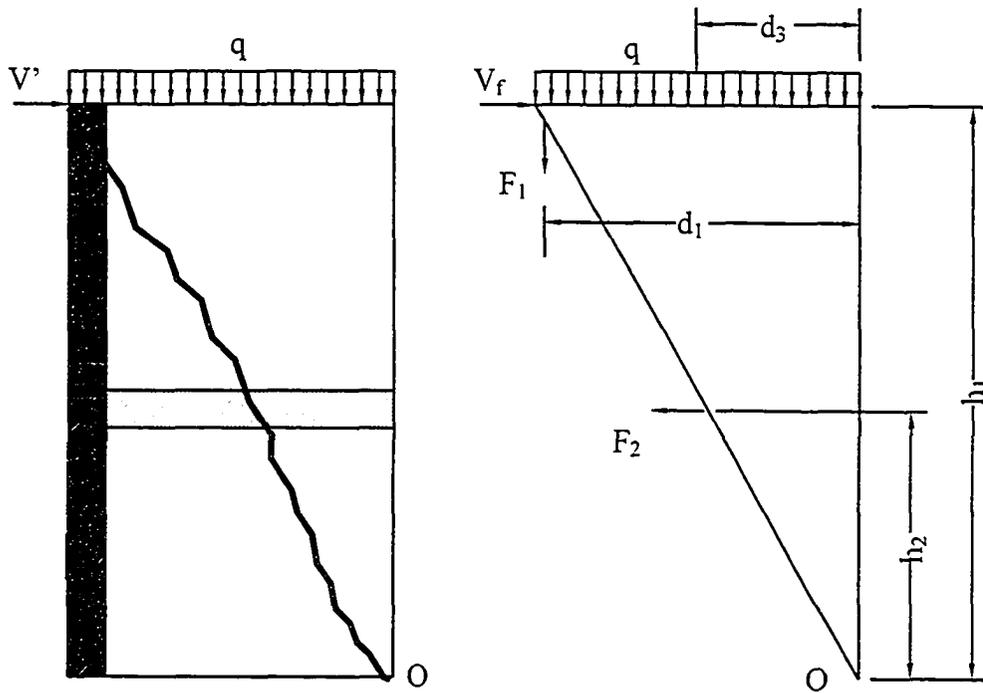
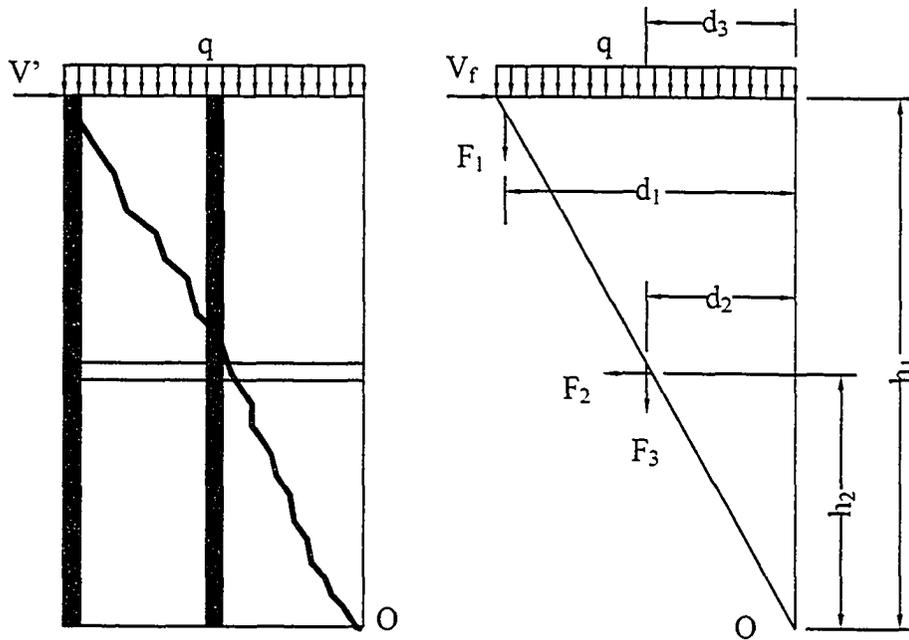
**Free-Body of a Cracked Pier 2 in Model (b) for Wall 2 and Wall 3**

**Free-Body of a Cracked Pier 2 in Model (b) for Wall 4**

Free-Body of a Cracked Pier 2 in Model (c) for Wall 2 and Wall 3

Free-Body of a Cracked Pier 2 in Model (c) for wall 4

Figure 5-7 Analytical Model to Estimate Shear Contribution of CFRP Sheets using Proposed Method

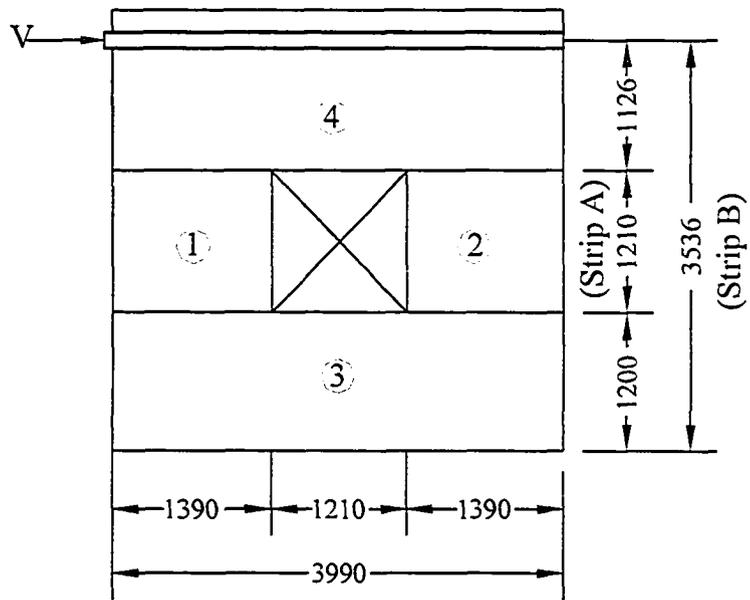
**Figure 5-8 Pier Model for Stiffness Calculation**

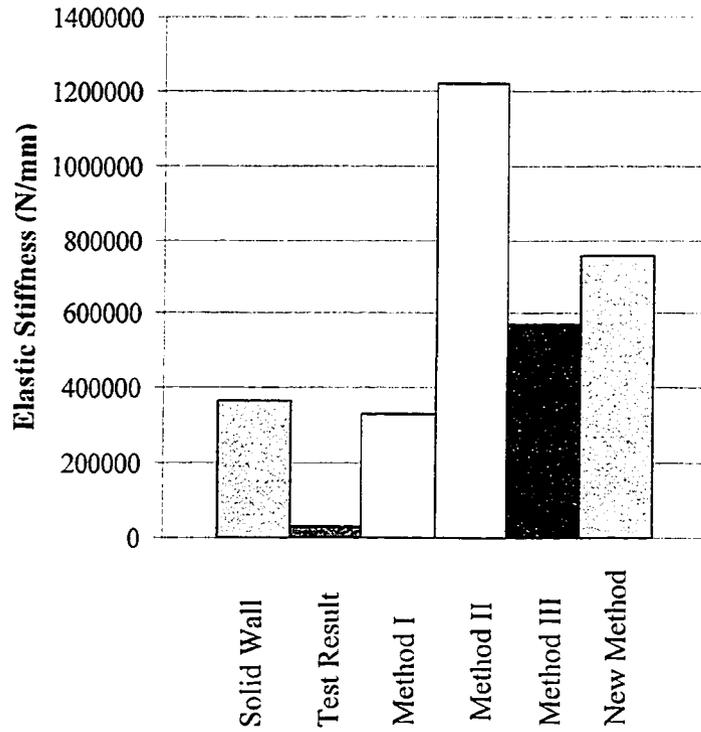
**Figure 5-10 Predicted and Experimental Wall Stiffness**
