Structural Engineering Report 156

MASONRY VENEER WALL SYSTEMS

JANUARY 1988

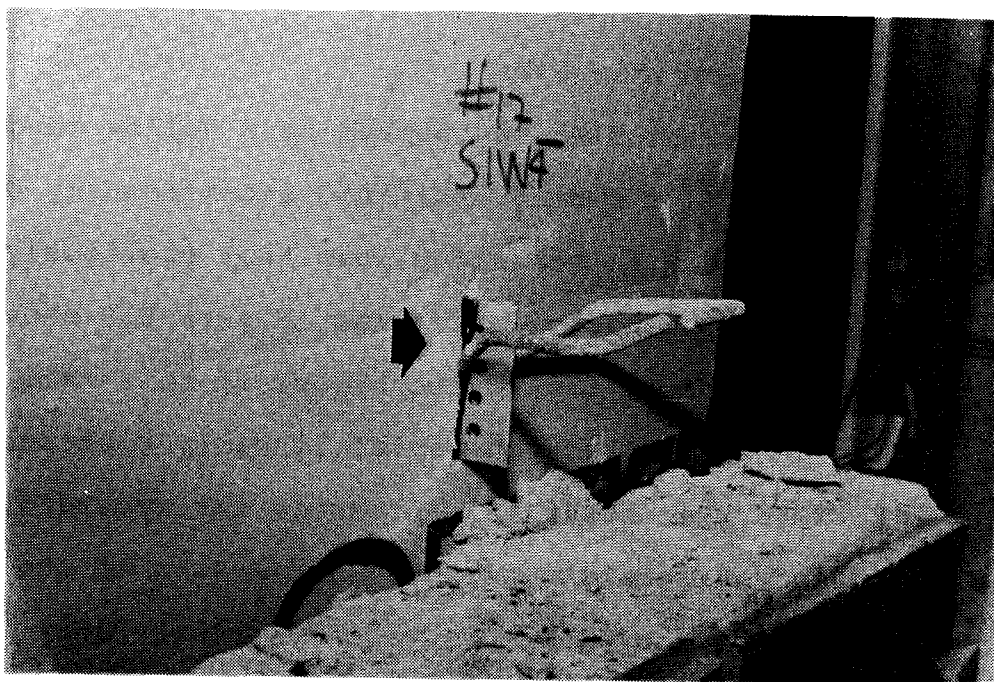
Plate 5.6 Shear Deformation of V Tie Attachment (S1W4)

Plate 5.6 shows that the "V" rod tie attachments of Specimen S1W4 experienced severe shear deformation at
