Structural Engineering Report No. 235

**BEHAVIOUR OF
DISTORTION-INDUCED FATIGUE
CRACKS IN BRIDGE GIRDERS**

December, 2000

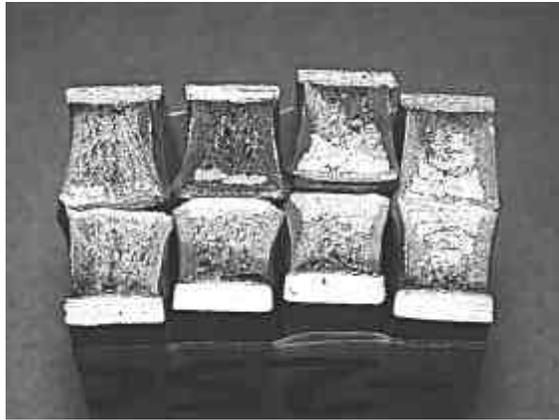
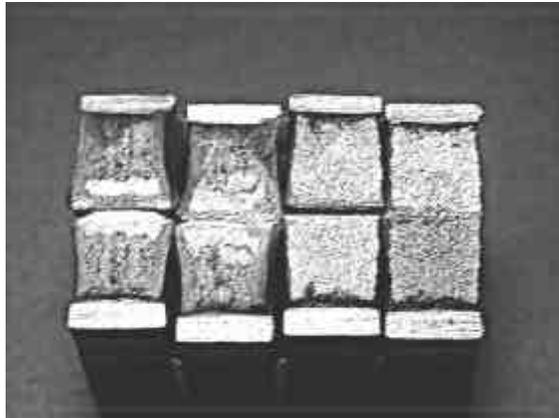
Figure 6-19 Fracture Surface Appearance of Charpy Specimens

(a) +20° C

(b) -25° C

(c) -50° C
