STURGEON RIVER

2018 Watercourse Crossing Assessment

Prepared for: North Saskatchewan Watershed Alliance

Date: January 24, 2019

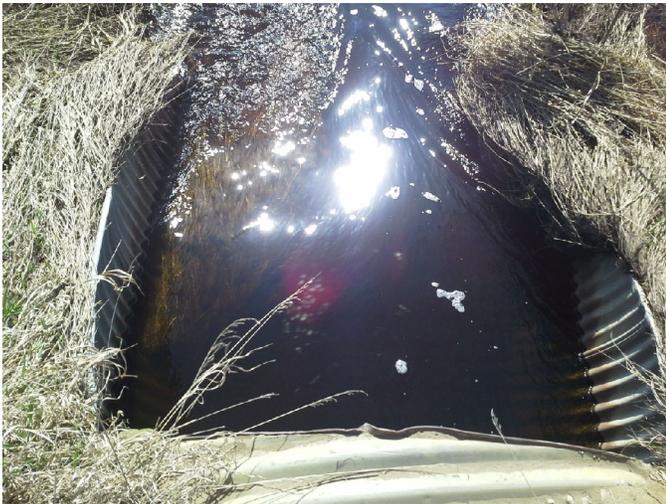
Photo No.: Photos-20180507-173419.jpg
Description: Veg Bunch In Outlet

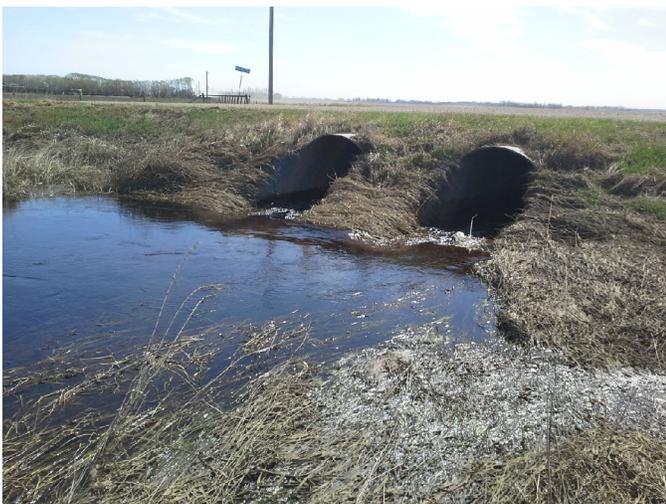
Photo No.: Photos-20180507-174213.jpg
Description: Inlet

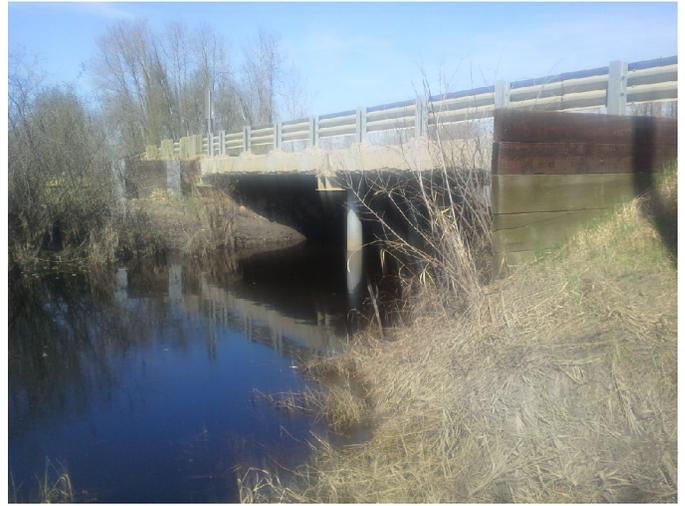
Photo No.: Photos-20180508-175535.jpg
Description: Outlet

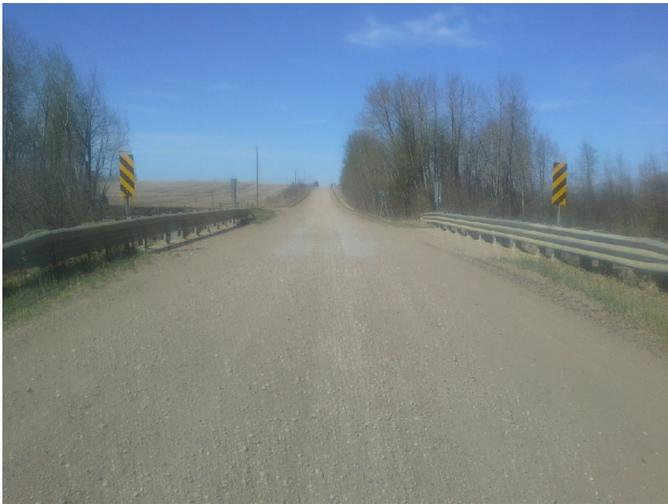
Photo No.: Photos-20180508-175611.jpg
Description: Deck

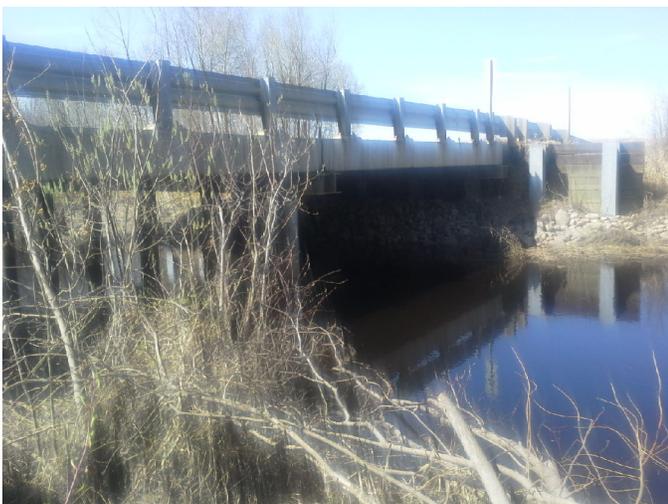
Photo No.: Photos-20180508-175712.jpg
Description: Inlet

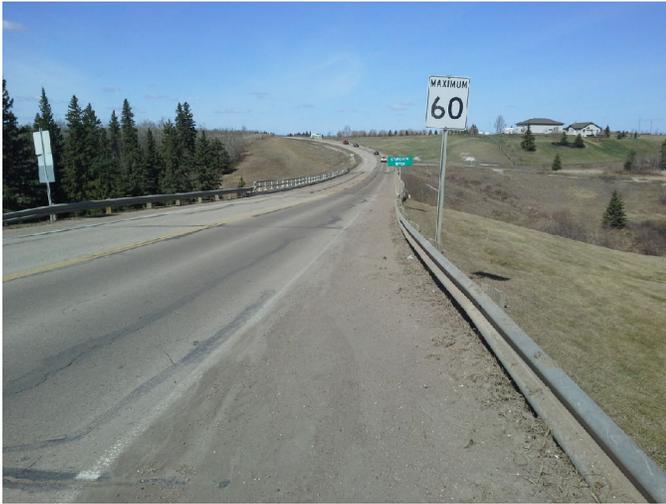
Photo No.: Photos-20180504-172702.jpg
Description: Deck

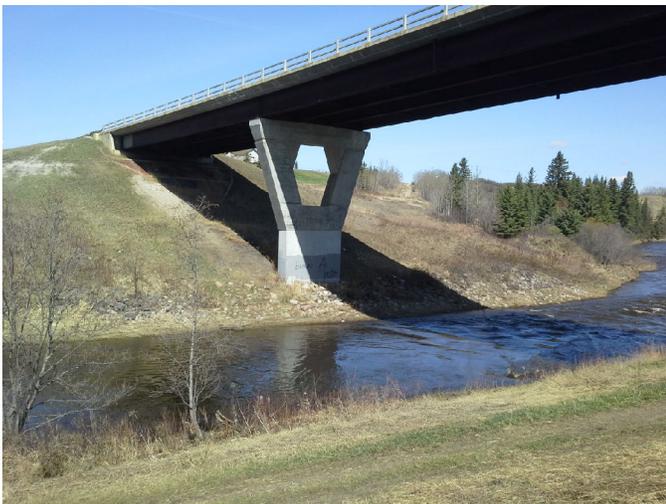
Photo No.: Photos-20180504-173356.jpg
Description: Inlet West

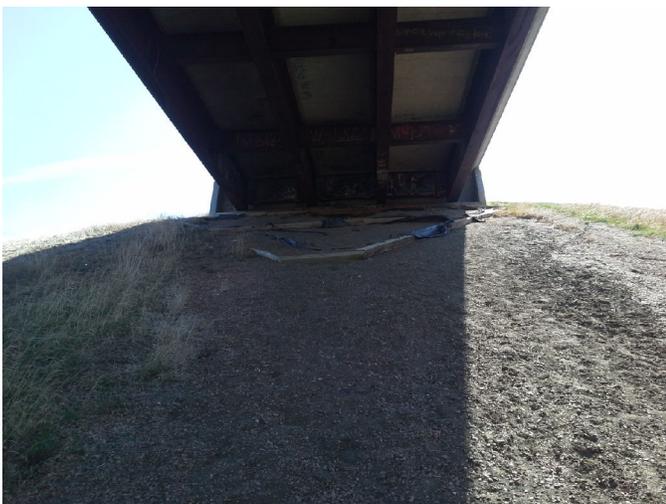
Photo No.: Photos-20180504-173600.jpg
Description: Armour

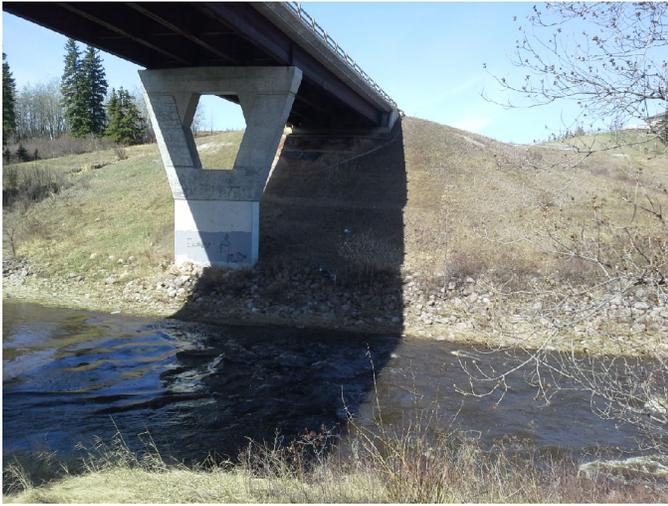
Photo No.: Photos-20180504-173646.jpg
Description: Outlet West

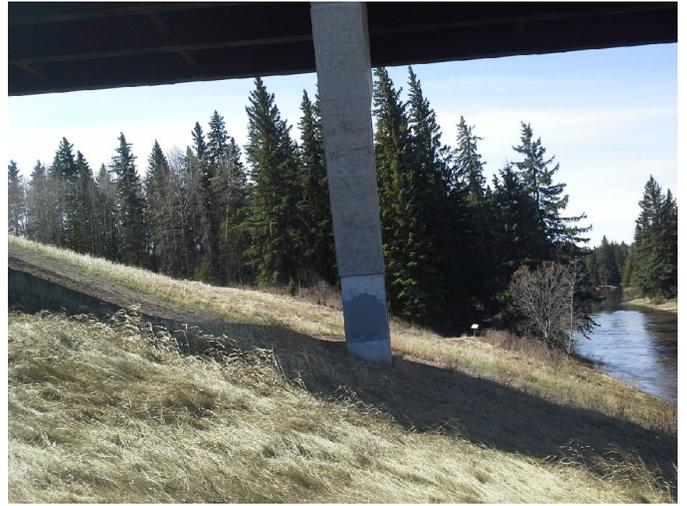
Photo No.: Photos-20180504-173715.jpg
Description: Outlet - East

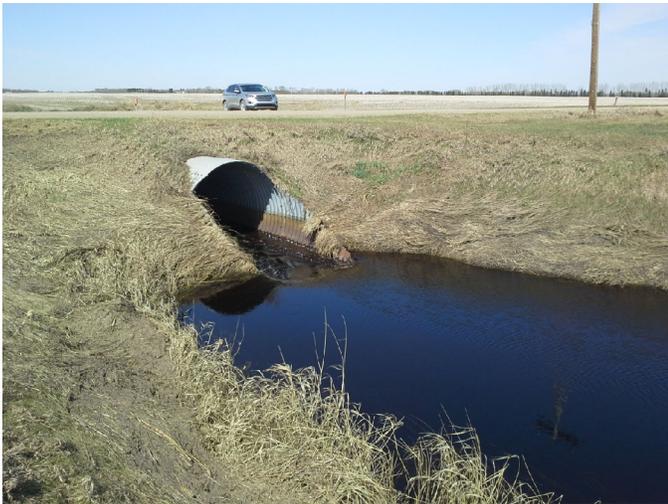
Photo No.: Photos-20180507-180127.jpg
Description: Inlet

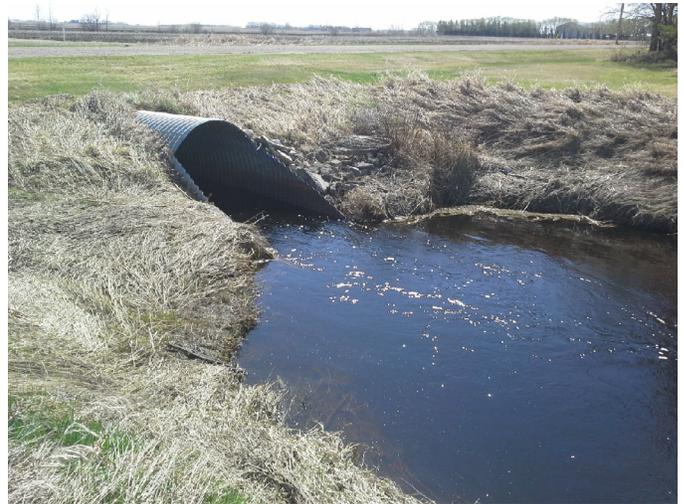
Photo No.: Photos-20180507-180241.jpg
Description: Outlet

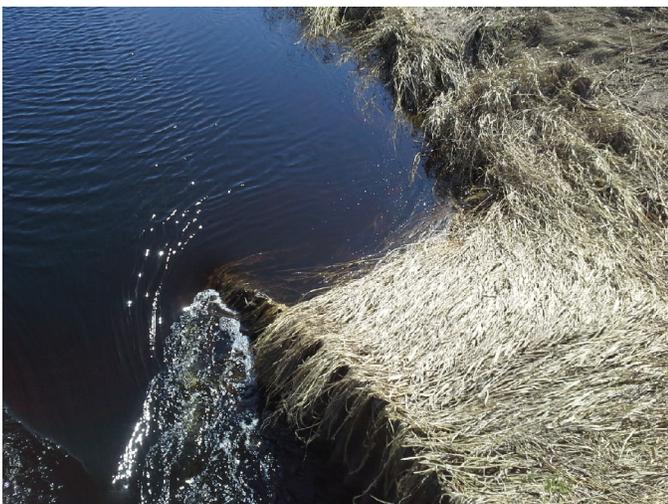
Photo No.: Photos-20180507-180437.jpg
Description: Side of culvert pools

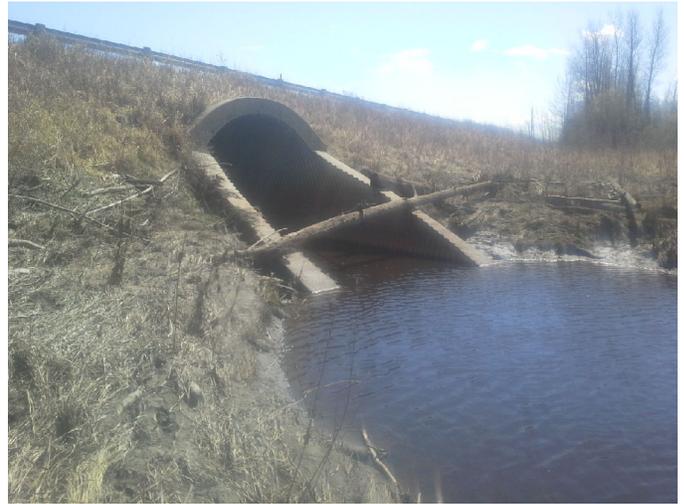
Photo No.: Photos-20180508-195804.jpg
Description: Inlet

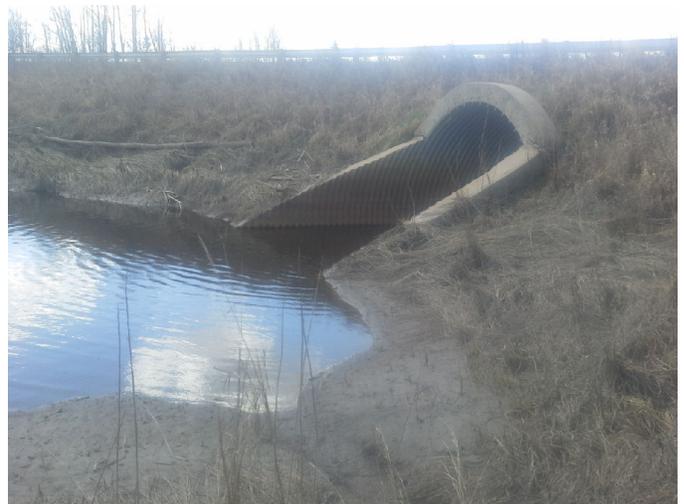
Photo No.: Photos-20180508-200037.jpg
Description: Downstream

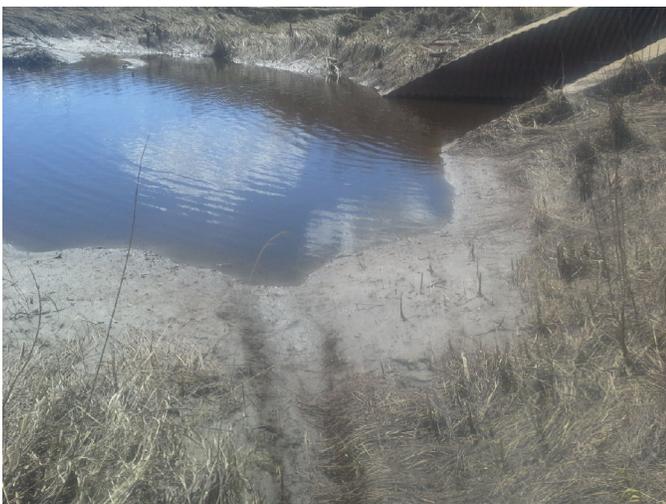
Photo No.: Photos-20180508-200222.jpg
Description: Outlet

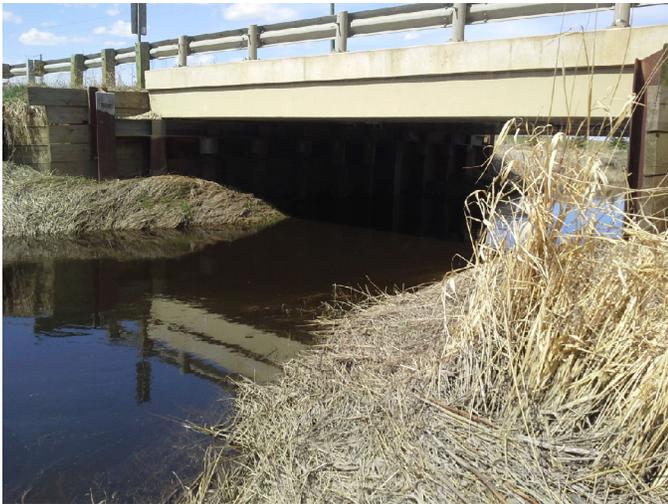
Photo No.: Photos-20180507-202114.jpg
Description: Outlet

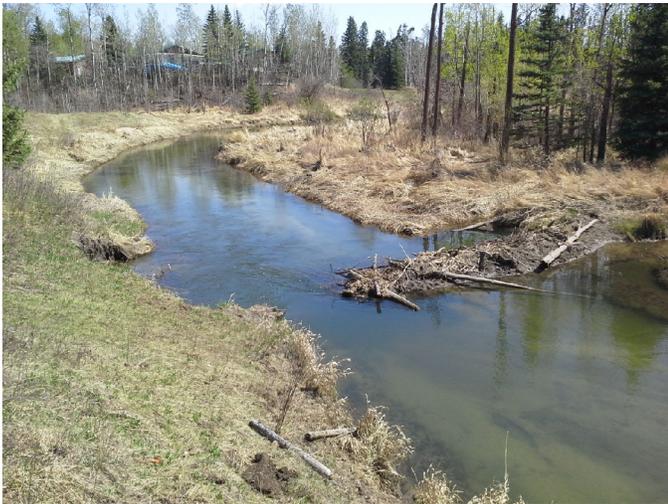
Photo No.: Photos-20180511-193743.jpg
Description: Downstream with 3/4 beaver dam

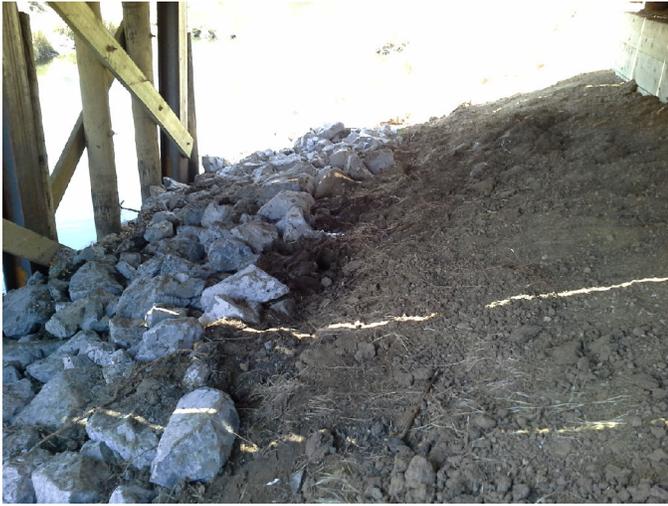
Photo No.: Photos-20180511-194337.jpg
Description: Rip rap

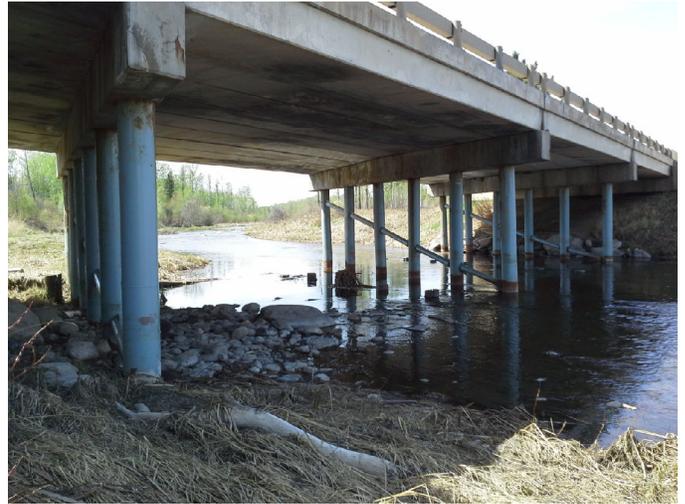
Photo No.: Photos-20180514-202621.jpg
Description: Outlet

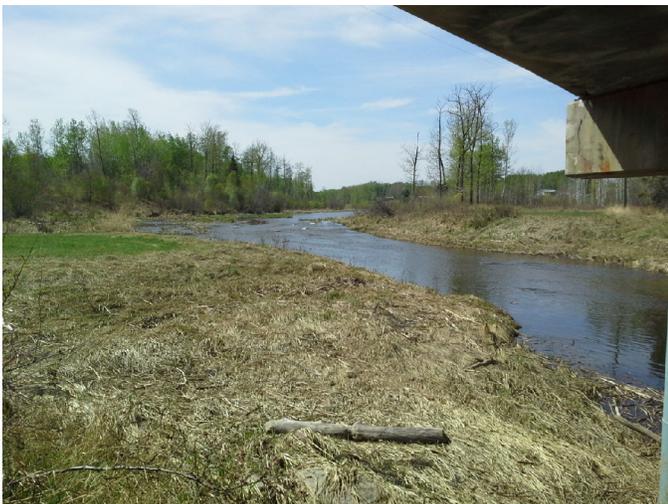
Photo No.: Photos-20180514-202746.jpg
Description: Upstream

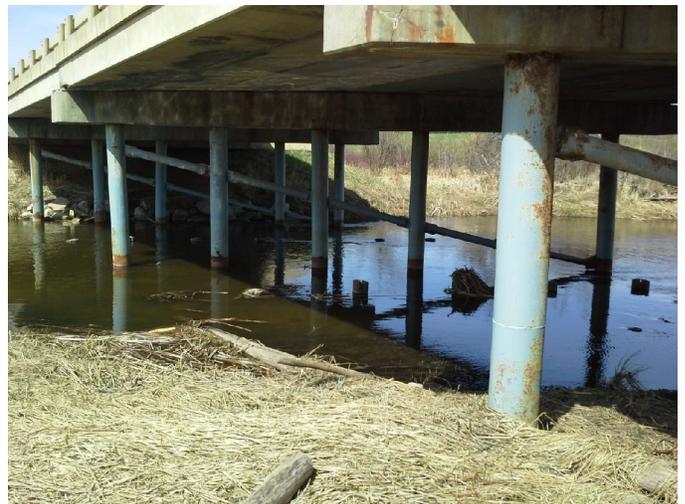
Photo No.: Photos-20180514-202825.jpg
Description: Inlet
