NSWA Sturgeon River Watercourse Assessment

## **Appendix 5: High Risk Watercourse Crossing Overview Map and Field Sheets**

**NWSA**  
**Sturgeon River Study**  
 Water Course Crossing

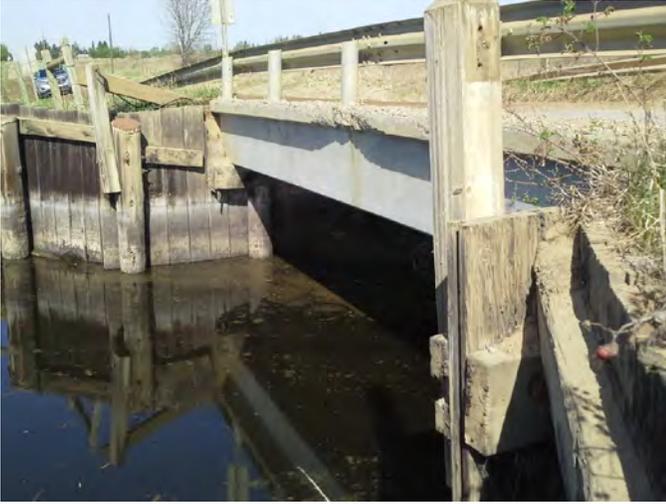
Photo No.: Photos-20180514-162446.jpg  
Description: sedimentation from road

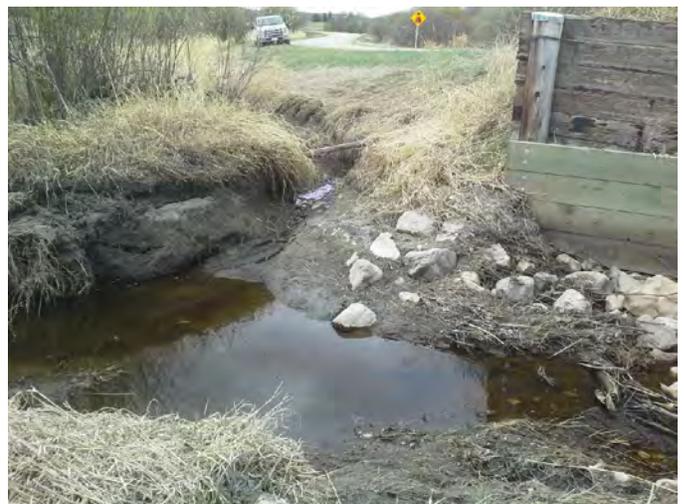
**Comments:** Area of secondary inflow has brought material to in front of wingwall.

Photo No.: Photos-20180509-172106.jpg  
Description: Secondary inflow

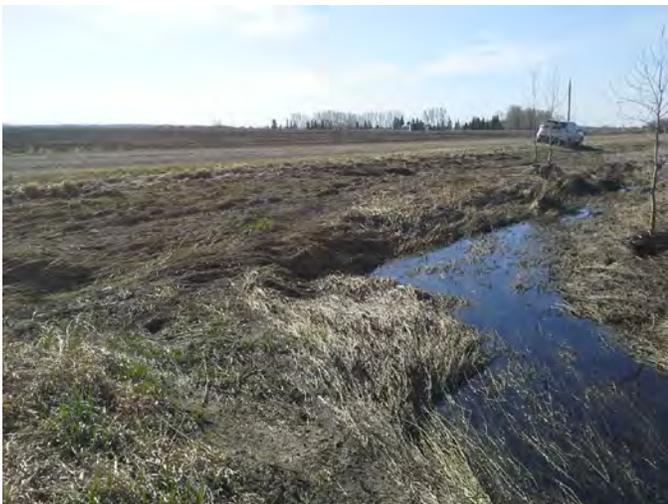
**Comments:** No culvert found for crossing road. There is no water apparent on other side of road. Creek flows along ditch. Has the flow been altered from a historical route when the road was created?

Photo No.: Photos-20180507-160413.jpg  
Description: Towards Road

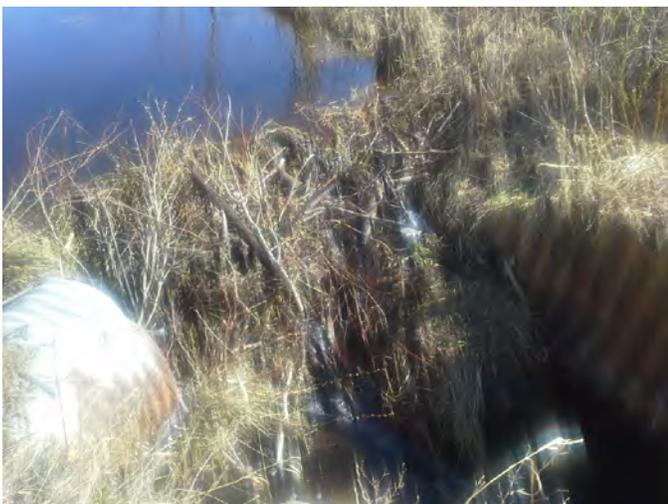
**Comments:** logs and sticks causing blockage are beaver removed and possibly flowed downstream collecting in culvert inlet . second culvert on north side of TS 572 fully exposed with outlet gap of 0.4m is aiding in collection of sticks. third culvert on south side of TS 572 is situation in the same fashion but not causing concerns. serious fish passage concerns due to pooling upstream from 90% blockage. blockage is at the tip of culvert. Possible breakage of blockage and flash flooding downstream

Photo No.: Photos-20180508-164626.jpg  
Description: Blockage

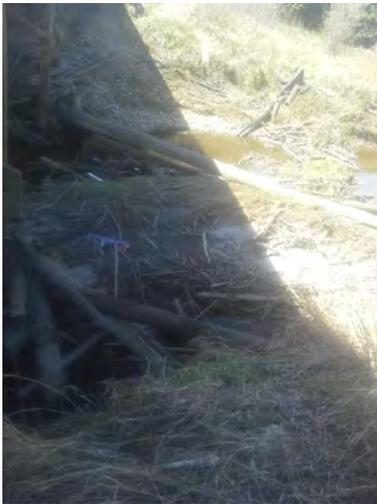
Photo No.: Photos-20180508-193835.jpg  
Description: Blockage Inlet

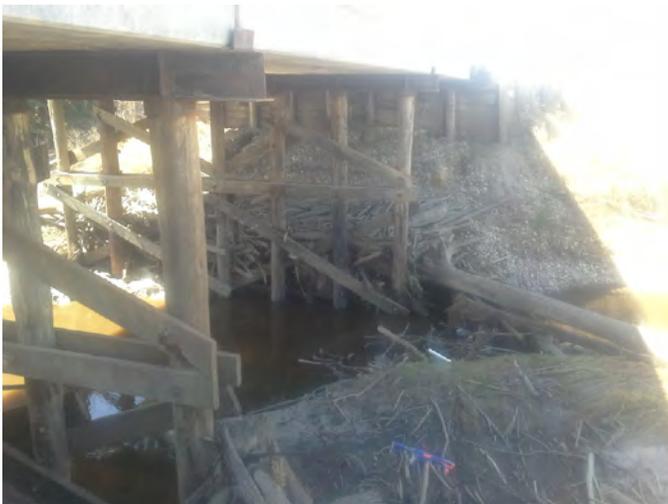
Photo No.: Photos-20180508-193923.jpg  
Description: Blockage

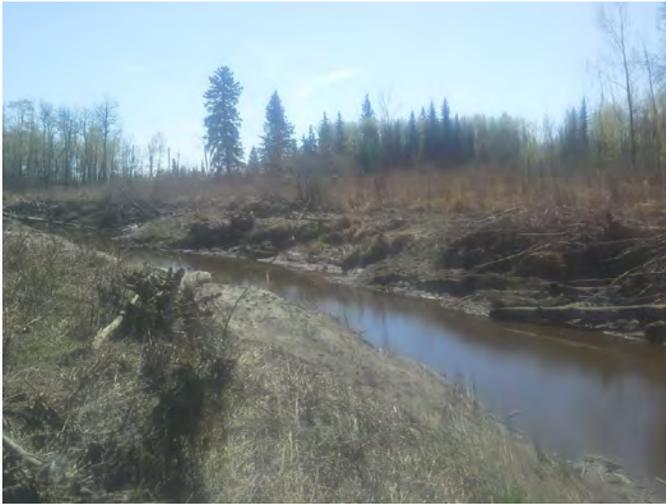
Photo No.: Photos-20180508-194145.jpg  
Description: Downstream

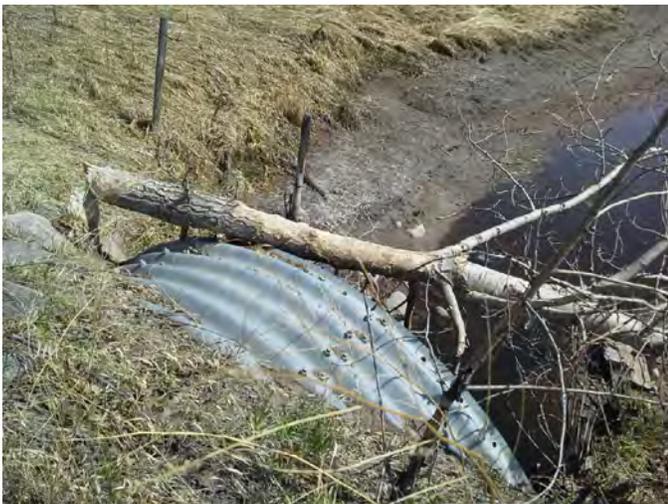
Photo No.: Photos-20180514-183320.jpg  
Description: Beaver activity

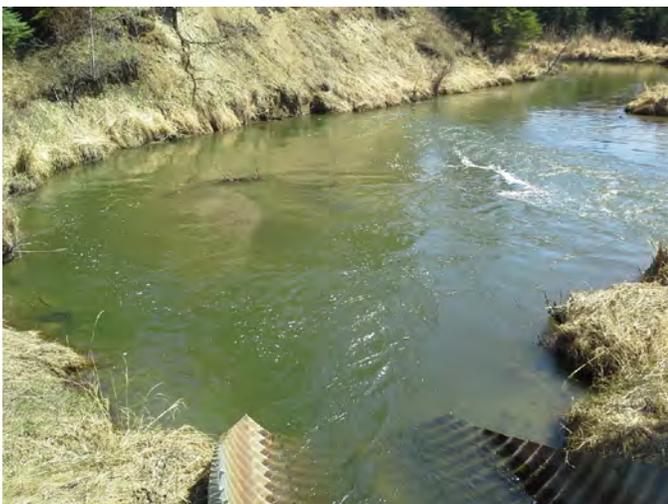
Photo No.: Photos-20180511-200159.jpg  
Description: Scour pool

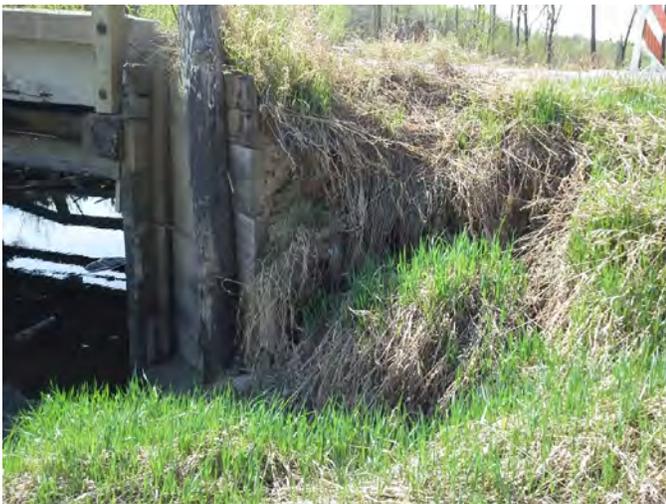
Photo No.: Photos-20180514-172915.jpg  
Description: Erosion

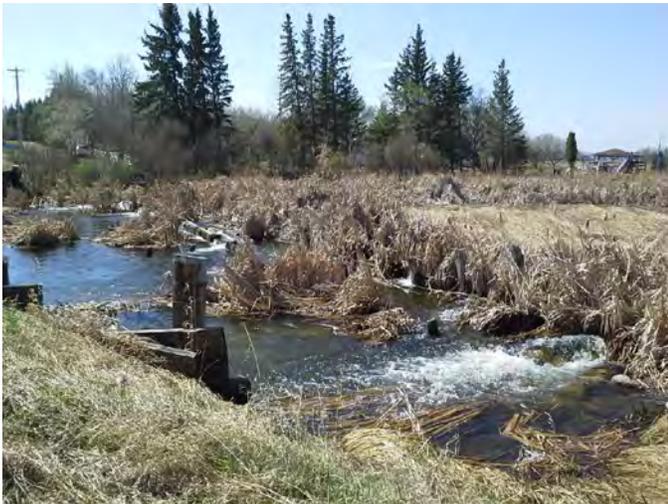
Photo No.: Photos-20180511-174755.jpg  
Description: Blockage upstream

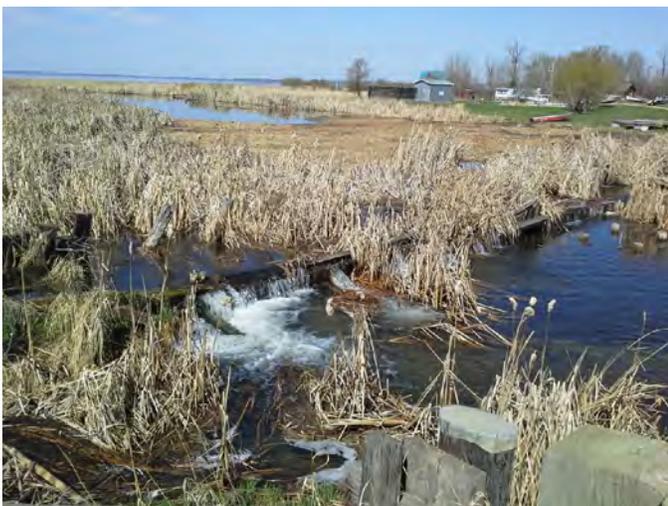
Photo No.: Photos-20180511-175107.jpg  
Description: Blockage

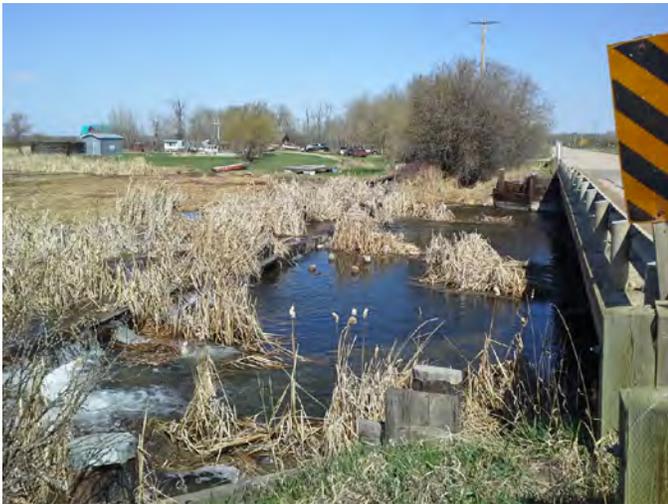
Photo No.: Photos-20180511-175949.jpg  
Description: Distance between blockage and bridge at inlet

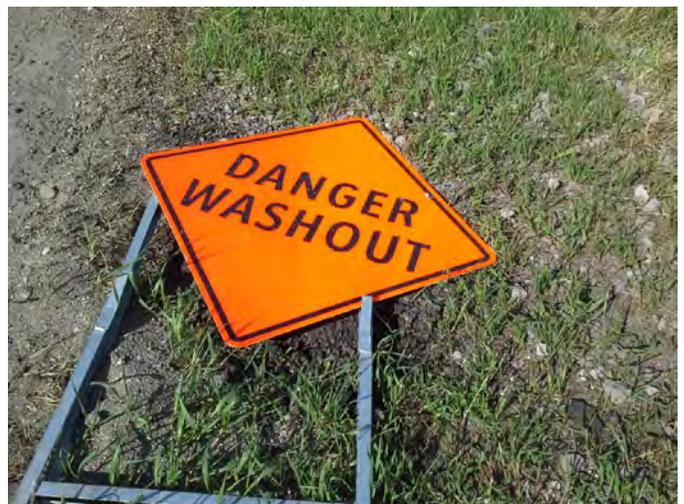
Photo No.: Photos-20180518-171253.jpg  
Description: Sign in area

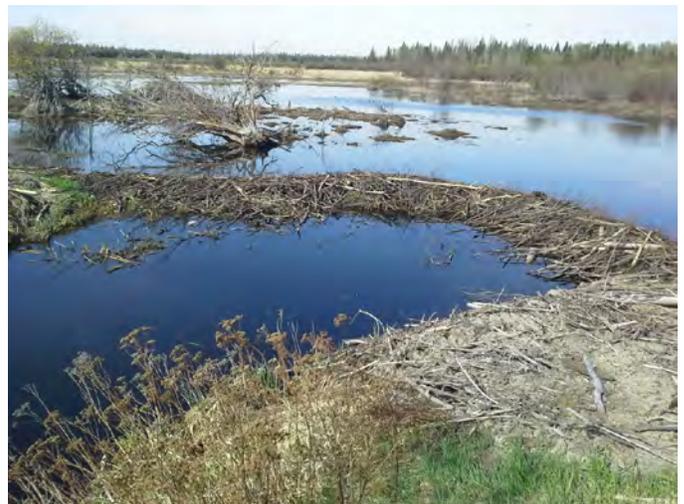
Photo No.: Photos-20180514-155956.jpg  
Description: beaver dam

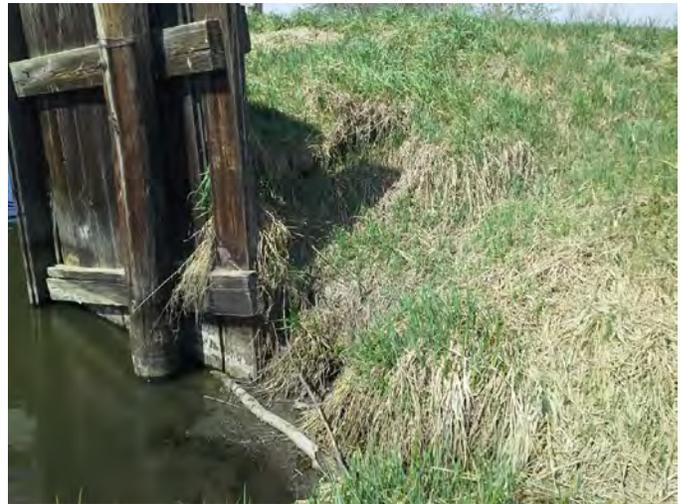
Photo No.: Photos-20180516-173632.jpg  
Description: Slumping

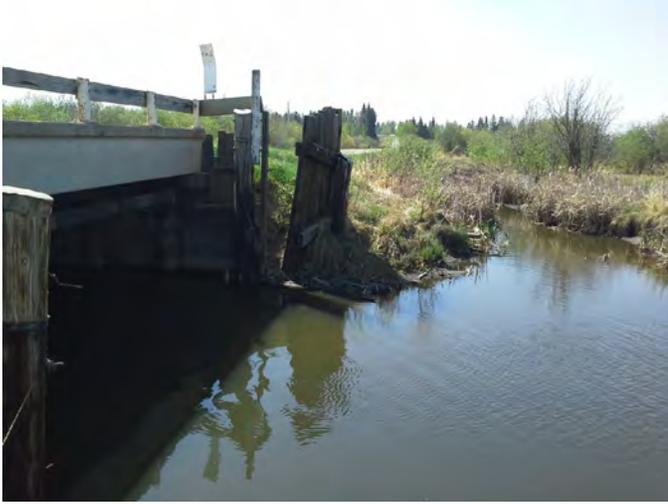
**Comments:** Two wingwalls have started to let go from the main structure. Creeks looks to have been anthropologically directed in which way to go. Marshlands on either side of creek and both up and downstream of bridge. Bullet holes in grader markers.

Photo No.: Photos-20180516-173759.jpg  
Description: Second wing wall failing

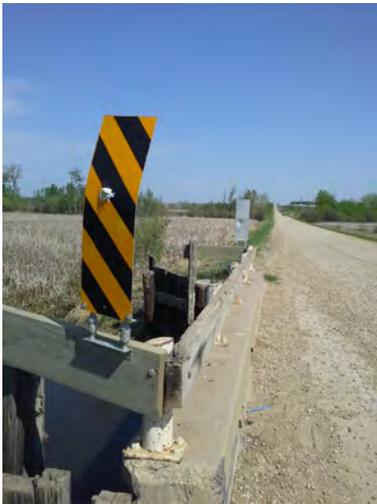
Photo No.: Photos-20180516-173856.jpg  
Description: Shotgun bullet holes in graders

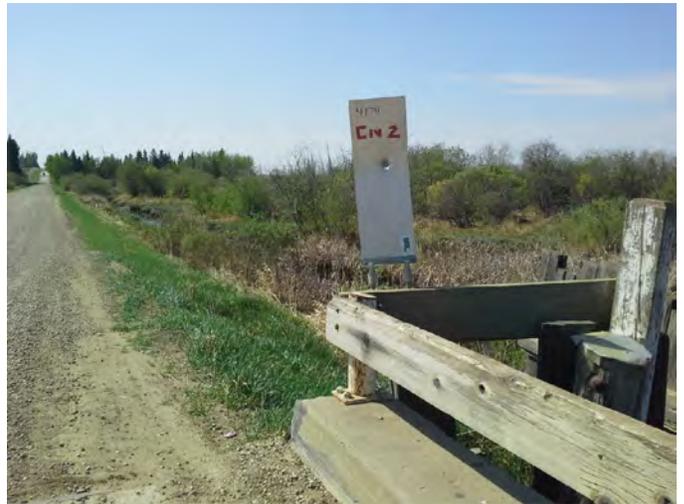
Photo No.: Photos-20180516-173941.jpg  
Description: Send channel upstream

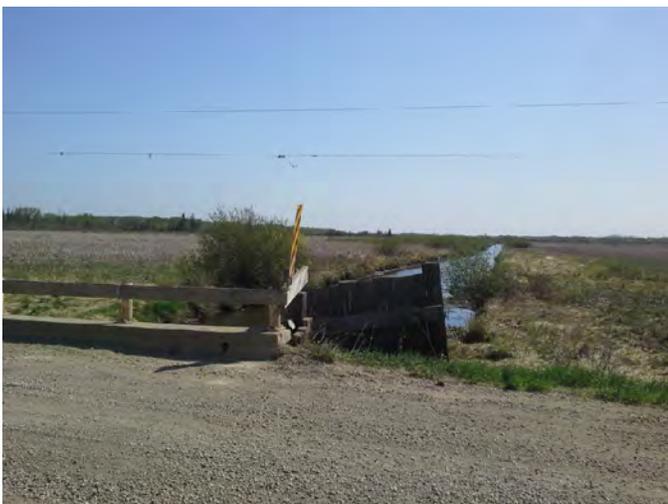
Photo No.: Photos-20180516-174219.jpg  
Description: Downstream marshlands

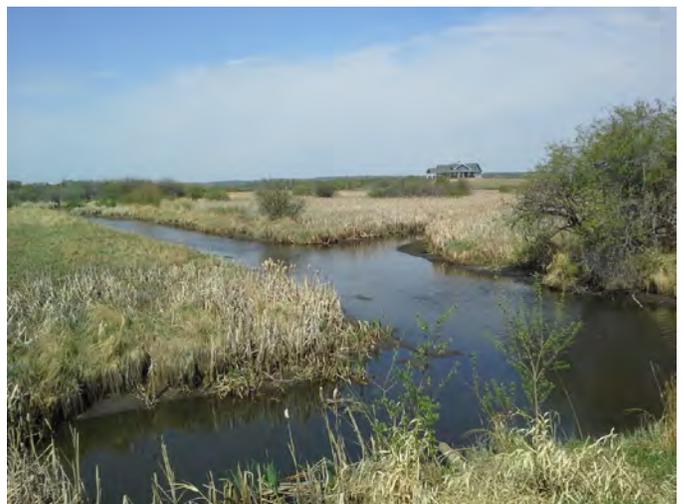
Photo No.: Photos-20180516-174239.jpg  
Description: Upstream marshlands

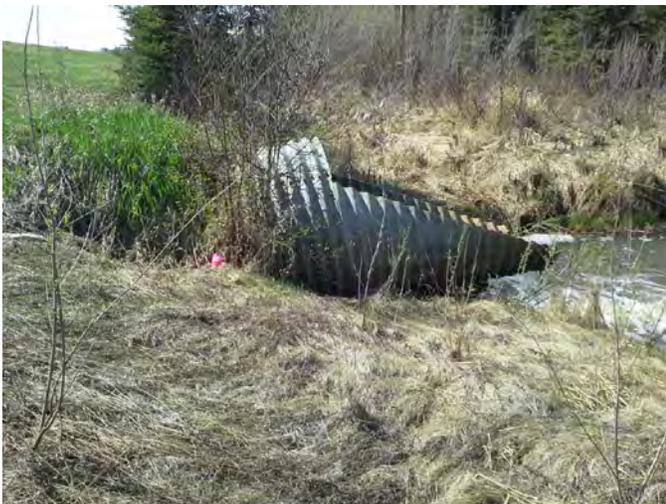
Photo No.: Photos-20180515-210521.jpg  
Description: Erosion

**Structural Problems:** Yes, undersized culvert and damaged

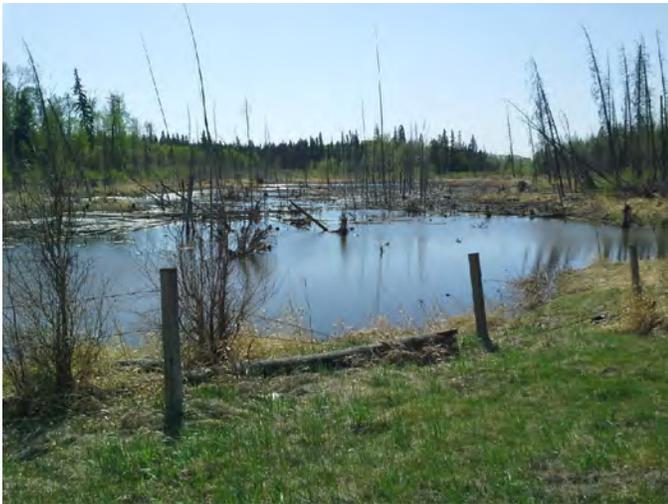
Photo No.: Photos-20180515-205343.jpg  
Description: Area view of water back up

**Comments:** Might have been a removal of a beaver dam recently, the debris blocking the inlet of the culverts is evident of beaver.

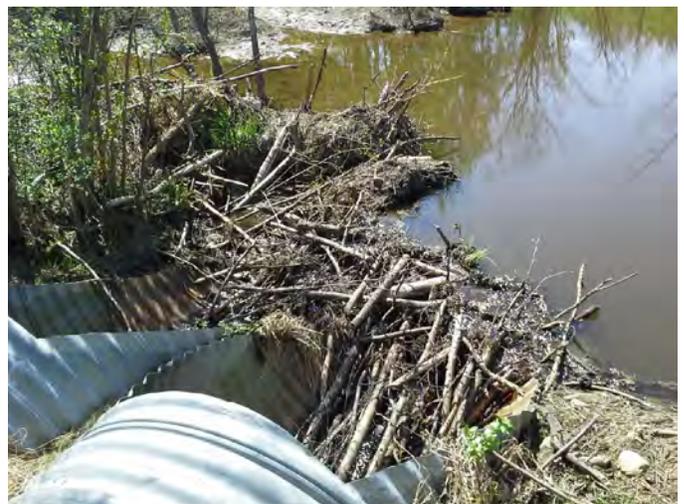
Photo No.: Photos-20180515-181452.jpg  
Description: Blockage

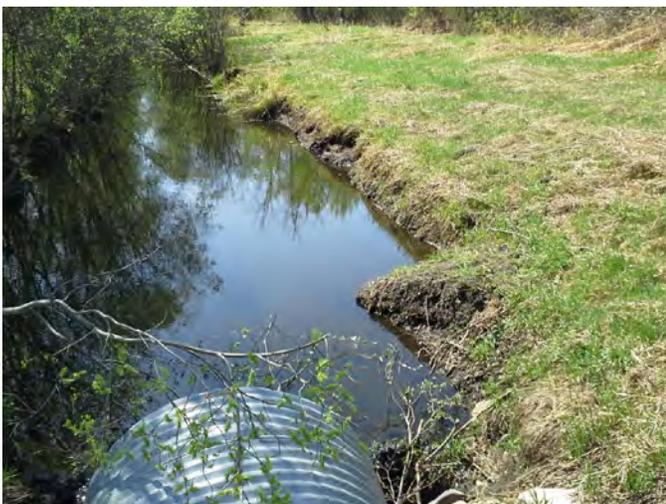
Photo No.: Photos-20180515-173259.jpg  
Description: Erosion

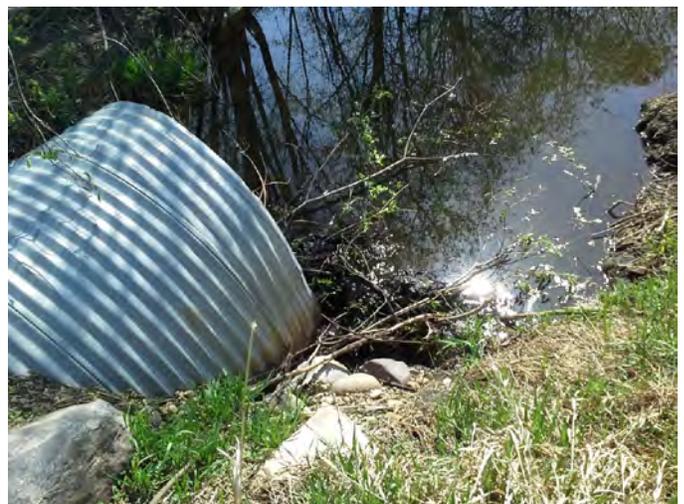
Photo No.: Photos-20180515-173347.jpg  
Description: Erosion

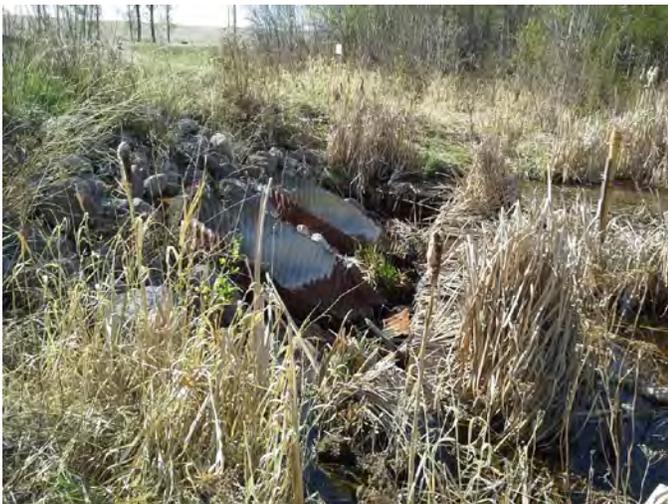
Photo No.: Photos-20180515-161716.jpg  
Description: Inlet

**Comments:** There is heavy debris build up of large logs at inlet. Damage to the south abutment lumber wall, possibly from large rip rap falling into wall.

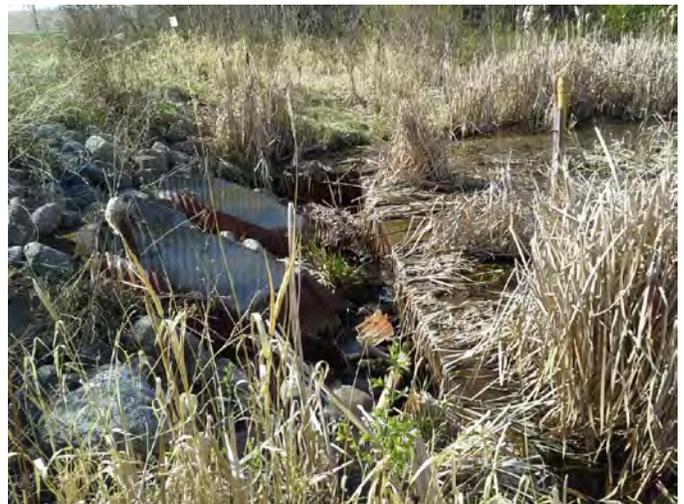
Photo No.: Photos-20180515-161734.jpg  
Description: Inlet

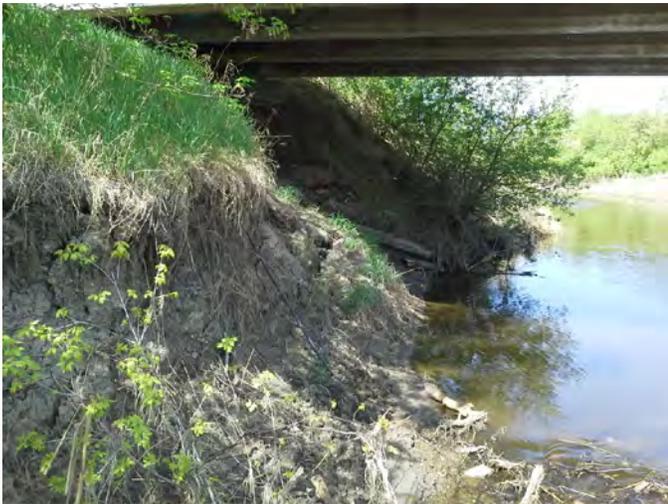
Photo No.: Photos-20180518-180929.jpg  
Description: Erosion

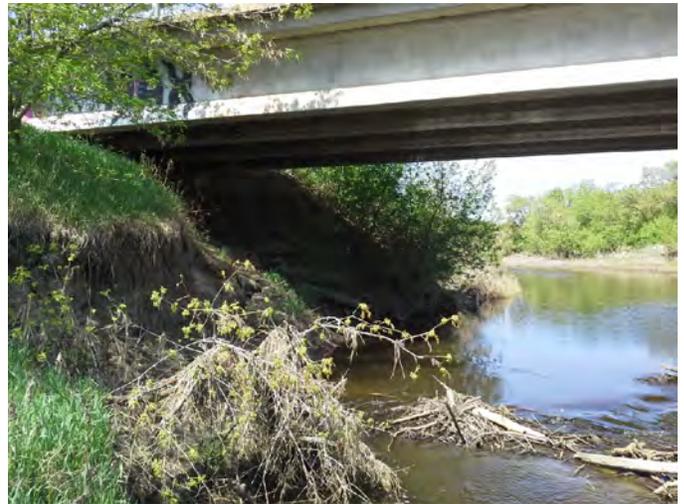
Photo No.: Photos-20180518-180953.jpg  
Description: Erosion

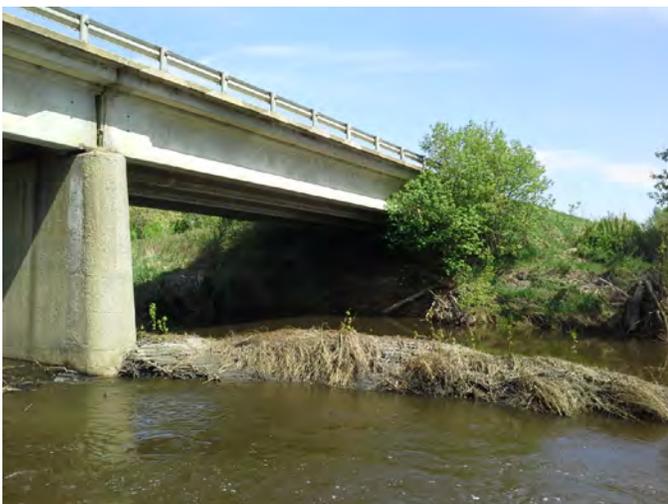
Photo No.: Photos-20180518-181008.jpg  
Description: Erosion

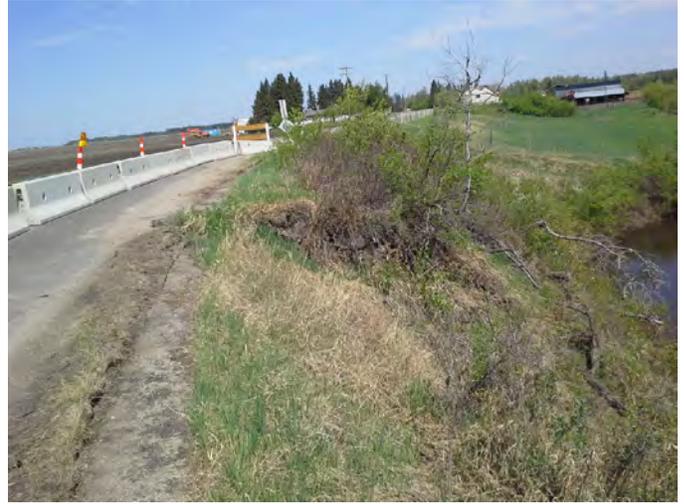
Photo No.: Photos-20180518-181524.jpg  
Description: Bank give out

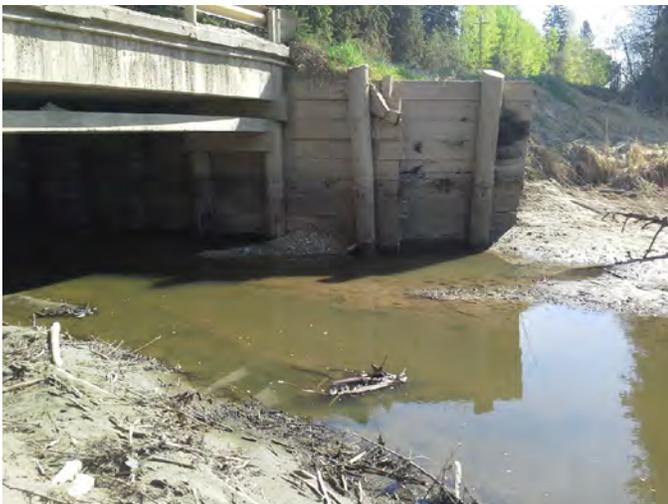
Photo No.: Photos-20180514-164405.jpg  
Description: Road material erosion
